Service Bulletin

Bulletin No.: 17-NA-357

Subject: Noise or Malfunction of Trim Door on Broken Quarter Upper Trim Panel, Possible Convertible Top Inoperative

Brand:	Model:	Model Year:		VIN:		Engine:	Transmission:
		from	to	from	to		
Chevrolet	Camaro Convertible	2016	2024	—	—	All	All

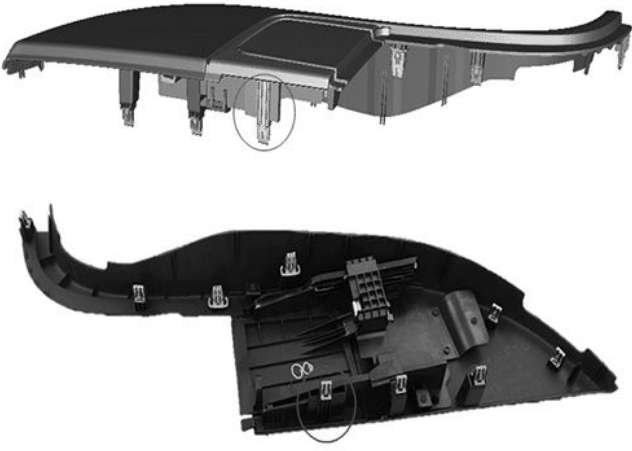
Involved Region or Country	North America, Argentina, Brazil, Bolivia, Chile, Colombia, Ecuador, Paraguay, Peru, Uruguay, Europe, Russia, Middle East, Israel, Japan, China, Taiwan, Philippines
Condition	<p>Some customers may comment on a noise or malfunction of the trim door on a quarter upper trim panel. Upon inspection, the technician may find the quarter upper trim panel broken.</p> <p>Upon inspection, the rear side rail link assembly underneath the trim cover may also be found damaged.</p> <p>Continued use, or an increased interference, may eventually render the convertible top inoperative.</p>
Cause	The cause of the condition may be various reasons the quarter upper trim panel and/or rail link assembly may break or fail.
Correction	<div style="text-align: center;">

</div> <p>Note: As shown circled in the graphic above, the quarter upper trim panel design has been improved to include a 3rd retaining clip. 4889567</p> <p>Verify the condition, replace the affected quarter upper trim and possibly the quarter window regulator on that same side. Follow the vehicle build date breakpoint information noted in the Service Procedure below.</p> <p>Follow the vehicle build date breakpoint information noted in the Service Procedure below.</p>

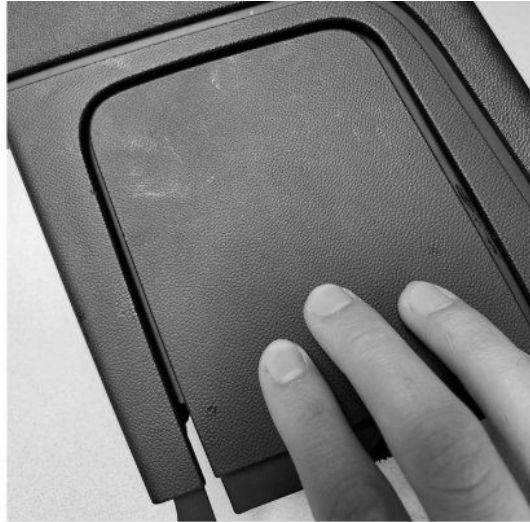
Example	Quarter Upper Trim Panel flip door in correct position on tracks with the top down:

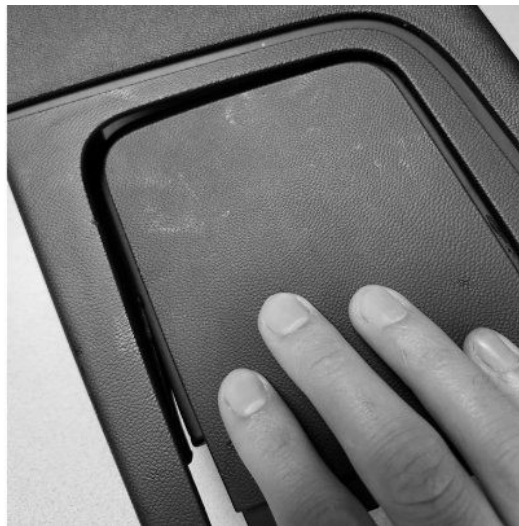
6750826

This is an example of the door off the track and vulnerable to damage if folding top is commanded to close.

Important: DO NOT apply any downward force on this door while the folding top is down.
