PROTERRA

TECHNICAL SERVICE BULLETIN

ISSUE DATE:	6/21/2022
SERVICE BULLETIN SUBJECT:	Upper Stanchion Spatula Retrofit
VINs or MODELS AFFECTED:	Service Specified Buses
COMPLETE BY:	Next Service Opportunity
SERVICE BULLETIN #:	SC-22-73
LABOR OPERATION CODE:	IR56Z

UPPER STANCHION SPATULA RETROFIT

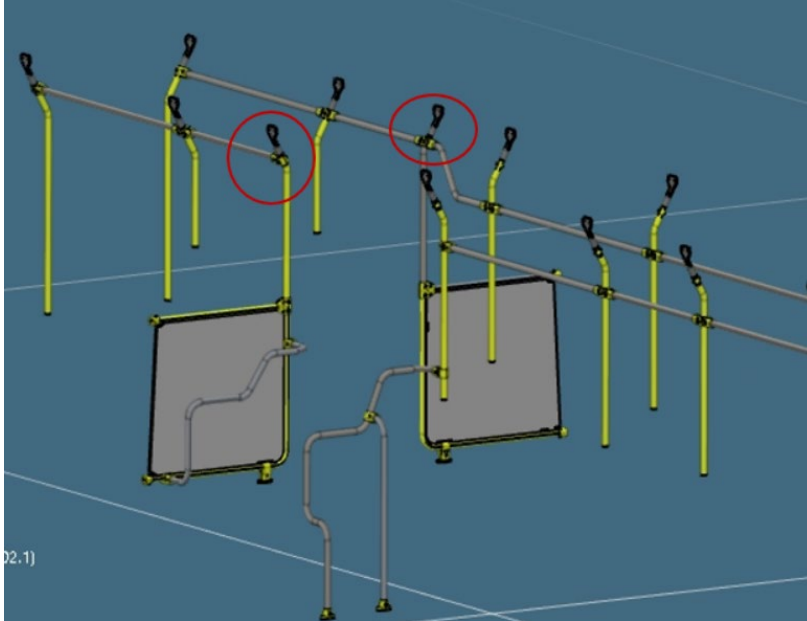
1. Working inside the bus, locate any damaged upper Stanchion Fittings.
2. Using a 3/16-Inch Allen Driver, replace the commonly failed Spatulas shown circled in red in the following illustration. Escalate the work order with Proterra Service if additional damaged fittings are found.
