# Service Bulletin

Bulletin No.: 24-NA-145

**Subject: Malfunction Indicator Lamp (MIL) Illuminated - DTC P219A Set as Current or History**

Brand:	Model:	Model Year:		VIN:		Engine:	Transmission :
		from	to	from	to		
Buick	Enclave	2024	2025			2.5 LK0	
Chevrolet	Traverse						
GMC	Acadia

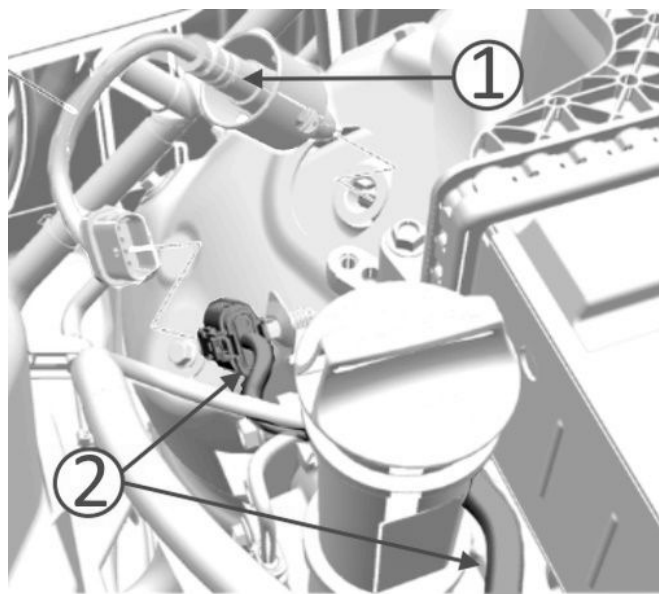
6709693

**Note:** The wiring from the PCM X3 connector cavity 48 routes to cavity 3 and cavity 49 routes to cavity 4 in the HO2S connector.

1. Disconnect the battery negative cable.
2. Remove the Air Cleaner Outlet Duct. Refer to *Air Cleaner Outlet Duct Replacement* in SI.
