## STAR ONLINE PUBLICATION

**Case Number:** S2402000003

**Symptom/Vehicle Issue:** Front Control Arm Bushing Has Rubber Peeled Away From The Bushing.

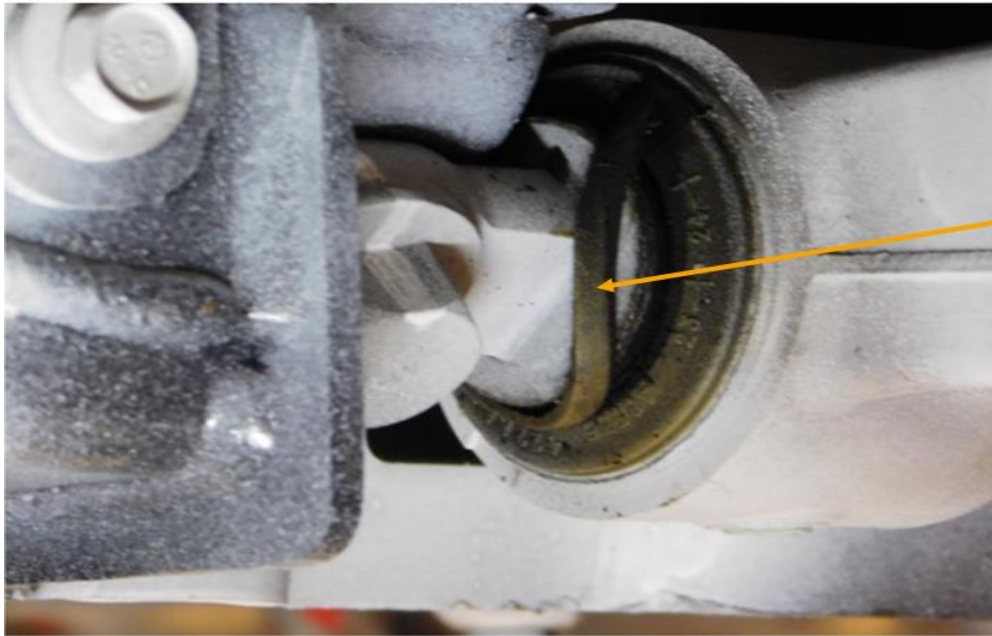
The above image is an ok condition and not a bushing failure. This flashing is not a functional part of the control arm front dog bone bushing and will cause no issue for the customer. No parts should be replaced for this appearance condition.
