**SIB 28 02 24**

SERVICE ACTION: DOUBLE CLUTCH TRANSMISSION REWORK AT TRANSFER CASE

U11 (X1 Sports Activity Vehicle)	U10 (X2 Sports Activity Coupe)
----------------------------------	--------------------------------

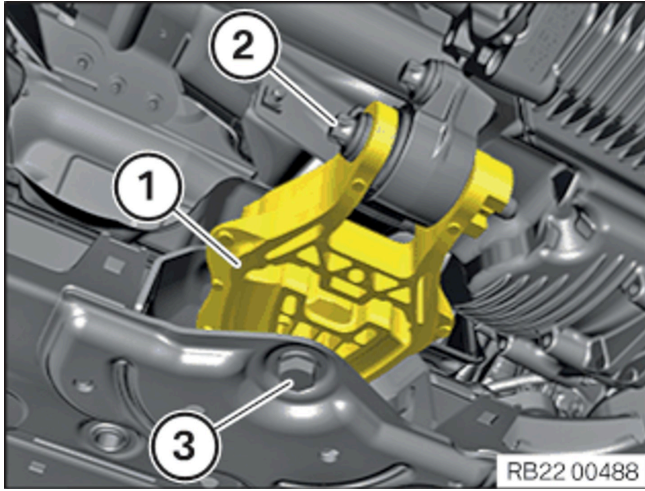
Remove the stabilizer link (1).

Reinstallation: Replace bolts 2 and 3

Tighten to 100 Nm and torque angle 90°

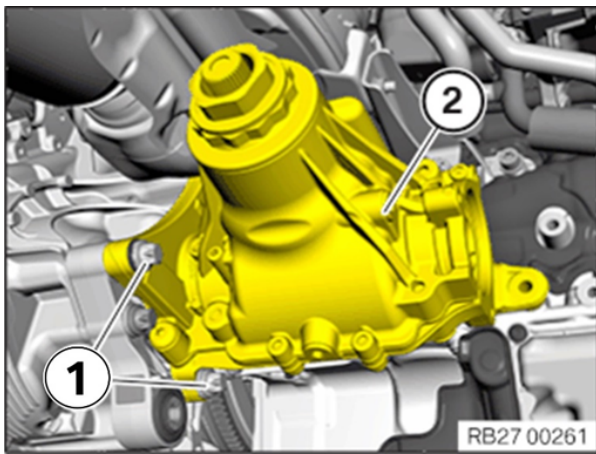
Remove the two bolts (1) on the transfer case.

Reinstallation: Replace both bolts

Tighten to 100 Nm and torque angle 90°
