REFERENCE:	TSB: 08-047-24 REV. A GROUP: 08 - Electrical	Date:	November 19, 2024	REVISION:	08-047-24
VEHICLES AFFECTED:	2023 - 2024 (GG) Dodge Hornet This bulletin applies to vehicles built on or before September 04, 2023 (MDH 0904XX).			MARKET APPLICABILITY:	
				<input checked="" type="checkbox"/> NA	<input type="checkbox"/> MEA
				<input type="checkbox"/> SA	<input type="checkbox"/> IAP
				<input type="checkbox"/> EE	<input type="checkbox"/> CH
CUSTOMER SYMPTOM:	Customers may experience one or more of the following: <ul style="list-style-type: none"> Dome lamps do not illuminate when the door is opened. Dome lamps do not illuminate when switched to ON. 				
CAUSE:	Wiring issue

This bulletin involves modifying the dome lamp wiring harness by adding a resistor in line with circuit M24 and updating the Body Control Module (BCM) software.

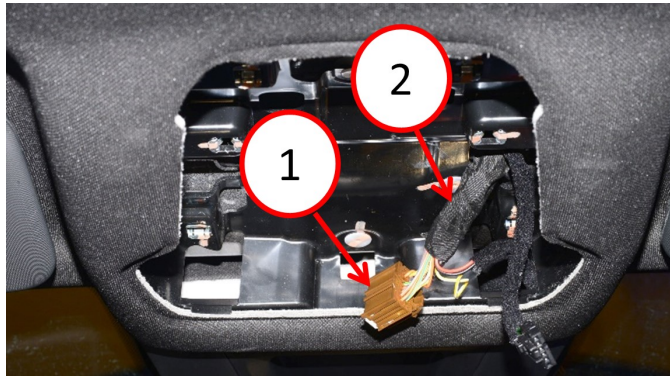
Fig. 1
Dome Lamp Wiring Harness Connector And Tape

1 - Dome Lamp Wiring Harness Connector
2 - Tape To Remove

7. Remove the front dome lamp assembly. Refer to the detailed service procedures available in DealerCONNECT/Service Library under: Service Info > 08 - Electrical / 8L - Lamps and Lighting / Lamps/ Lighting - Interior / Lamp, Dome / Removal.
8. Remove approximately 0.7 - 1.18 cm (2 - 3 in.) of the wiring harness tape, from the dome lamp wiring harness [Fig. 1](#).

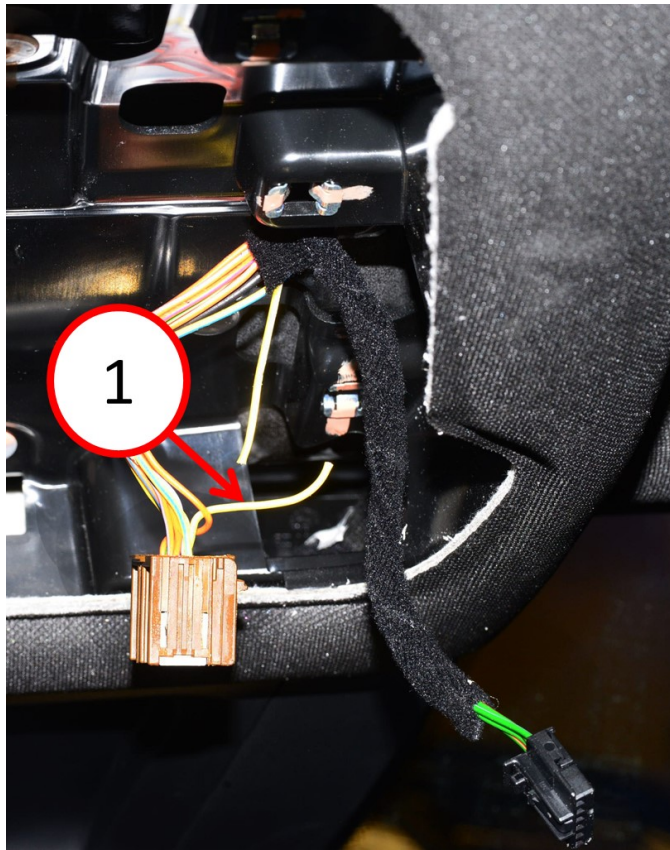
Fig. 2
Yellow/White Wire (Pin 6)

1 - Yellow/White Wire (Pin 6)

9. Cut the dome lamp wire harness yellow/white wire (pin 6) [Fig. 2](#).

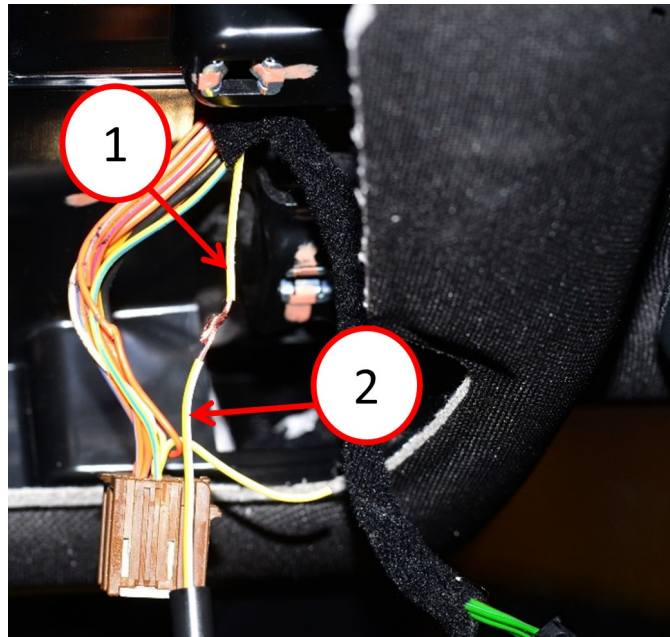
Fig. 4
Yellow/White Wires To Solder

1 - Yellow/White Wire From Connector
2 - Yellow/White Wire From Jumper

11. Solder the jumper harness to the dome lamp wire harness (pin 6) yellow/white wire [Fig. 4](#).

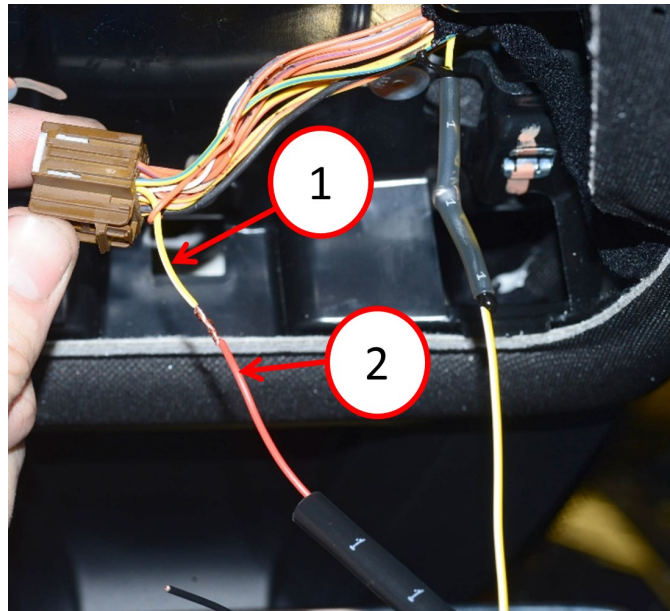
Fig. 5
Red Jumper Harness Wire To Dome Lamp Yellow/White Wire

1 - Yellow/White Dome Lamp Connector Wire (Pin 6)
2 - Red Jumper Wire Harness Wire

12. Using a suitable heat gun, heat the heat shrink tubing until it is tightly formed around the wires and sealant begins to seep out of both ends of the tubing.
13. Position heat shrink onto the red jumper harness wire and connect the red wire to the cut dome lamp yellow/white wire connector side (pin 6) [Fig. 5](#). **Do not heat the heat shrink tubing.**

14. Solder the red jumper harness wire to the yellow/white dome lamp connector wire (pin 6) [Fig. 5](#).
15. Using a suitable heat gun, heat the heat shrink tubing until it is tightly formed around the wires and sealant begins to seep out of both ends of the tubing.

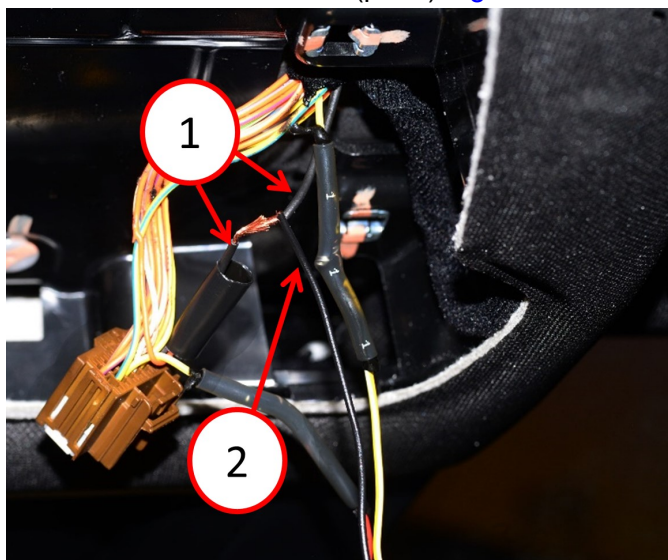
Fig. 6
Black Wires

1 - Black Dome Lamp Harness Wires (Pin 2)
2 - Black Jumper Harness Wire

16. Cut the dome lamp wire connector harness black wire (pin 2) [Fig. 6](#).

17. Position heat shrink onto one of the black wires and connect all three black wires [Fig. 6](#). **Do not heat the heat shrink tubing.**
18. Solder all three black wires from the jumper harness and the dome lamp wire harness black wire [Fig. 6](#).
19. Using a suitable heat gun, heat the heat shrink tubing until it is tightly formed around the wires and sealant begins to seep out of both ends of the tubing.
20. Using tesa tape, tape the soldered wire connections to the dome lamp wiring harness.
21. Insert the dome lamp wire harness with jumper wire harness, into the right side dome lamp assembly mounting square cavity [Fig. 7](#).

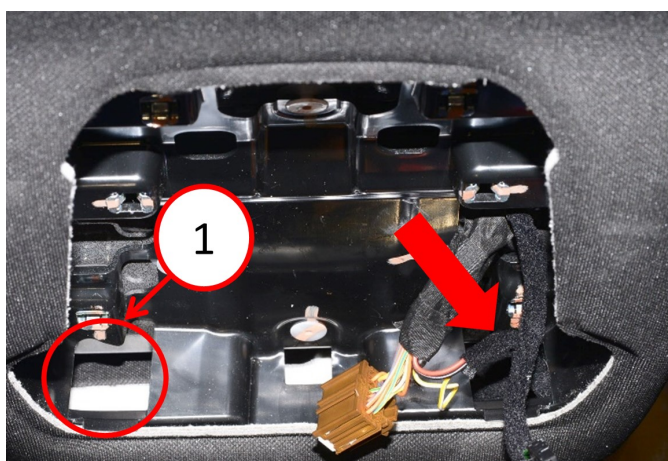
Fig. 7
Dome Lamp Assembly Mounting Cavities

1 - Left Side Dome Lamp Assembly Mounting Square Cavity Shown (Right Side Similar)
