REFERENCE:	TSB: 08-243-24 GROUP: 08 - Electrical	Date:	November 20, 2024	REVISION:	-
VEHICLES AFFECTED:	2024 (JL) Jeep Wrangler 2024 (JT) Jeep Gladiator This bulletin applies to vehicles equipped with a Uconnect 5 Nav W 12.3" Display (ECE) (Sales Code UHX).			MARKET APPLICABILITY: <input type="checkbox"/> NA <input type="checkbox"/> MEA <input type="checkbox"/> SA <input type="checkbox"/> IAP <input checked="" type="checkbox"/> EE <input type="checkbox"/> CH	
CUSTOMER SYMPTOM:	<p>Customers may experience one or more of the following:</p> <ul style="list-style-type: none"> • Unable to select the Turn by Turn Navigation. • Blank Performance Pages (Rearview Camera (RVC) Functions Normally). • Android Auto® Voice Recognition (VR) inoperative. • Media tuner delayed. • Charge Schedule not accepting updates via phone (RVC Functions Normally). • Ambient light inoperative. • Map in Instrument Panel Cluster (IPC) inoperative. • Media Widget blank. • Navigation map black. • Off-Road Pages inoperative (RVC Functions Normally). • VR inoperative. • Incorrect song title displayed (Carplay® only). • Radio display switches from Media Page to Home Page (RVC Functions Normally). • Ghost touch on Navi

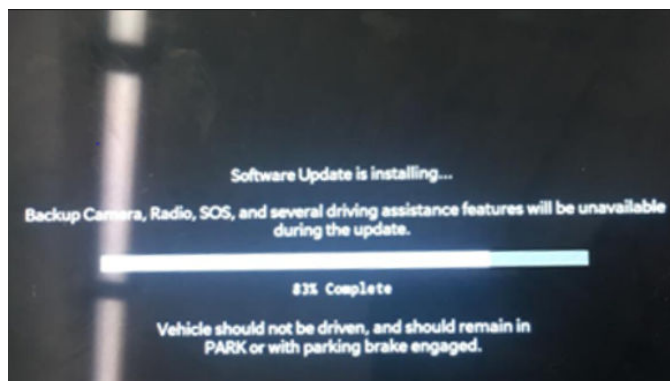
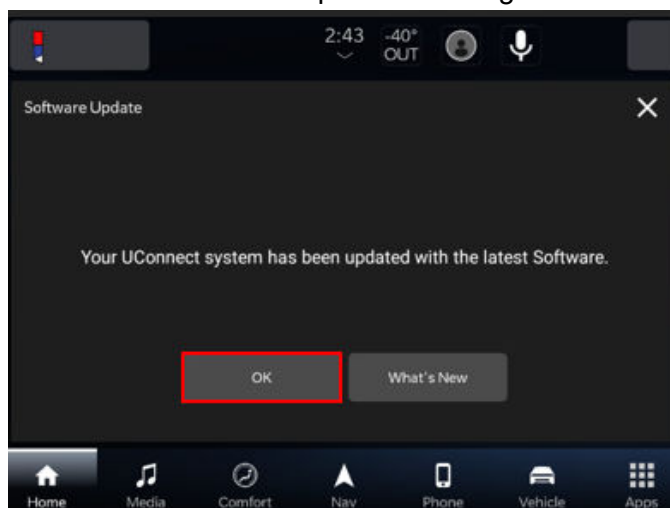
Fig. 5
Software Update Installing

Fig. 6
Software Update Complete

NOTE: System update process takes approximately five minutes. Wait until radio restarts and Home screen is displayed [Fig. 5](#), [Fig. 6](#).

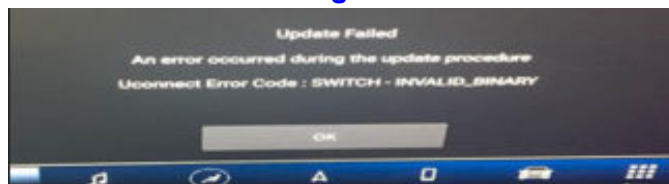
Fig. 7
Invalid_Binary_Switch Error

NOTE: Sometimes the radio throws an error pop up "Invalid_Binary_Switch" after successful radio update. Please ignore this error and click ok [Fig. 7](#).
