REFERENCE:	TSB: 08-038-24 REV. A GROUP: 08 - Electrical	Date:	November 23, 2024	REVISION:	08-038-24						
VEHICLES AFFECTED:	2019 - 2023 (BV) Jeep Renegade This bulletin applies to vehicles equipped with one of the following radios: <ul style="list-style-type: none"> • Uconnect 4 W 7" Display (Sales Codes UGG, ULG, UJG or UMG). • Uconnect 4 W 8.4" Display (Sales Codes UGM or UJM). • **Uconnect 4 with 7" Display (Sales Code UCG). • Uconnect 4 with 7" Display (Sales Code UAG).** 		MARKET APPLICABILITY:

This bulletin supersedes Technical Service Bulletin (TSB) 08-038-24, date of issue February 03, 2024, which should be removed from your files. All revisions are highlighted with **asterisks**** and include a new market, added new sales codes and updated Repair Summary.**

****This bulletin involves updating the software via USB to 23.04.17.01.****

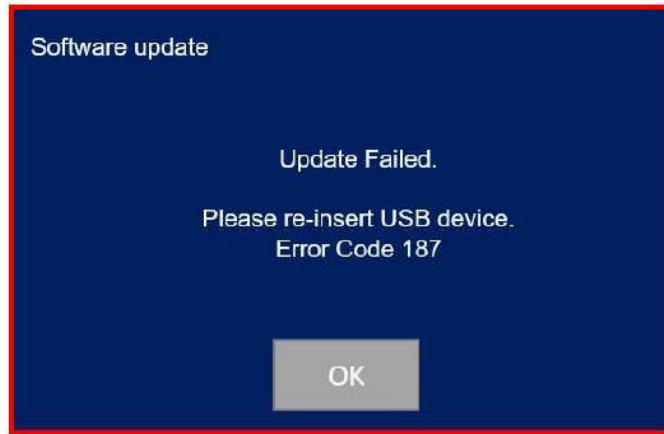
Fig. 7

11. If you see during reflash on the screen any error message like “Error code 187, 255 or 260” there is a reading problem with USB stick. Just reinsert USB. If it repeats use another USB stick [Fig 7](#).

Error Message Display
