S24DG

Subject: S24DG: 7.3L Transmission Oil Cooler Interface Update & Cross Contamination Inspection

S24DG: 7.3L Transmission Oil Cooler Interface Update & Cross Contamination Inspection

Models Affected: BBCV buses with Ford 7.3L / 6R140 with build dates between July 18th, 2022 through November 8th, 2023

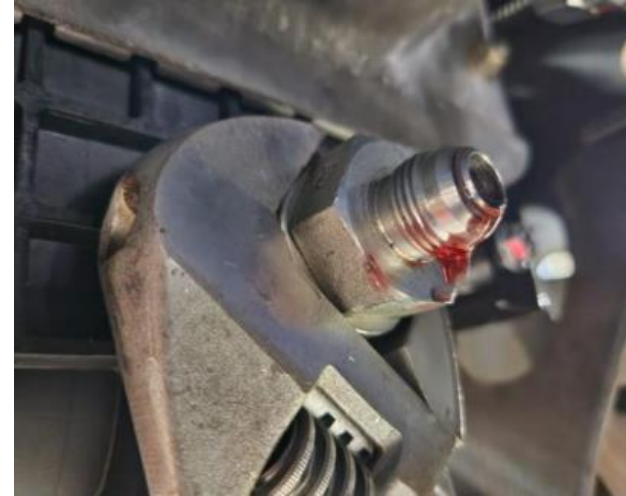
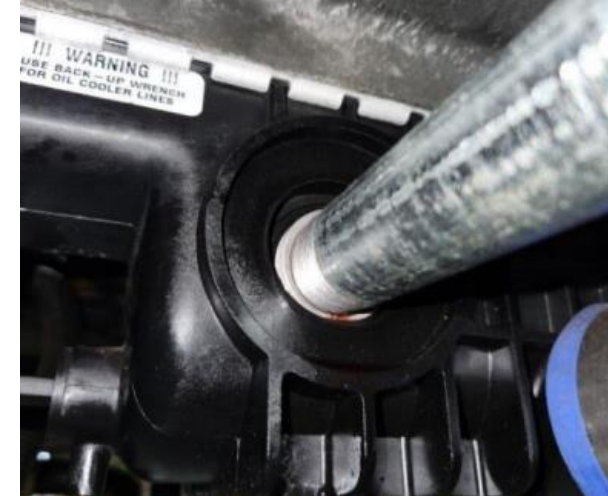
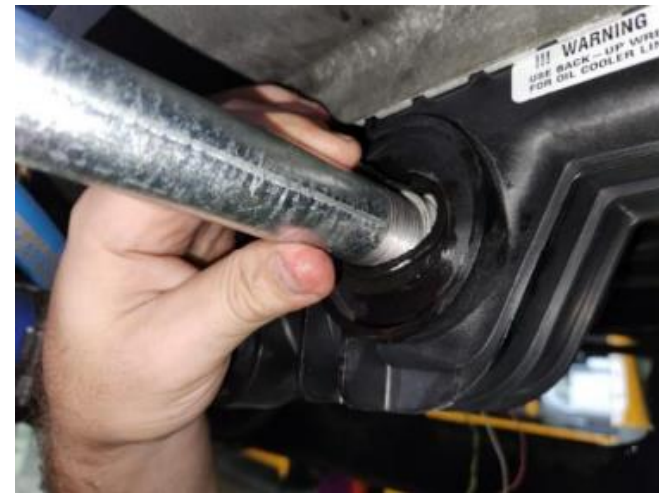
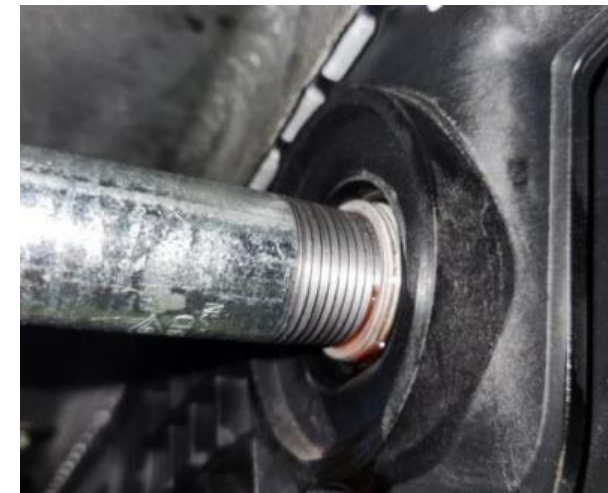
11) Using the pipe nipples for handles, remove & replace the EPDM gaskets that seals the trans cooler to the lower radiator tank. Use long pick to maneuver gasket in/out.

12) Using the same pick, remove hardened Loc-Tite™ from the trans cooler threads.

NOTE: Take your time here because any leftover Loc-Tite™ will inhibit the new nuts from threading on without galling the threads. The cooler is Stainless Steel and will gall easily.

13) Apply 271 and install both brass nuts that came in the 10059342 kit, using the pipe nipples to help position the cooler. Once hand tight, remove nipple at that location. Torque nuts to 28 Ft-LBS (38 N-M).

14) Remove pipe nipple, apply Loc-Tite™567 to NPT threads, and install 10081789 90° fitting into the left/driver's side cooler port. Clock fitting as shown to the right.
