GENERAL MOTORS
DCS7081
URGENT - DISTRIBUTE IMMEDIATELY

Subject: N242478260 - Service Update
Loose Steering Gear Motor Bolts/Fasteners

Models: 2024 Cadillac Escalade ESV
2024 Chevrolet Silverado 1500
2024 Chevrolet Suburban
2024 Chevrolet Tahoe
2024 GMC Sierra 1500

N242478260 Loose Steering Gear Motor Bolts/Fasteners

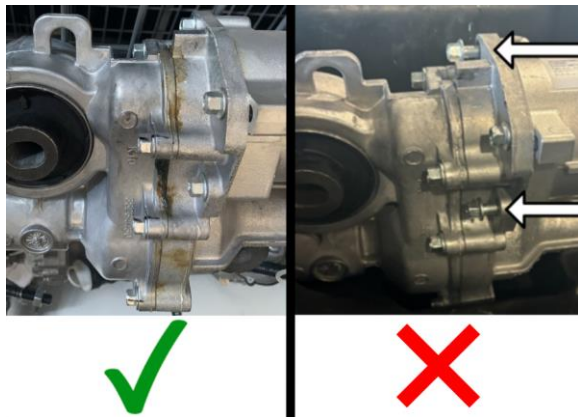
6765088

| Condition | Certain vehicles listed above may have a condition in which the steering gear motor bolts may be loose on steering gear assemblies. |

2. Inspect the Electric Belt Drive Rack and Pinion Steering Gear Fasteners for looseness.
 - If the Electric Belt Drive Rack and Pinion Steering Gear Fasteners are NOT LOOSE, no further action is required.
 - If the Electric Belt Drive Rack and Pinion Steering Gear Fasteners are LOOSE, proceed to Step 3.
3. Remove the Electric Belt Drive Rack and Pinion Steering Gear. Refer to *Electric Belt Drive Rack and Pinion Steering Gear Replacement* in SI.
4. Install the NEW Electric Belt Drive Rack and Pinion Steering Gear. Refer to *Electric Belt Drive Rack and Pinion Steering Gear Replacement* in SI.
5. Measure and adjust the front toe. Refer to *Wheel Alignment - Steering Wheel Angle and/or Front Toe Adjustment* in SI.
