Technical Service Bulletin (TSB)

Various Models - Engine Valley Cap (Flywheel Side) - Oil Leakage - Service Solution

REFERENCE:	TSB: 09-021-24 GROUP: 09 - Engine	Date:	November 23, 2024	REVISION:	
VEHICLES AFFECTED:	 2020 - 2024 (BV) Jeep Renegade 2020 - 2024 (MV) Jeep Compass This bulletin applies to 2020 - 2023 BV and MV vehicles built on or before November 03, 2023 (MDH 1103XX) equipped with one of the following engines: 1.3L 14 Turbo MAir DI Engine w/ESS (Sales Code EYF). 1.3L 14 Turbo MAir DI Engine (Sales Code EYH). 1.0L 13 Turbo Engine w/ESS (Sales Code EKA). This bulletin also applies to 2020 - 2024 BV and MV vehicles built on or or before December 15, 2024 (MDH 1215XX) that are equipped with the 1.5L 14 DOHC Turbo MHEV Engine (Sales Code EYP). 			MARKET AF	PPLICABILITY:
CUSTOMER SYMPTOM:	 Customers may experience the following: Oil leaks from the engine compartment, engine/transmission coupling. 				
CAUSE:	Oil leakage from engine valley cap

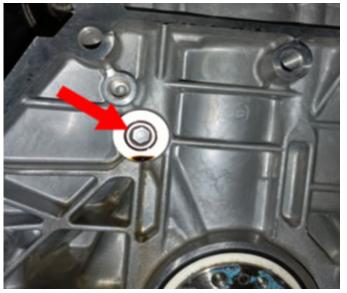
- 5. Inspect the engine valley cap for evidence of an oil leak Fig. 1.

Fig. 1 Oil Valley Cap Leaking

- 6. Is there oil leaking from the engine valley cap in the oil line?
 - YES>>> Proceed to Step 7
 - NO>>> This bulletin does not apply. Proceed to Step 11.

- 7. Remove and **DISCARD** the engine valley cap.
- 8. Thoroughly clean the engine valley thread.
- 9. Install a **NEW** engine valley cap and tighten to 27 N·m (20 ft. lbs.).
