Preview Solution CBR-2409-5

## 13L Engine - Rear Main Oil Seal Leak - Model Year 2025

Published 12 November 2024

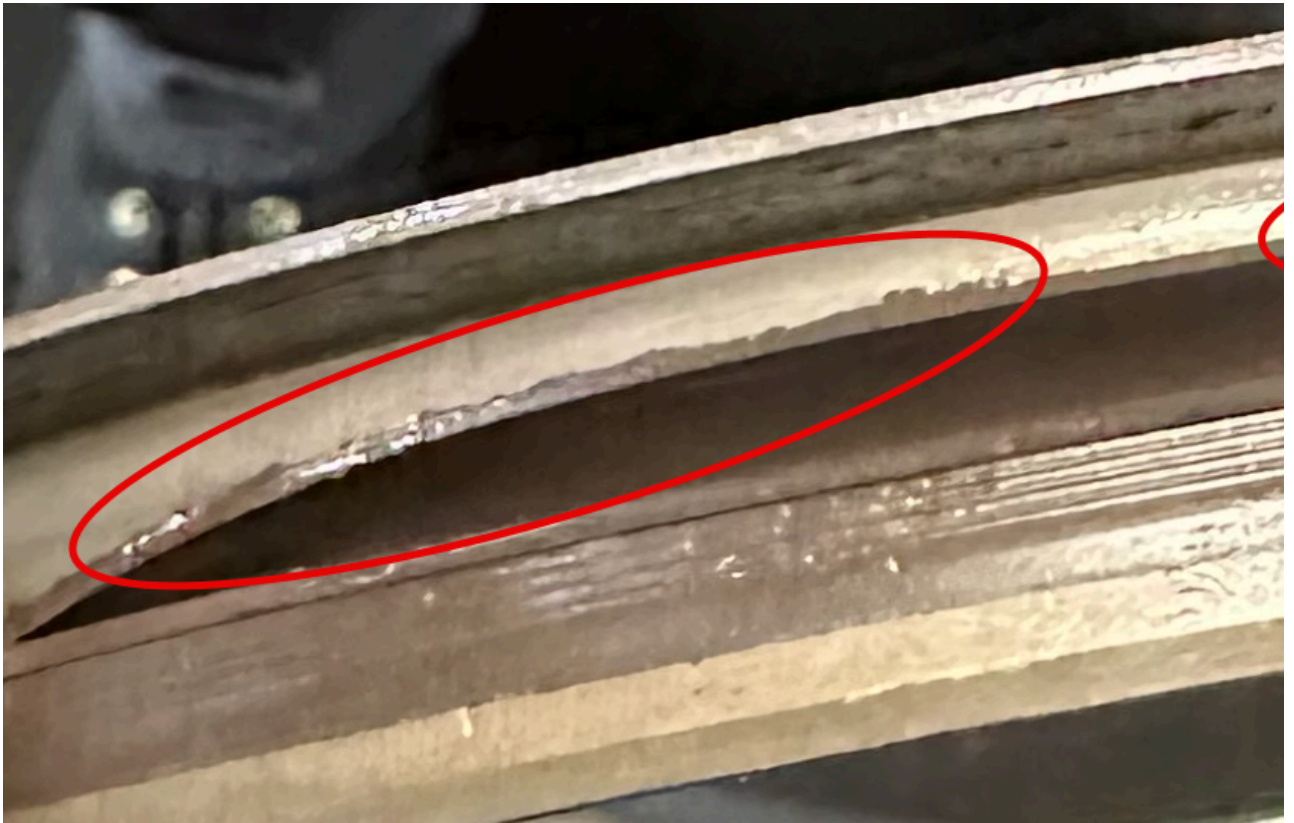
1. As you are removing the flywheel, check the flywheel bolts for oil.
  - **If oil is coming from the flywheel bolts** refer to CBR-997
  - **If there is no oil on the flywheel bolts** continue to the next step.
2. **Remove and replace the rear main seal.**
  - Before installing seal check the replacement seal for any flashing or damage. (See image below)

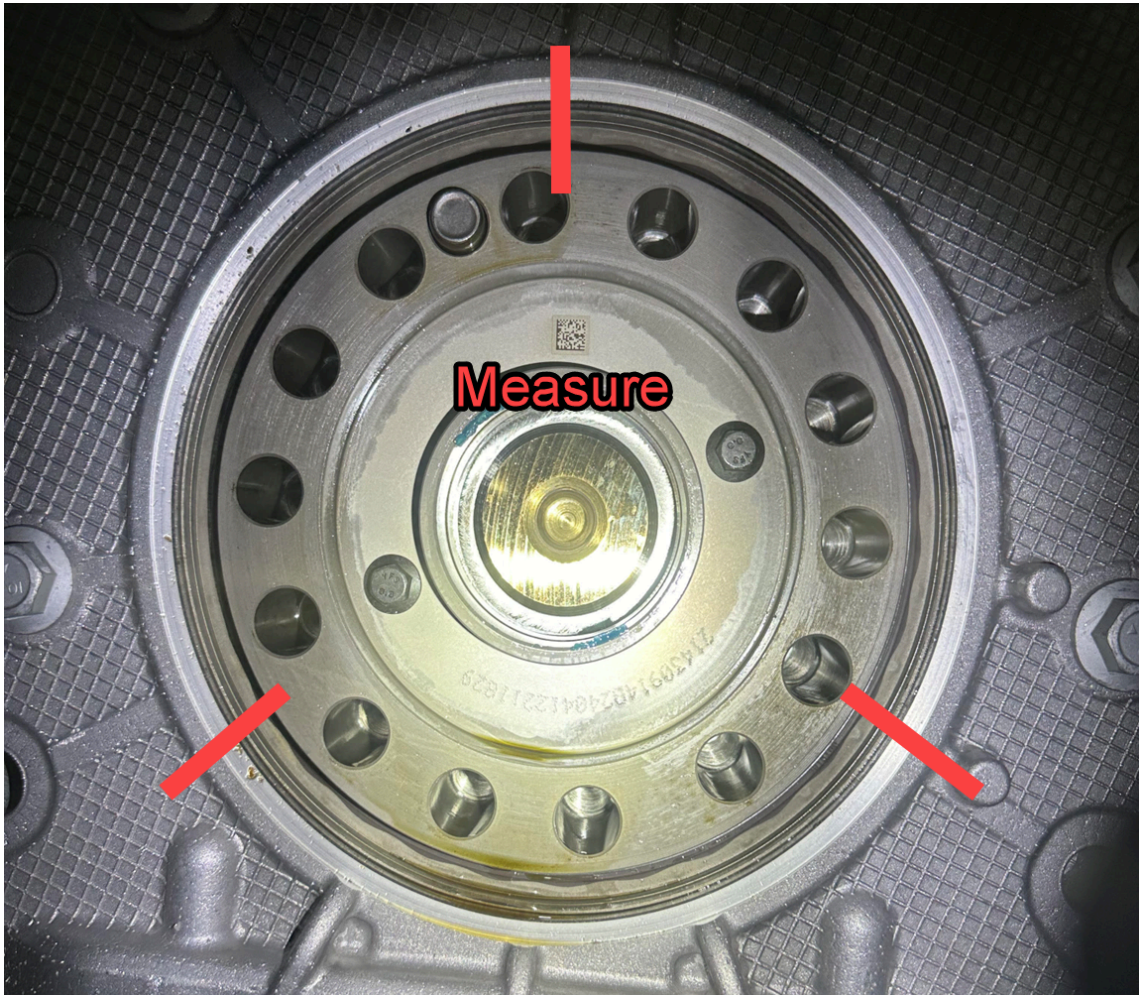
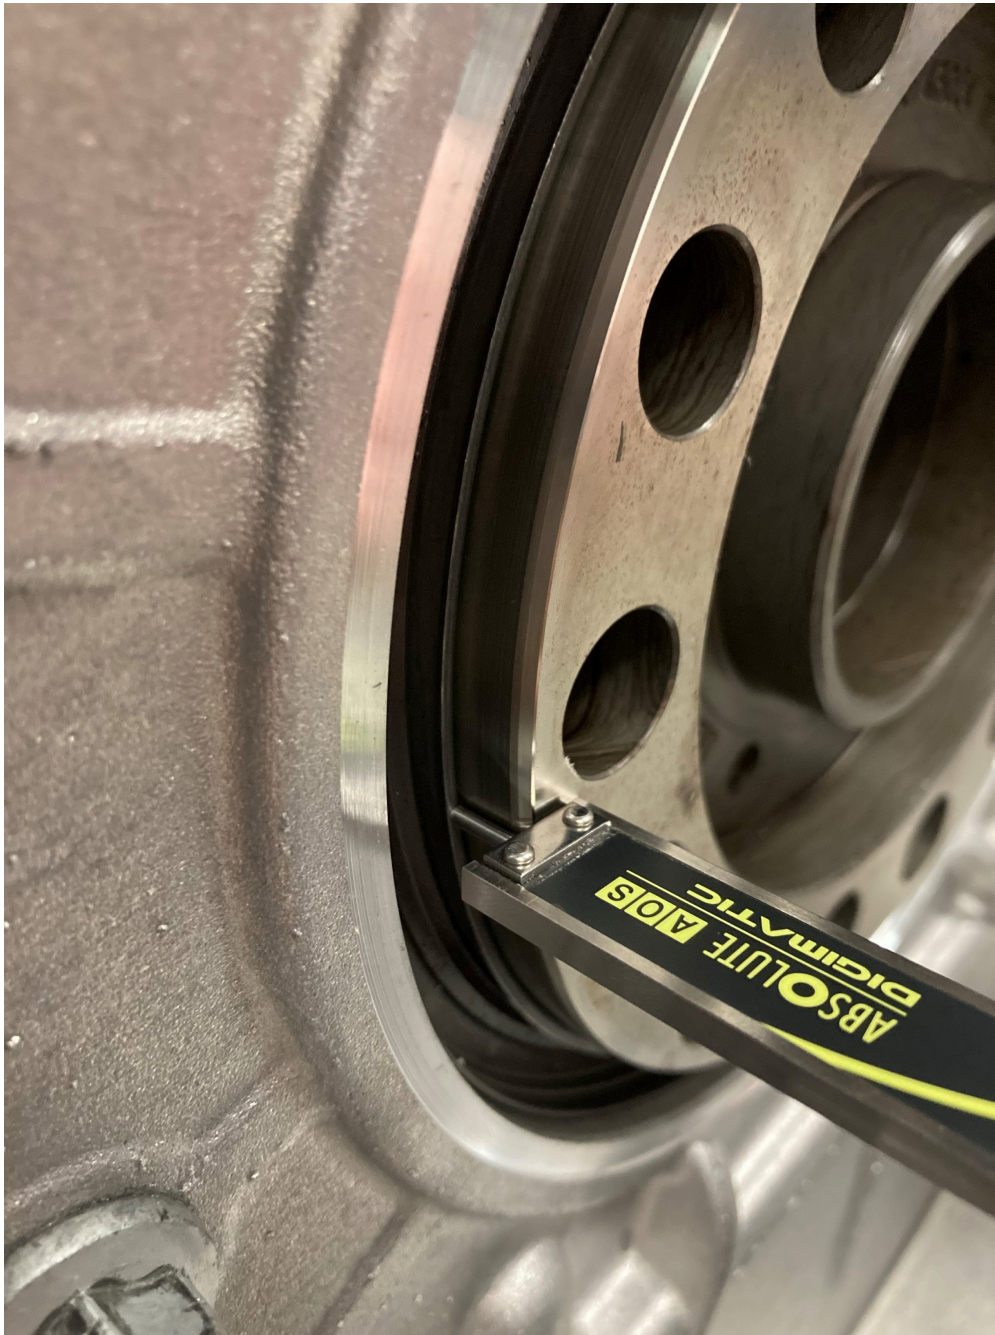
3. Refer to Impact for the correct use and combination of installation tool parts.
  - Insure to lube the outside diameter of the seal.
4. Upon reinstallation measure the depth of the rear main seal in three places as shown below: Measurement should be taken from the face of the seal to the outer surface of the crank gear.
  - Specification for seal depth:  $8.5 \pm 0.4$  mm
  - All three measurements should be within 0.4 mm of each other

5. If the depth is found to be out of spec, repeat the installation procedure.
