# Service Bulletin

Bulletin No.: 24-NA-166

**Subject: DTC C1171 C1172 C1173 C1174 Tire Pressure Monitor Sensor Unable to Relearn Ethernet Cable Overlay for TCP OnStar Module**

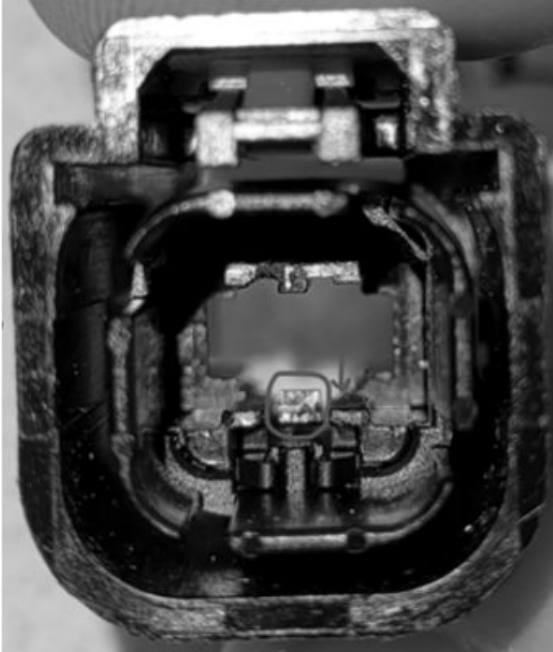
6720429

The X205 housing tab is very difficult to see with the cable installed.

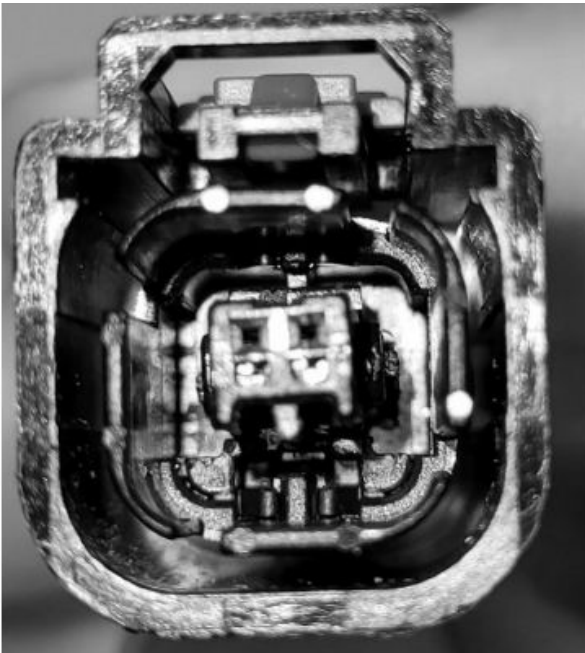
6720432

Following the middle ridge to the back, this is where the housing locks onto the cable.

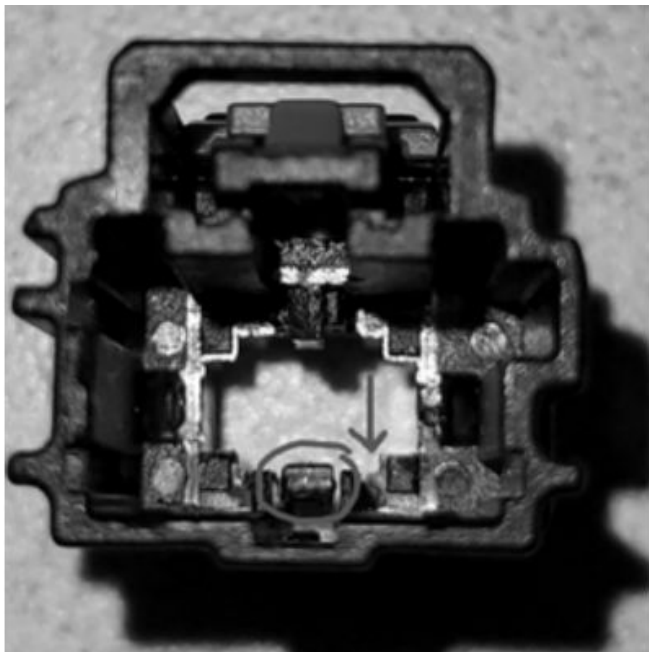
6720422

The X7 housing tab is very difficult to see with the cable installed.

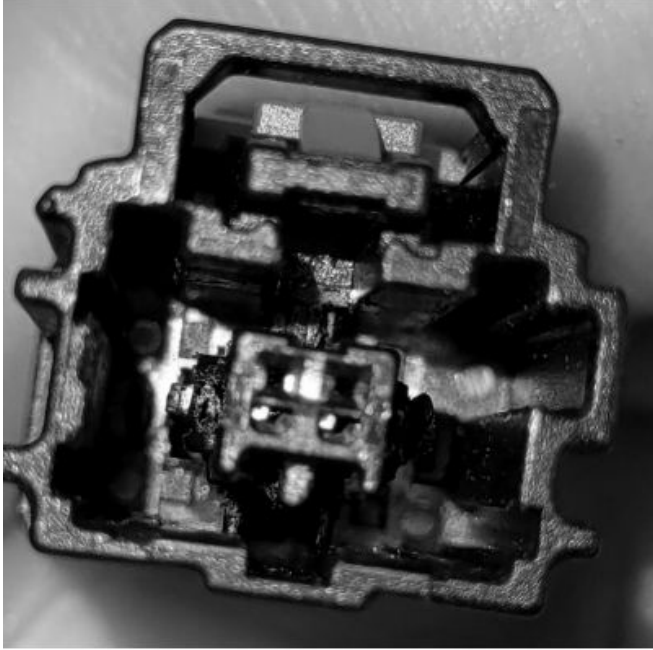
6720426

Following the middle ridge to the back, this is where the housing locks onto the cable.
