MAS004445 RU 24-42

Rapid Update 765

Maserati Grecale – Front Wiring Repositioning

DATE: November 21, 2024

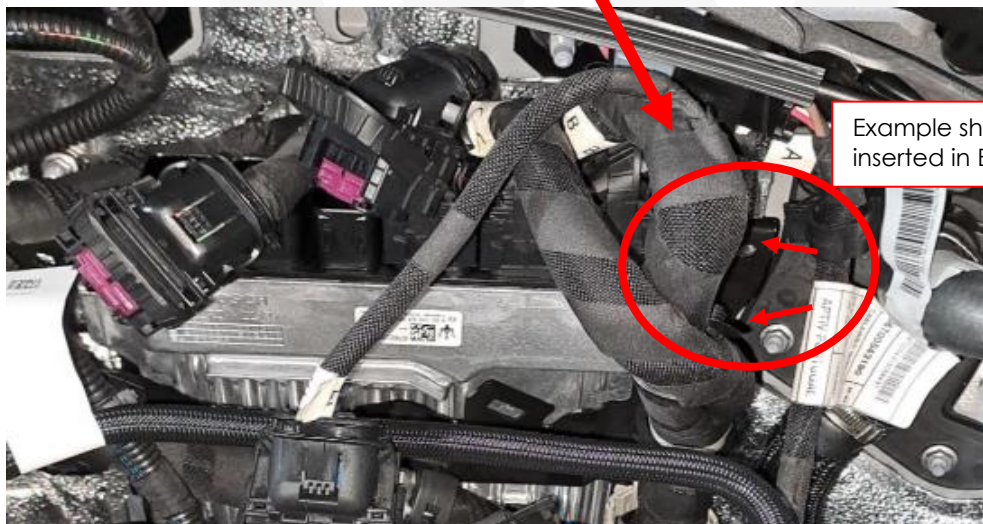
6. Locate the wiring harness and check the condition of the cable clip on the ECM control unit bracket in the indicated firewall area.

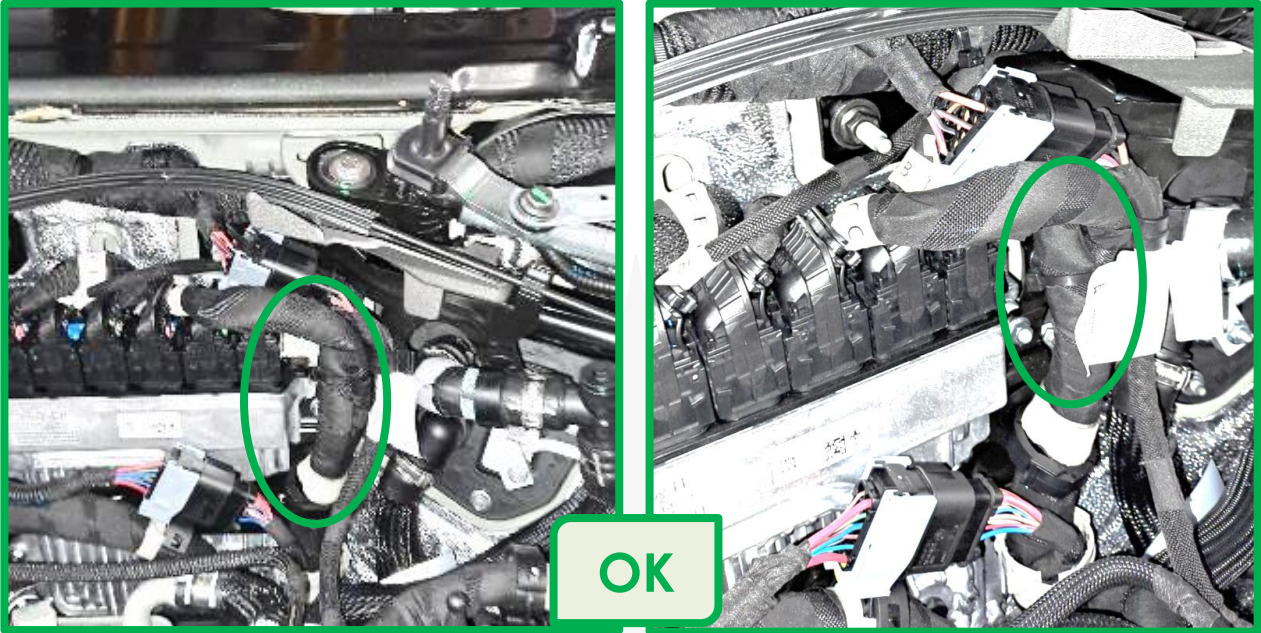
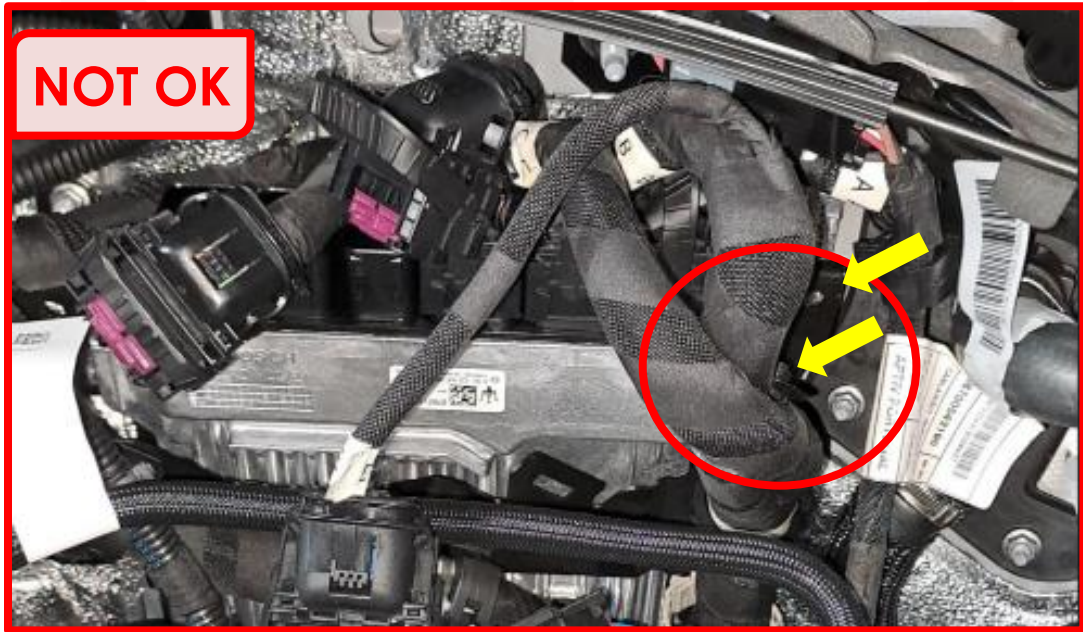
7. Check that the clip is securely inserted into the ECM control unit bracket.

- **OK** ▶ the clip is correctly inserted into the hole of the bracket; the procedure is finished. No further action is needed. Re-install all removed components and release the vehicle.
- **NOT OK** ▶ The clip is **not correctly positioned/inserted. Continue to step 9**

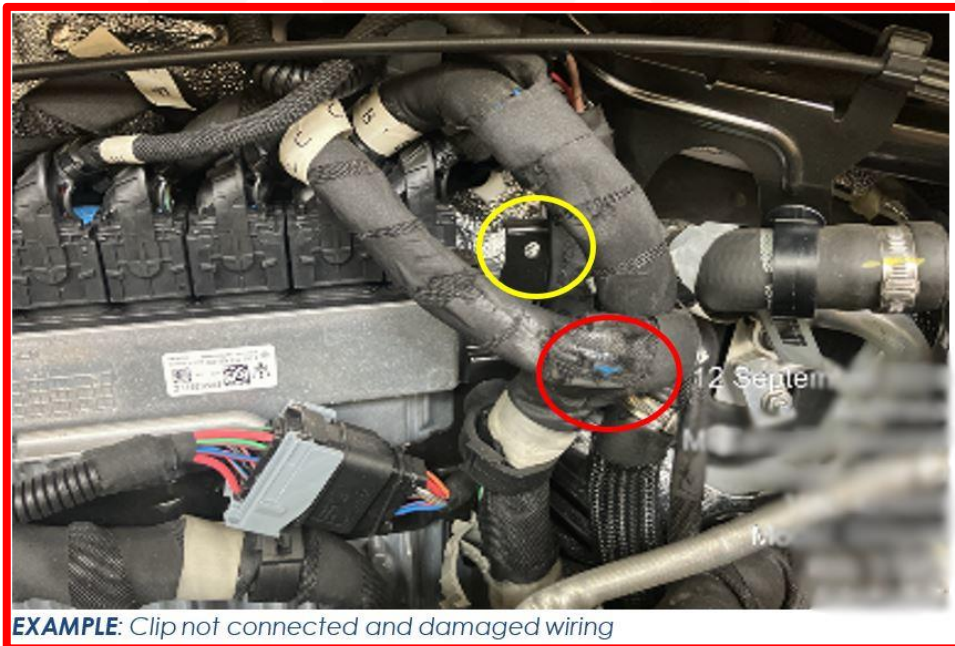
9. Before proceeding, check that the cable covering does not present any abrasions or defects of any kind by inspecting it carefully.

EXAMPLE: Clip not connected and damaged wiring

10. If the wiring harness **cover shows signs of damage** of any kind, remove the protective tape around the wiring harness in that section only and check for signs of damage on the individual wires.

- **OK ▶** If there is no damage to the individual wiring, **restore the tape protection** around the cable and proceed with restoring the clip position. **Continue to step 12.**
- **NOT OK ▶** Damage found. Open a BOL as "factory Information" to document the damage found and await instructions. Refer to procedure **00.30.005 – 80** for wiring repair.

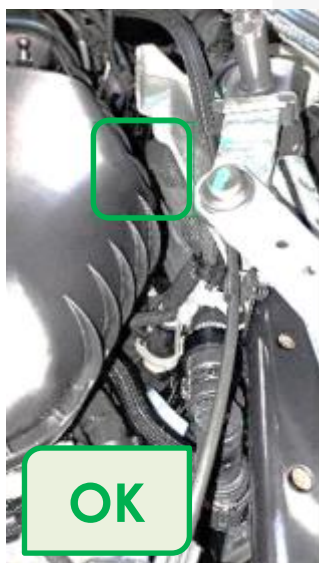
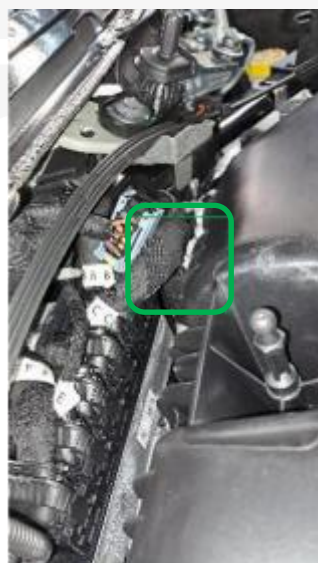
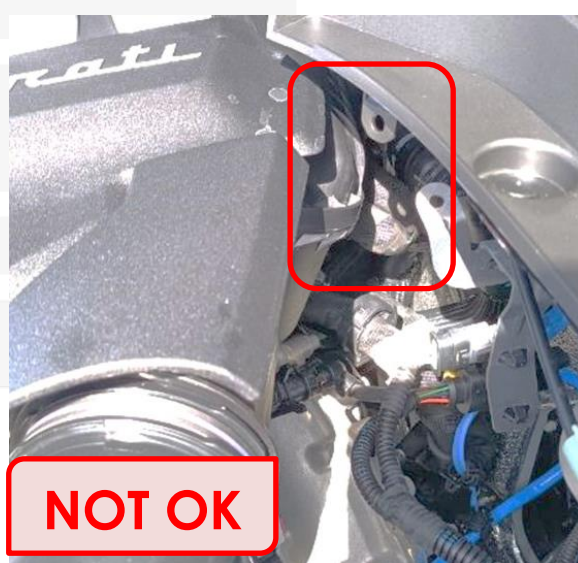
15. Temporarily reassemble the air filter and check that there is no contact between the harness and the filter box housing.

16. Once you have checked that **the air filter and the cable do not come into contact**, proceed to reassemble any components that may have been removed, following the procedure in reverse order.
