MAS004466 RU 24-41

Rapid Update 766

Grecale Multiple Software Updates

DATE: NOVEMBER 19, 2024

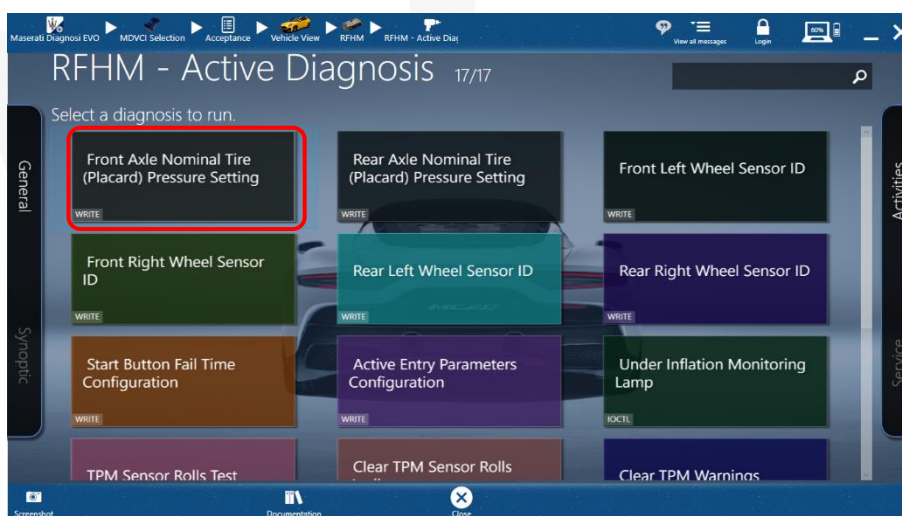
This update is essential to prevent the occurrence of a false TPMS (Tire Pressure Monitoring System) warning indication. In specific situations, the front tire pressures might erroneously appear in yellow on the cluster display, even when the actual tire pressures meet or exceed the specified values. This problem stems from an incorrect internal calculation related to the hexadecimal conversion between psi and bar. It's crucial to note that this update does not alter the tire pressure values as stated in the owner manuals and technical documentation.

IMPORTANT for 19" tires only:

- Select **RFHM – Active diagnosis – Front Axle Nominal Tire (Placard) Pressure Setting**:

- Insert **31** in the text box and click on **Execute** to set the new value.

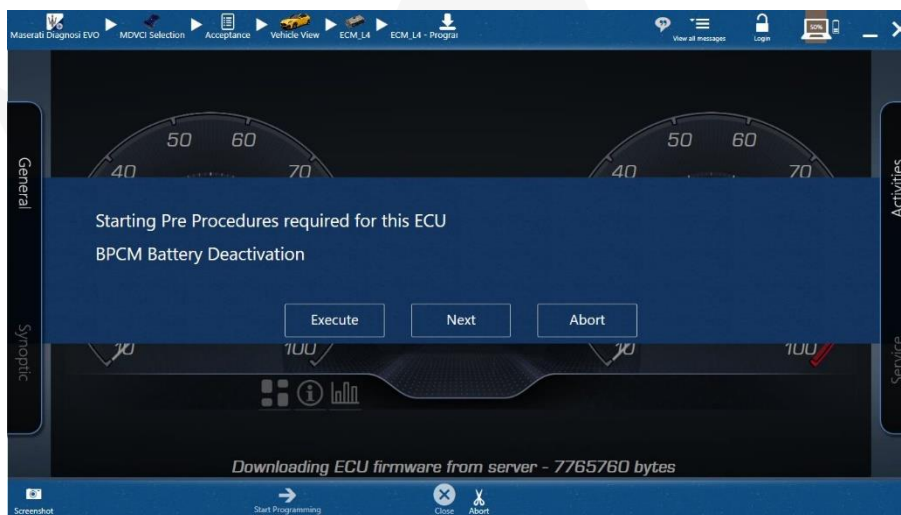
This update is essential to rectify a potential loss of CAN communication between the ECM and other ECUs (AGSM, DTMC, BSM, etc.) when the ECU temperature is high. This new software corrects this behavior avoiding multiple warning lights. No loss of torque or recovery strategy is activated for this concern. The new software also fixes a potential MIL attributed to P-codes P106A and P1066 related to the MultiAir solenoid valve. **This Software update requires the TCM to be updated as well.**

- From ECU View, select the **ECM – ECU programming**.
- Press **“Execute”** starting pre-procedures:
