# TECHNICAL SERVICE BULLETIN

TECHNICAL SERVICE BULLETIN: 10-1871  
SERVICE CAMPAIGN: 001169

# TECHNICAL SERVICE BULLETIN 10-1871 REMEDY INSTRUCTIONS

| <br><b>FOREST RIVER</b> | Make(s): FLAGSTAFF & ROCKWOOD<br>Model(s): FLT26RBWS & RLT2606WS<br>Model Year(s): 2025 | Repair Code: SB-562-09-00-004645<br>Allotted Time: 1.00 HRS.<br>Inspection Code: N/A<br>Allotted Time: N/A |

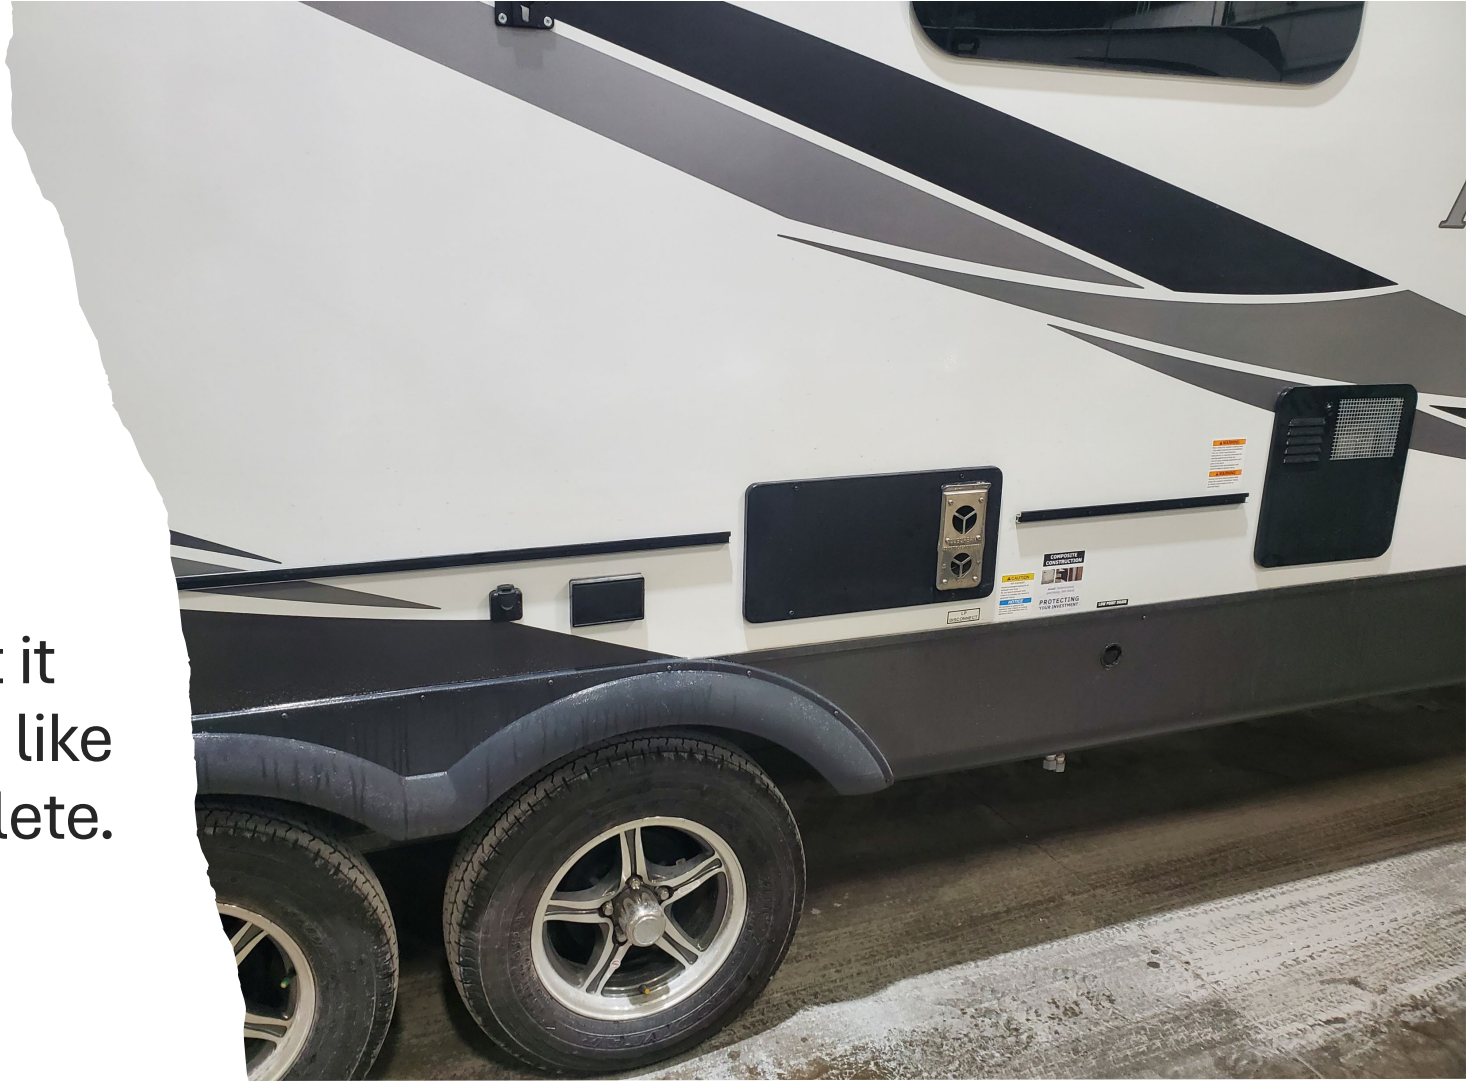
This is what it  
should look like  
once complete.

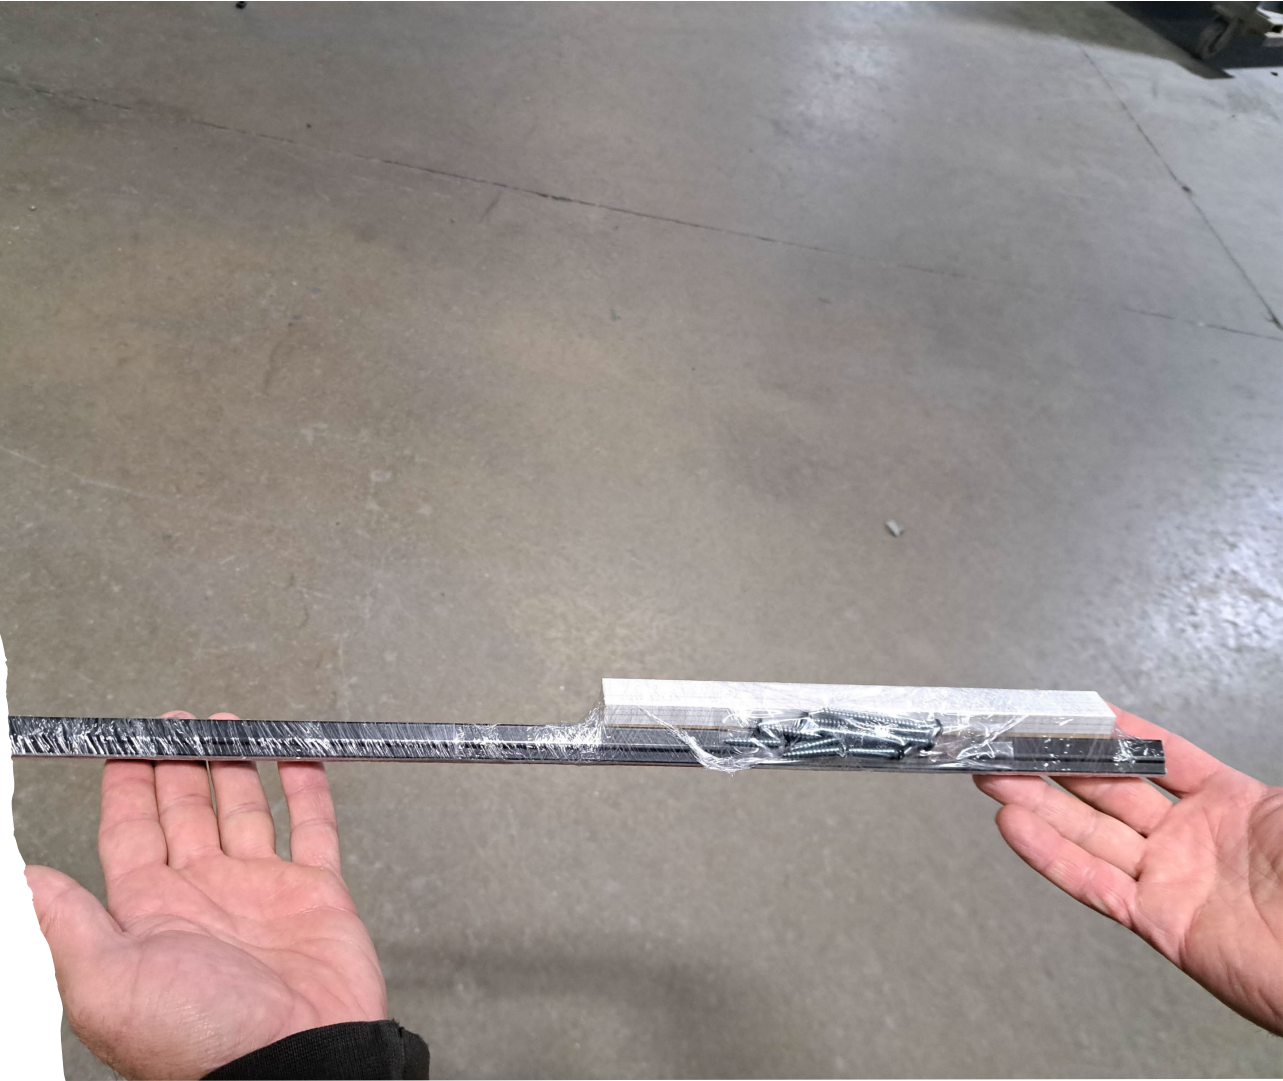
Kit #: F100684870

This is a picture of the Kit  
you will receive to  
complete this fix which  
includes:

- Rail with tape applied.
- Backer
- Screws
