Preview Solution CBR-997-9

Oil Leak At Clutch And Flywheel Housing; Possible Burnt Clutch Smell And/Or Clutch Slipping; Report Of Crankshaft Rear Main Seal Leak

Published 14 November 2024

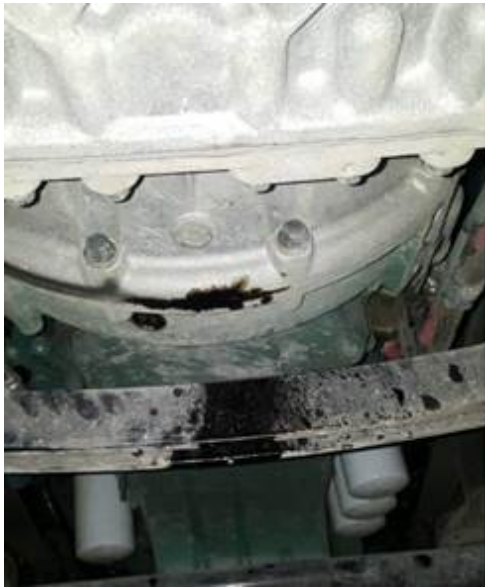
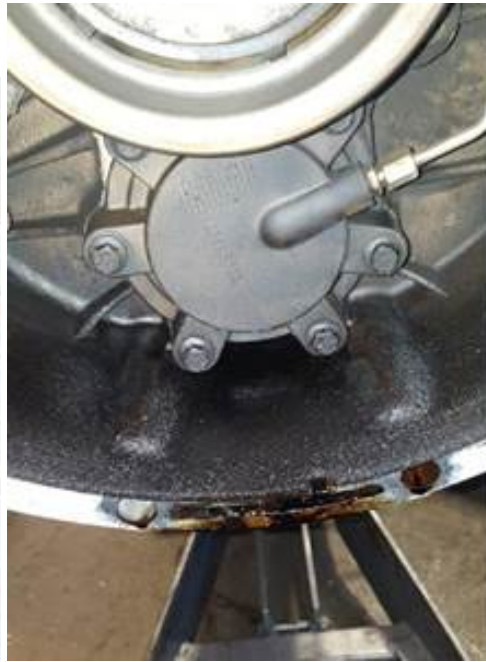
Engine Oil Accumulation in Bottom of Flywheel Housing

A. This repair will require the removal of the flywheel housing in order to remove the rear crank flange adaptor and replace the o-ring. An exploded diagram showing the o-ring can be seen below:

B. The clutch and pressure plate need to be replaced.

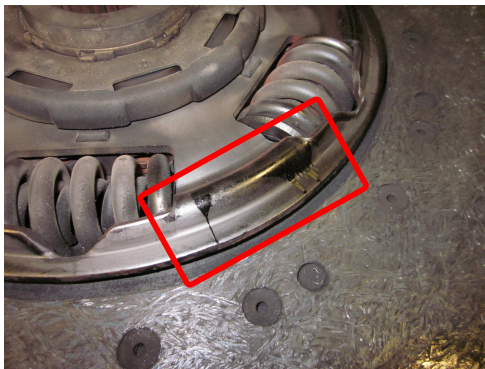
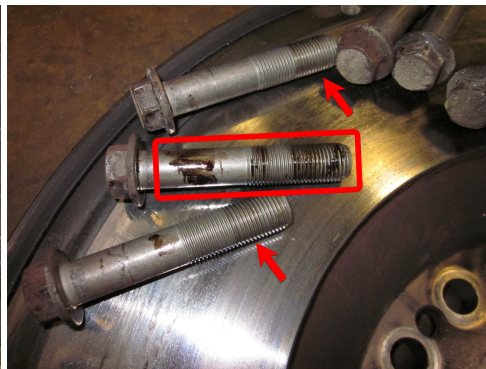
Engine Oil on the Clutch Disk and Flywheel Bolt threads

C. The flywheel should be cleaned and inspected, then resurfaced or replaced as necessary.

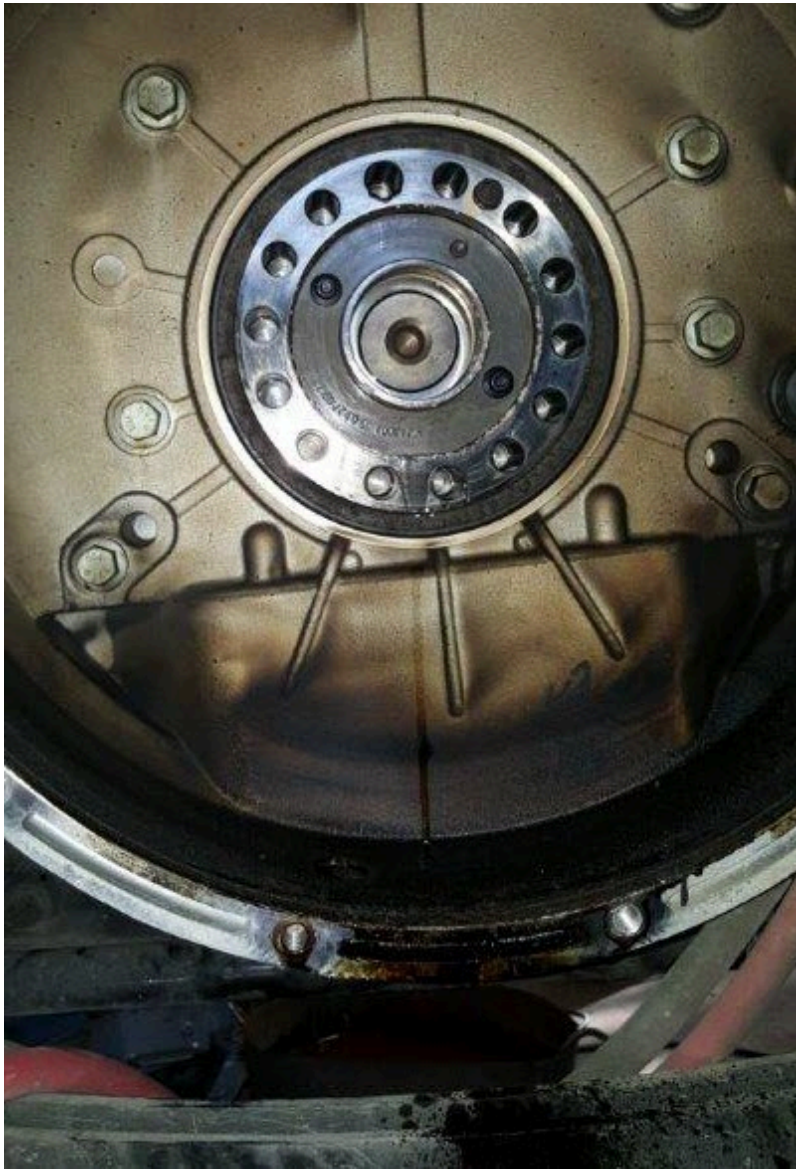
Engine Oil Leak - Not from Main Seal - Note that there is no oil path visible from the bottom of the crank flange down the face of the housing to the visible buildup

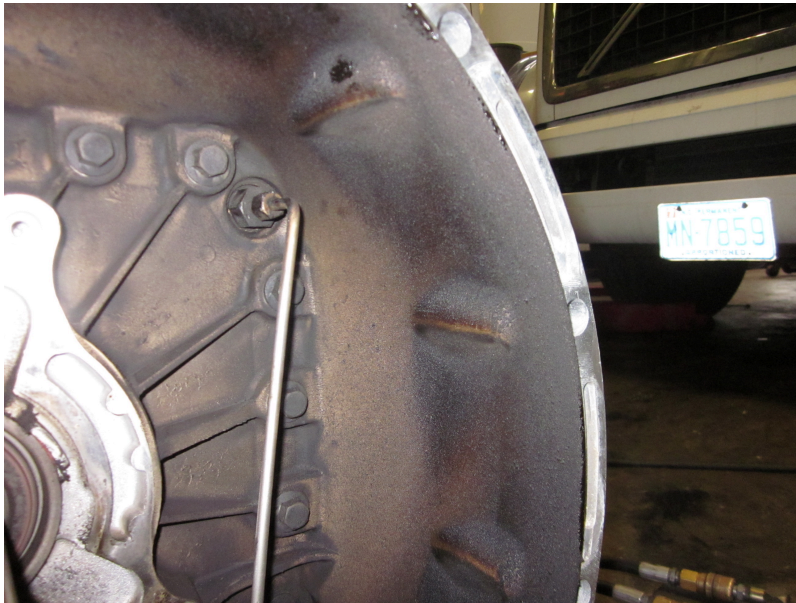
Oil Film visible on inner circumference of the Clutch Housing

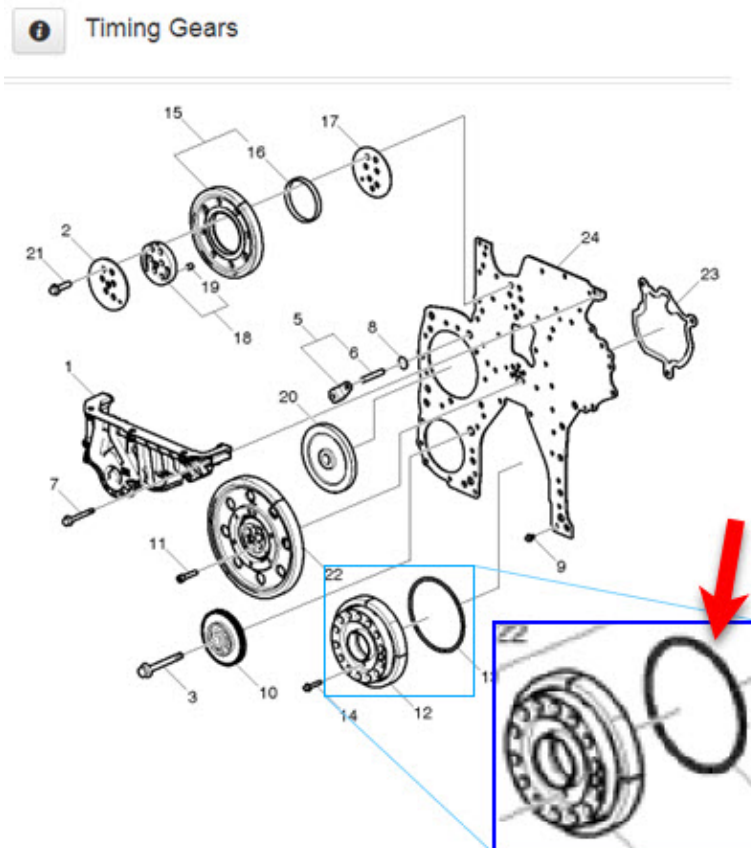
Note that the O-ring is located under the Timing Gear assembly in Impact, not the Crankshaft assembly.

- The procedure for flywheel housing removal and reinstallation can be found in the Service tab of Impact, Operation [2125-03-02-03 Flywheel Housing, Replacement](#).
