# TECHNICAL SERVICE BULLETIN

Technical Service Bulletin: 55-1865

Forest River is alerting you to an issue involving certain 2025 Dynamax Isata ISC24FWSFXM, ISC24SSSF XM, and ISC24FWSFXMCD Class C Motorhome Recreational Vehicles. Please see the information below, which describes the issue and provides you with details on the steps you should take to have your vehicle repaired.

**Technical Service Bulletin Number 2024-04**

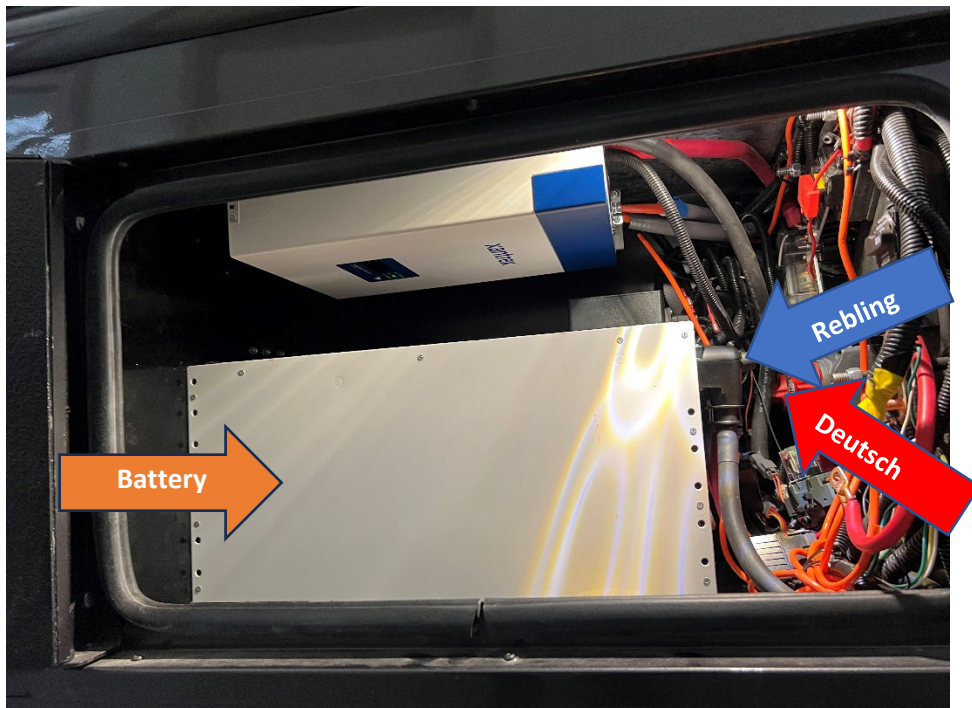
**Problem Description:** The functionality of the 310Ah – 12V batteries (884-0310-12) can be compromised due to the premature failure of a sense board mounted to the cells of these batteries. A resistor on the sense board is prone to failure at temperatures above 140 degrees F (60 degrees C). This problem results in the eGen screen showing a B: fault and/or the cell reading showing 412 degrees F. In both cases, the battery faults and opens its contactor so it is no longer able to be charged or discharged. This issue doesn't represent a safety hazard on the product.

**Step 1:** Locate the battery in the battery compartment.

**Remedial Action:** As part of the process to upgrade Batteries to the 4.1 Firmware at Dynamax Dealerships, Xantrex recommends replacing the affected batteries with Rev. A sense boards. Batteries will be replaced with new or refurbished batteries with the latest sense board revision, Rev. C. All replaced batteries will have the same warranty with an end date per Xantrex's Warranty policy for Lithium Batteries, 10 years from the original purchase date of the vehicle.

**Step 2:** Un-screw the battery from the floor of the coach and disconnect the Rebling connector and Deutsch connector.

**Step 3:** Install the new or refurbished battery by screwing this battery to the floor of the battery compartment and connect the Rebling and Deutsch connectors to the battery. The new battery has 4.1 firmware pre-installed so the battery will need to be taken out of transport mode and will then operate normally.
