Service Bulletin

Bulletin No.: 24-NA-218

Subject: Seats Will Intermittently Lose Memory Position Settings

Brand:	Model:	Model Year:		VIN:		Engine:	Transmission:
		from	to	from	to		
Cadillac	XT4	2024	2024

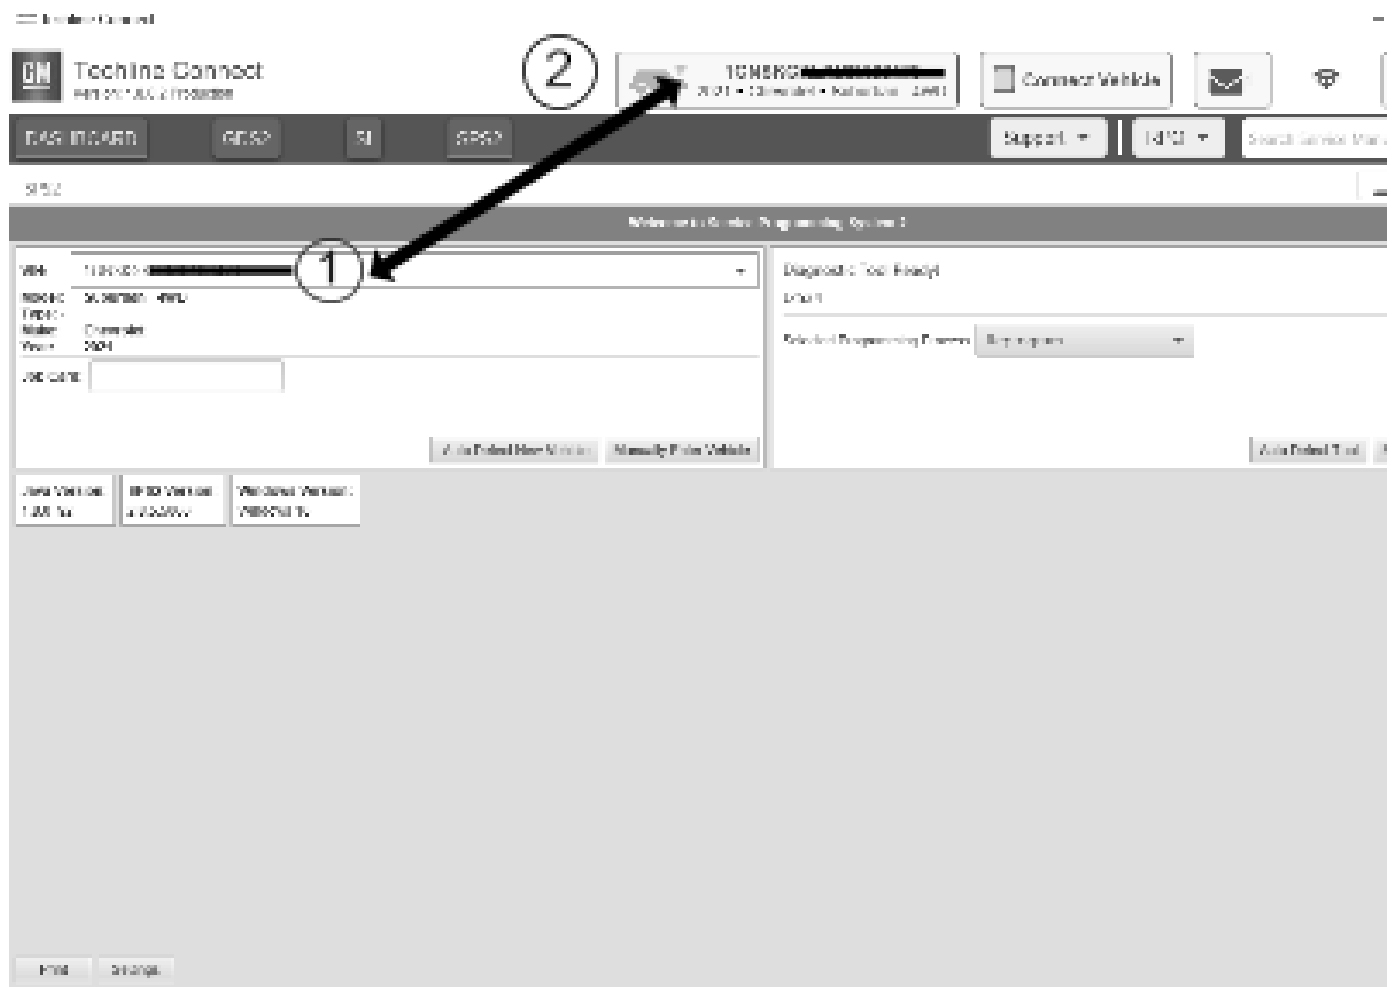
Caution: Be sure the VIN selected in the drop down menu (1) is the same as the vehicle connected (2) before beginning programming.

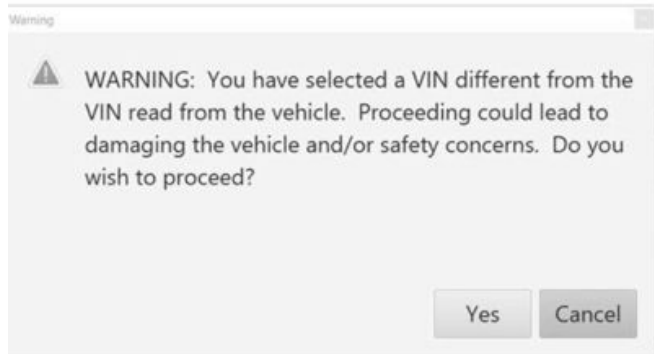
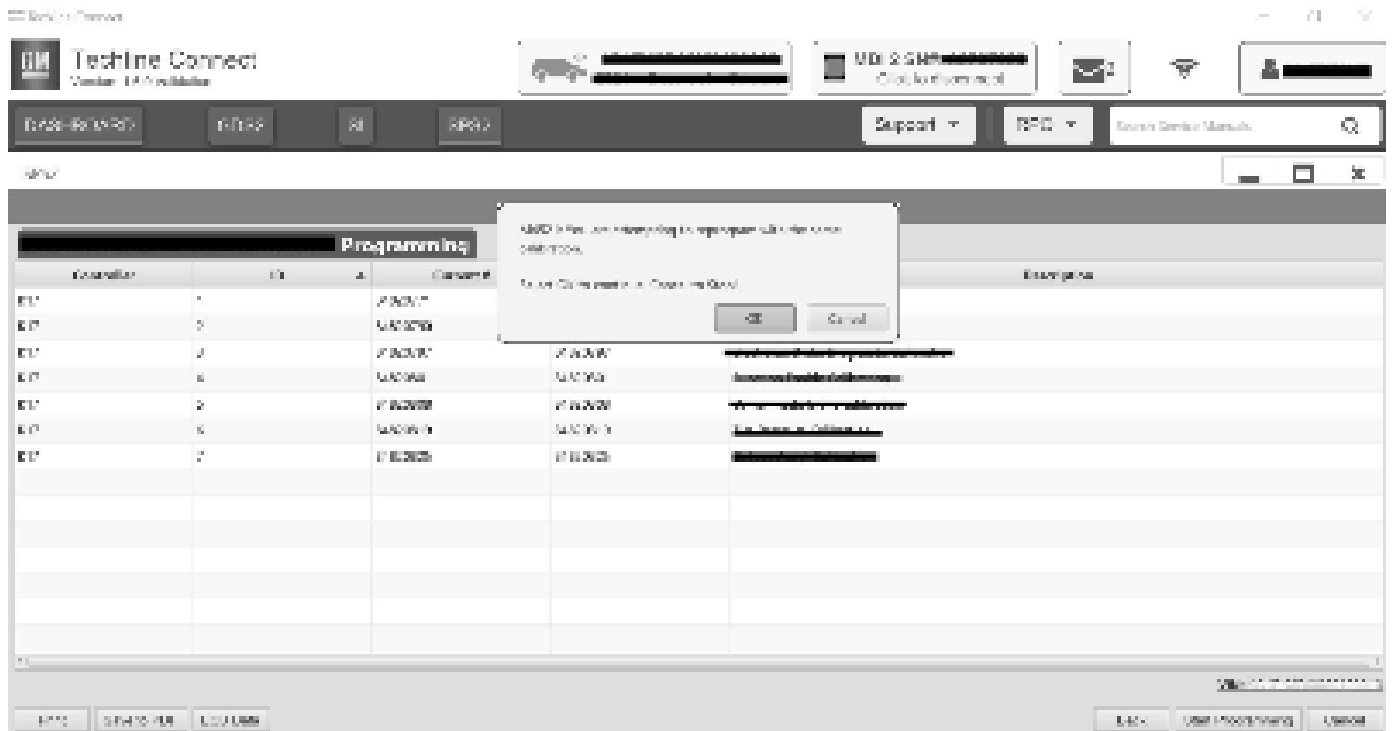
5644477

Important: If the vehicle VIN DOES NOT match, the message below will be shown

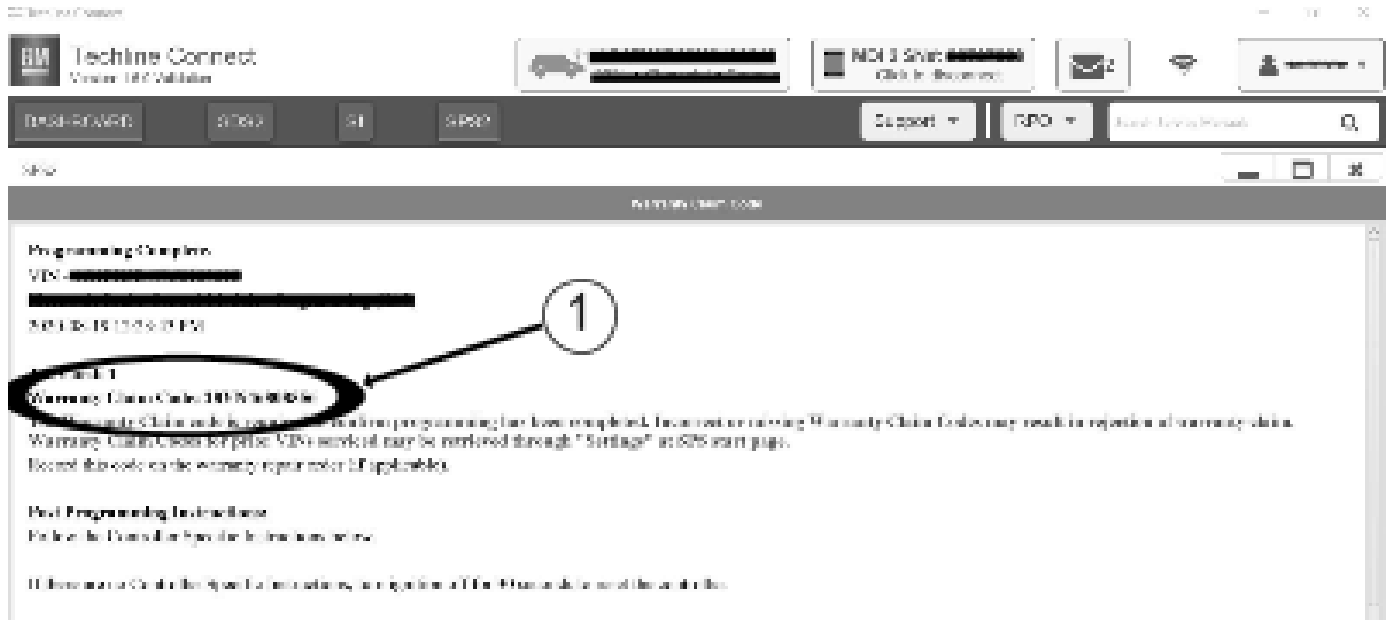
5644478

Note: The screenshot above is an example of module programming and may not be indicative of the specific module that is being programmed. Module selection and VIN information have been blacked out.

1. Reprogram the Driver Seat Memory Module. Refer to *K40D Seat Memory Control Module - Driver: Programming and Setup in SI*.

Important: To avoid warranty transaction rejections, you MUST record the warranty claim code provided on the Warranty Claim Code (WCC) screen shown above on the job card. Refer to callout 1 above for the location of the WCC on the screen.
