SIB 17 06 24

DELIVERY STOP: CHECK AND IF NECESSARY, REPLACE COOLANT LINE

E-Series	Model Description	Production Date
G45	X3 Sports Activity Vehicle	July 11, 2024 – October 18, 2024

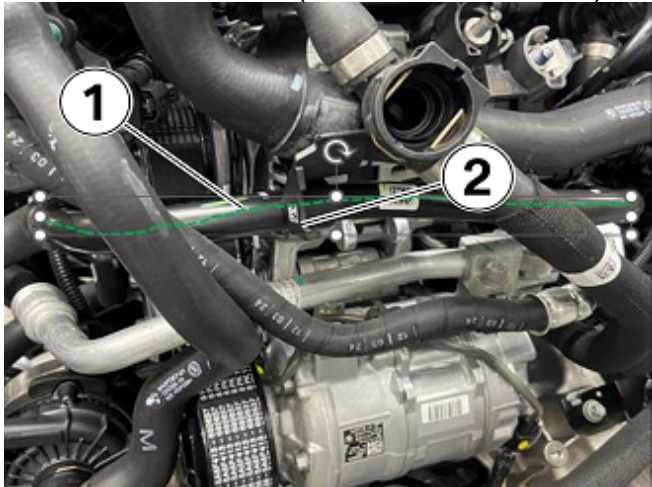
Locate the coolant line (P/N 17 12 5 A2F DE3) under the hood.

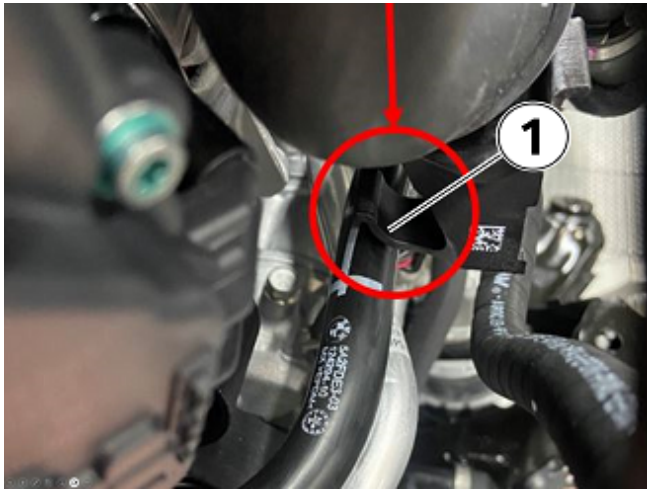
Check for proper installation of the coolant line in the bracket (1). If the coolant line is properly installed, no further action is necessary.

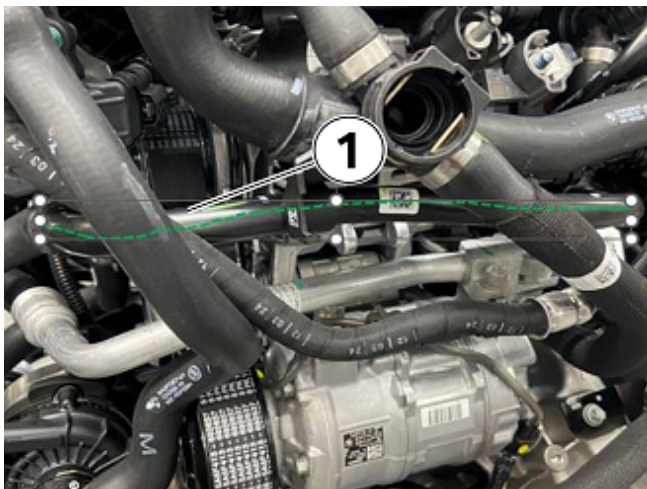
The coolant hose will need to be inspected if it is not properly seated in the bracket (1).

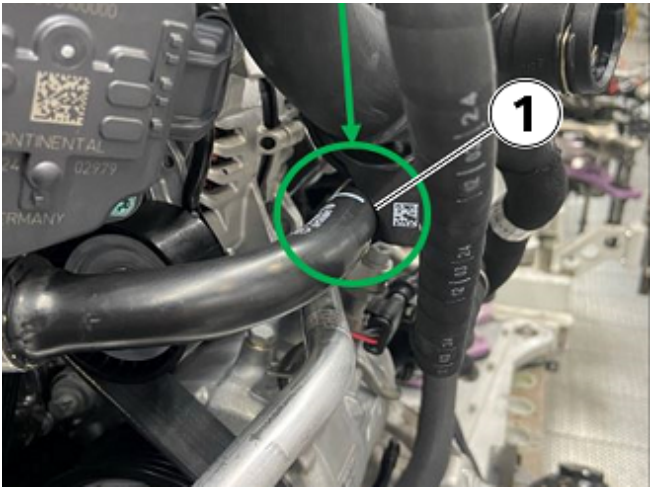
Check the coolant line at the belt tensioner pulley (1) for wear marks or coolant leaks. Any mark on the coolant line will require replacement.

If no wear marks are found, install the coolant line into the bracket (1).

Follow Repair Instructions **REP 17 12 615 Replacing the coolant hose of the charge air cooler auxiliary coolant pump.**
