SIB 01 09 24

2024-11-27

F15 I12 PHEV HV BATTERY CELL MODULE TEMPERATURE SENSORS  
EXT LTD WTY (ELW) 10/120

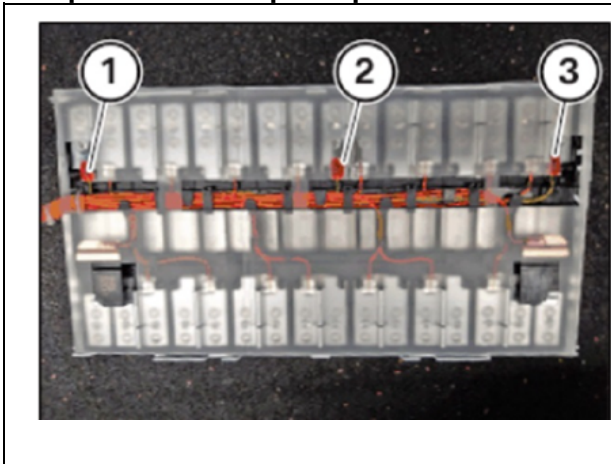
For the eligible vehicles, BMW of North America, LLC (BMW NA) is extending the limited warranty for the vehicle's **the High-Voltage (HV) Battery Assembly's Cell Module Temperature Sensors (Internal NTC repair kit) (F15 Shown)** to:

The measured value for an individual temperature sensor inside each of the HV battery cell modules is plausibility checked against all the other HV battery cell modules' temperature sensors.

Over time, the temperature sensors may fail, this can cause the measured values of one or more of the temperature sensors to deviate from specification. The vehicle's monitoring system may interpret these deviating temperature sensor values as either implausible or impermissible.
