## SERVICE BULLETIN

**APPLICABILITY:** 2020-24MY Legacy & Outback  
 2022-24MY WRX (A/T Only)  
 2019-24MY Ascent

**NUMBER:** 16-151-24R

**SUBJECT:** TR690 Chain Slip, Judder, Shudder, & Hesitation Concerns

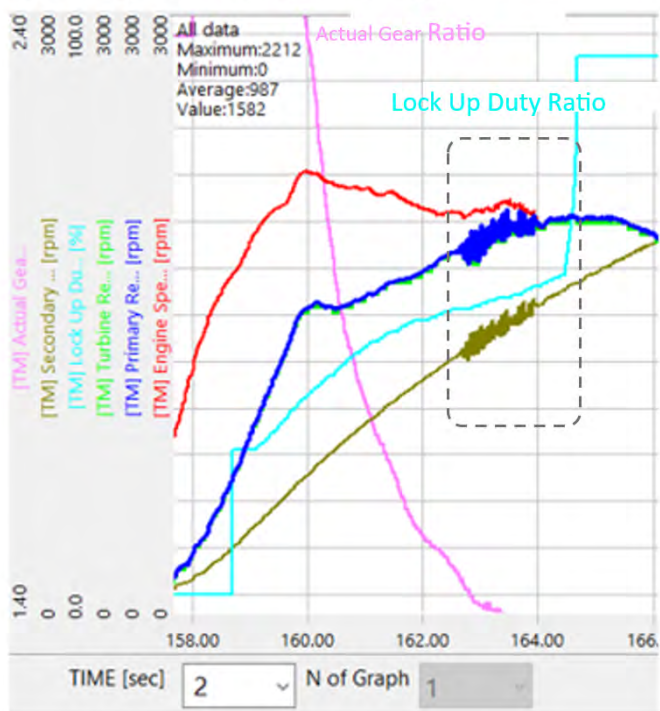
Example Graph for Lockup Judder Type A:

### Lockup Judder Type A Diagnosis Procedure.

After the test drive has been completed with replication of the symptom, refer to the judgement criteria and example graph below to determine if the condition matches Lockup Judder Type A. If replication has not been completed, refer to the replication steps below.

**STEP 5:** In case a when a judder sensation is felt, the vehicle is presenting <Lockup Judder Type A>.

**Lockup Judder Type A & B:** Torque Convertor (p.n. 31100AB460) replacement, CVT Fluid (p.n. 31333AA160) replacement, and TCM software reprogramming (newest software available).

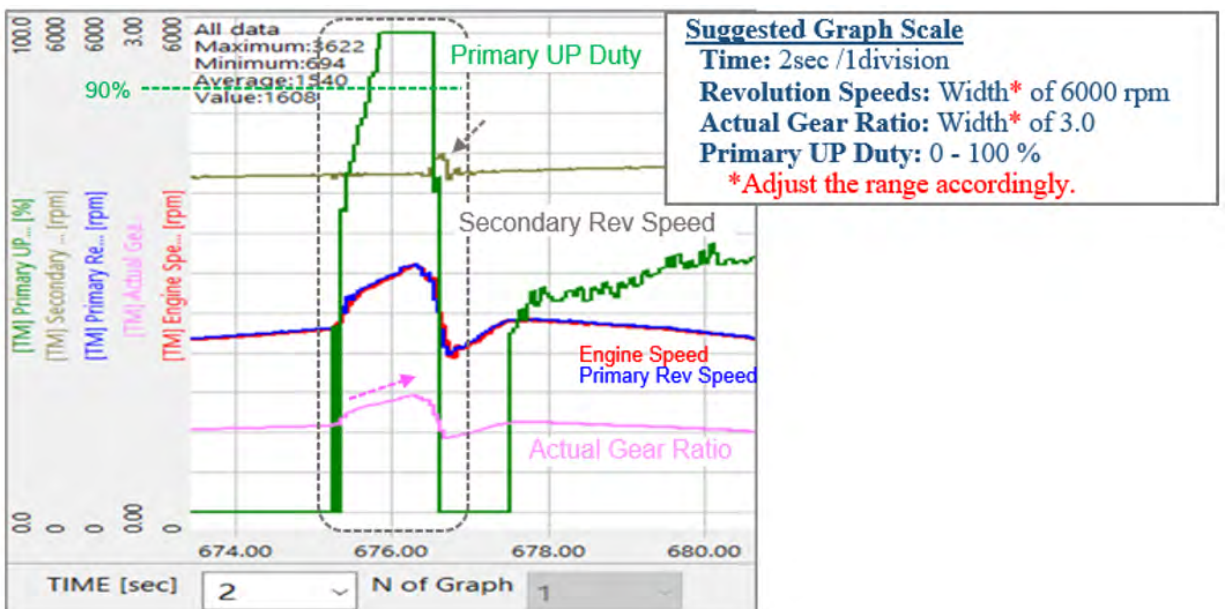
## 3. Long-Time Slip

When a long-time slip occurs, the Primary UP Duty monitor will be larger than 90% and the Actual Pulley Ratio monitor lowers for a duration of 0.5 seconds or more. Even after the Actual Gear Ratio monitor resumes to stable conditions, distinct fluctuations in revolution speed continues.

Using Subaru Select Monitor (SSM), check and record data monitors and compare to the three examples listed below. If the recorded data from the vehicle matches the examples below, the CVT will require replacement. The SSM data will be required for claim submission. A QMR containing the same information will also be required.

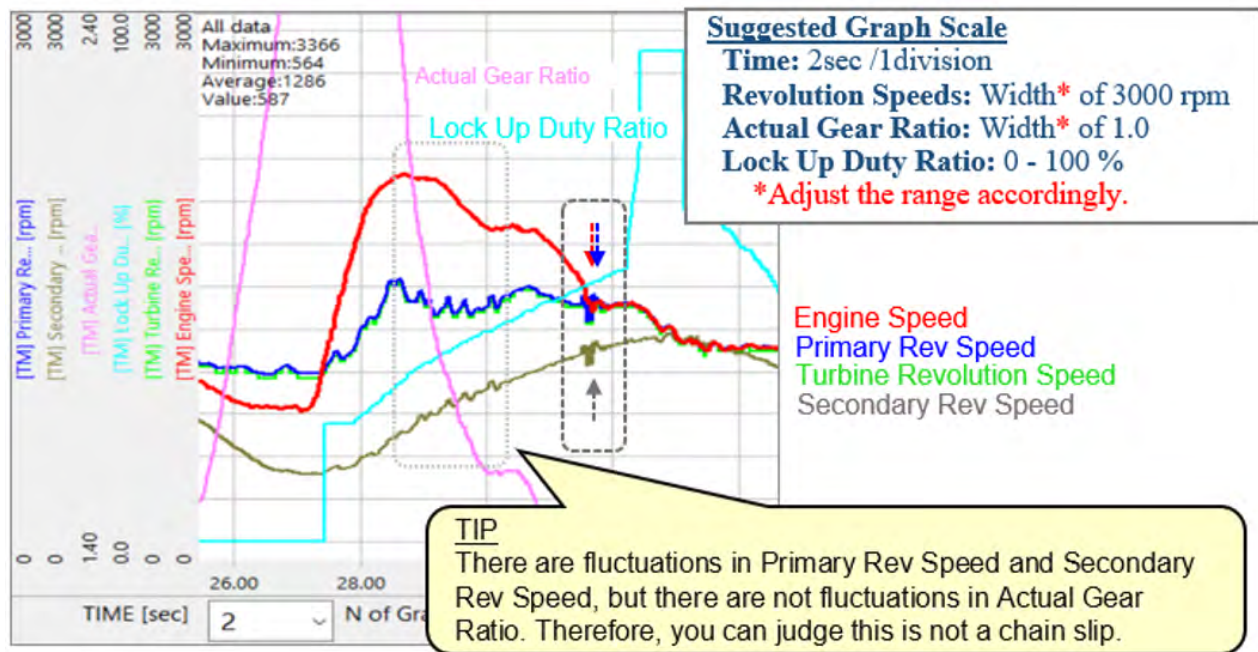
## 2. Lock Up Clutch Engagement Shock:

This shock can occur when the lock up engages rapidly. If this situation is reported, reprogram the TCM with the newest software available.
