SERVICE BULLETIN

APPLICABILITY: 23-25MY Outback/Legacy Models (including Wilderness models)
 23-24MY Ascent Models
 24MY Impreza
 24MY Crosstrek (including Wilderness models)
 24MY WRX
 25MY Forester

NUMBER: 15-305-22R
DATE: 11/15/22
REVISED: 11/07/24

SUBJECT: Reprogramming File Availability for Optimization of Gen 4.5 Denso CP1.5 Infotainment Systems

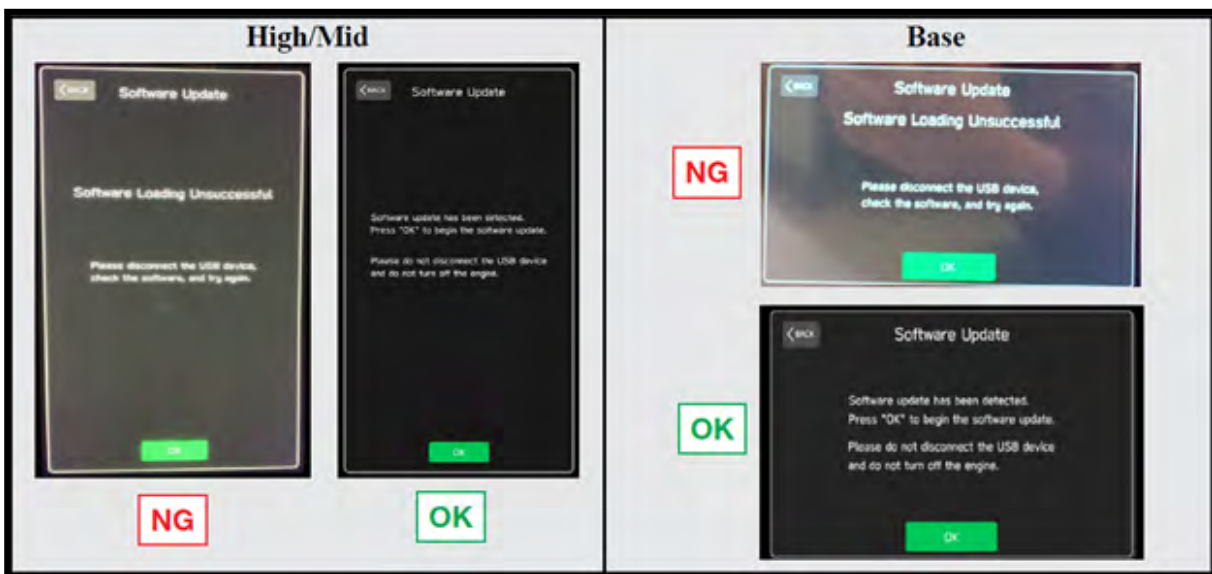
NOTE: If after plugging in the USB, the screen displays a **Software Loading Unsuccessful** message, confirm the USB device has been properly formatted and the software on the device matches the system being reprogrammed (example: Base software is being used to update a Base system) and retry.

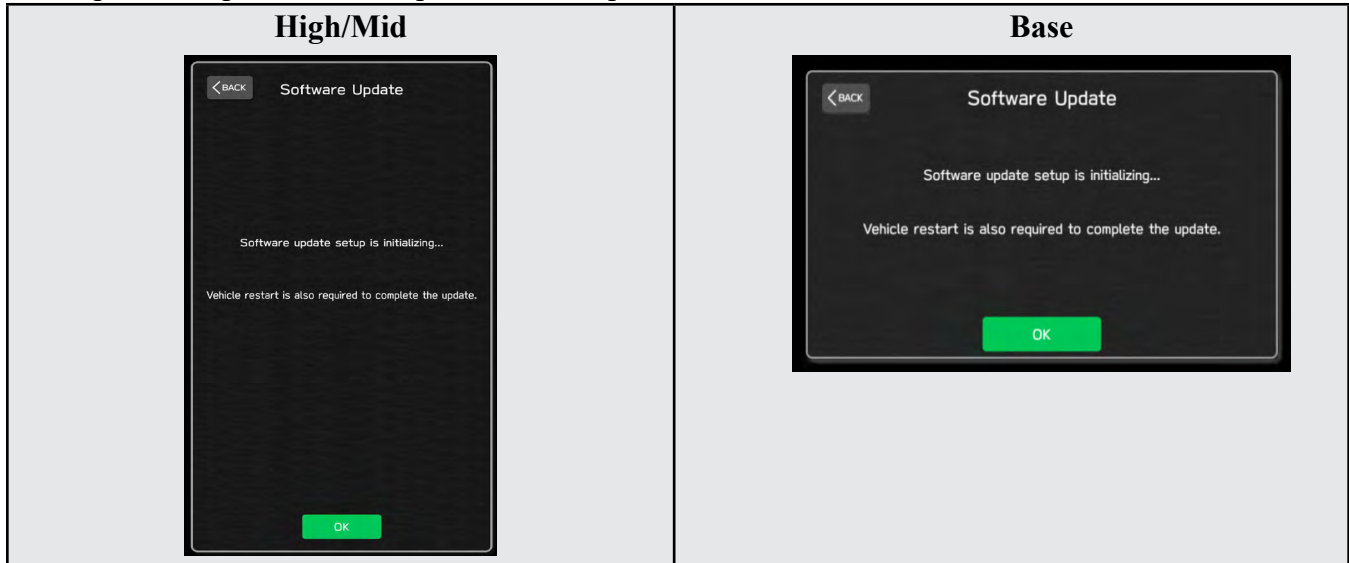
- If the screen shown below appears, **WAIT** for approximately 30 minutes or as long as necessary (waiting for longer than 60 minutes might indicate system malfunction). In that case please perform recovery according to the instructions in [Appendix 6 \(page 29\)](#) to allow the Software update setup initialization process to complete.

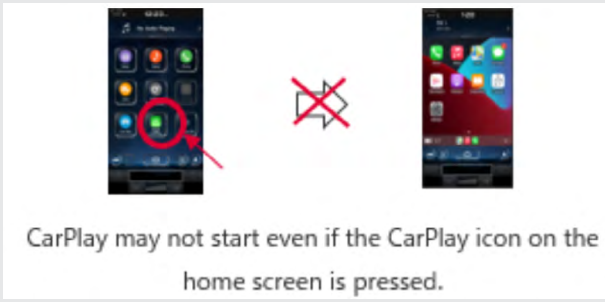
<p>CarPlay may not start even if the CarPlay icon on the home screen is pressed.</p> </div>

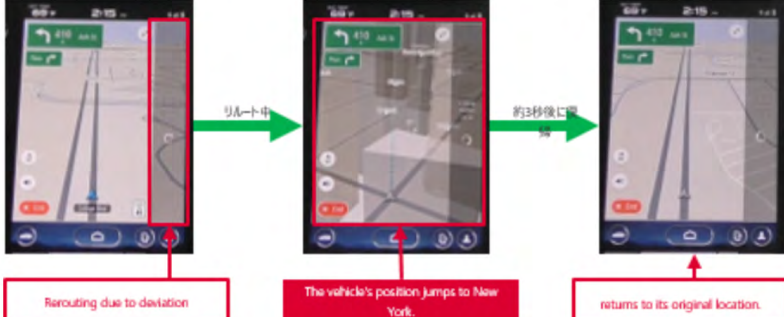
<p>- During long-distance route navigation, if you deviate from the planned route and a rerouting occurs, there is a sudden jump in your vehicle's position to New York (the default location) while the rerouting is in progress. After approximately 3 seconds, your position returns to its original location (only applicable to HIGH trim)</p>

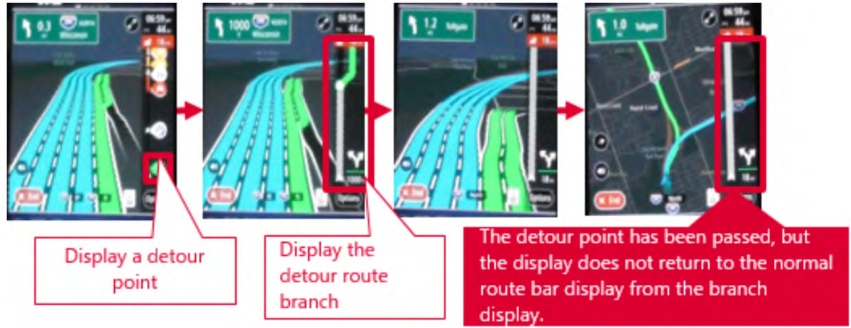
<p>- After passing through a detour point, the route bar does not return to the normal route bar from the detour route branch display on the map (only applicable to HIGH trim)</p>
