**SERVICE BULLETIN**

**APPLICABILITY:** 2020-2022MY Outback & Legacy  
 2022-2023MY BRZ  
 2022-2023MY WRX

**NUMBER:** 15-270-20R

**SUBJECT:** FOTA (Firmware Over-The-Air) Reprogramming for DENSO Gen 4 Audio / Navigation Infotainment Systems

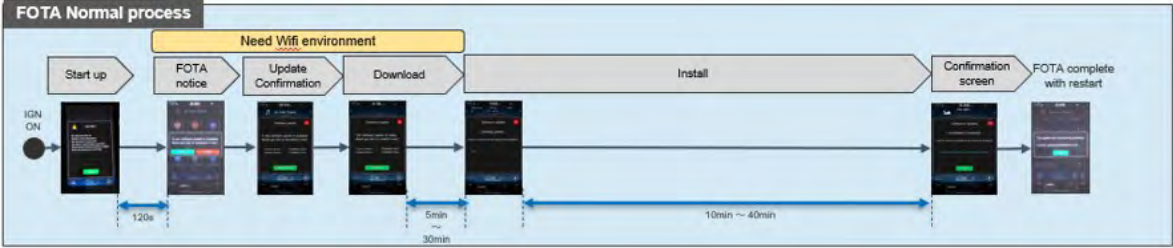
No.	Conditions/Symptoms to be improved
1	<p>System restarts itself during FOTA (Firmware Over The Air) update. FOTA operation is conducted in two processes: downloading (from the server to the Cockpit Control Unit via Wi-Fi) and installation (inside the Cockpit Control Unit). During the FOTA operation, after the new software has been downloaded to the Cockpit Control Unit (CCU) customer is to push “Install Now” on the Center Information Display (CID) to start installation of the software.</p>

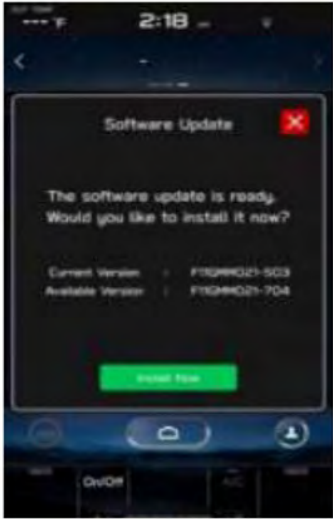
<p>The flowchart titled "Linux reset occurs" shows the same process as above but includes a "Linux reset" step. This step is represented by a red box labeled "Linux reset" and a black box labeled "CID Black screen" (Max 30s). This is followed by a "Restart" (120s) and "Install confirmation screen(Retry)" (10min ~ 40min + max150s) step. The final steps are "Restart install", "Confirmation screen", and "FOTA complete with restart". A blue box at the bottom contains the text: "•Linux reset(CID black screen) may occur during FOTA installation" and "•If Linux reset occurred, CID will be black screen max 30s, after that CID will restart automatically".</p> <p><b>Note*)</b> Even if this symptom occurs, after approximately 2 minutes, the system resumes, and the CID comes back to the below screen. Customer can then push the “Install Now” to proceed with the installation.</p>

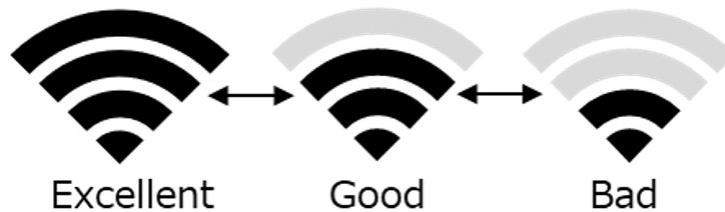
**5. If the “progress bar” does not progress after selecting “Download” or, if you receive a “Connect to Wi-Fi” popup while downloading:**

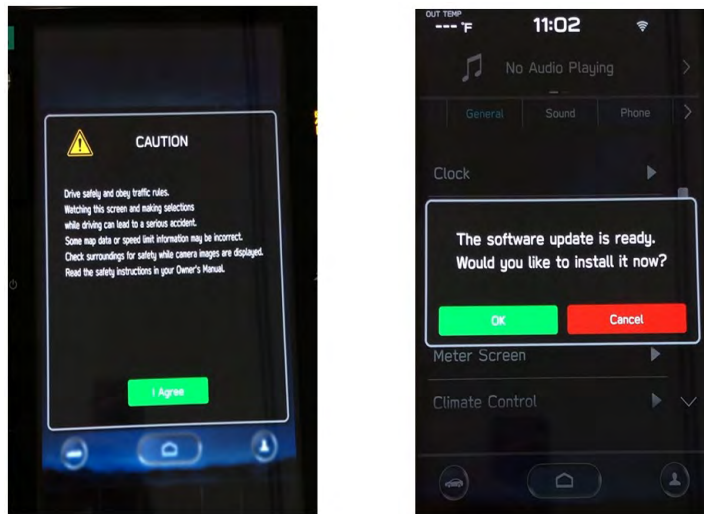
**6. If you encounter a blank screen and the update restarts during the installation process:**
