## SERVICE BULLETIN

**APPLICABILITY:** 2019-23MY Impreza  
 2019-23MY Crosstrek (Including Hybrid Model)  
 2019-24MY Forester  
 2019MY Legacy/ Outback  
 2019-21MY WRX  
 2019-21MY WRX STI  
 2019-21MY BRZ- Navigation -equipped ONLY  
 2019-22MY Ascent

**NUMBER:** 15-236-18R

**SUBJECT:** Reprogramming File Availability for Optimization of Harman Gen 3.1  
 and Gen 3.1α Audio and Navigation Head Units

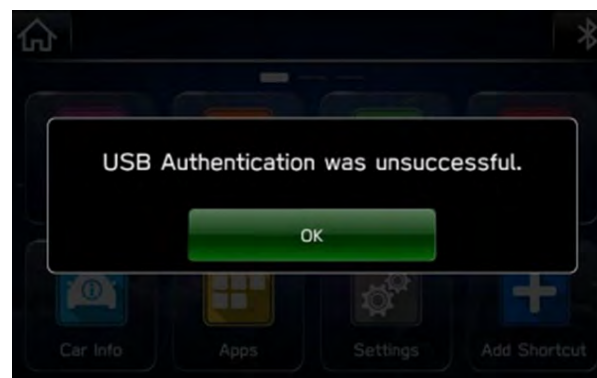
**NOTE:** If an attempt is made to install the wrong “grade” file into the wrong grade head unit (EXAMPLE: “Base” update file into a “Base Plus or Mid” or “High” head unit), the USB Authentication error screen below will be displayed:

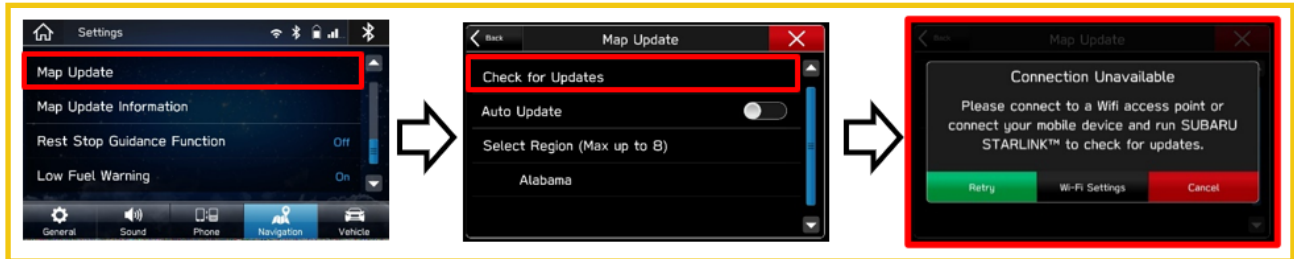
When customer attempts MOTA update after 12/2/2024 on the head with an outdated electronic certificate the following error pop-up will be displayed.

This popup is the same as the one that appears when Wi-fi connection is not available.

This software update was solely prepared to renew the electronic certificate programmed in the head unit to enjoy Map update Over the Air (MOTA) service. Only applied to HIGH trim Head Unit.

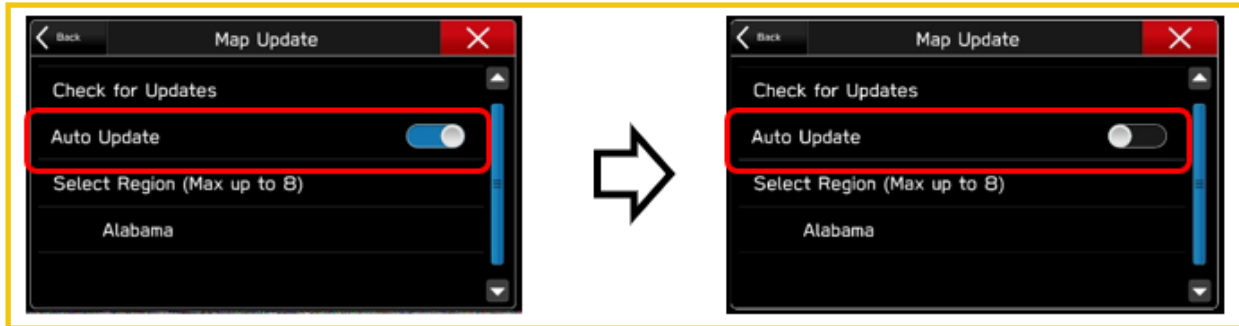
If you have set “Auto Update” to ON, after 12/2/2024, “Connection Unavailable” screen will pop up every time after Wi-fi connection. If you change Auto Update to OFF, the pop-up will not display.

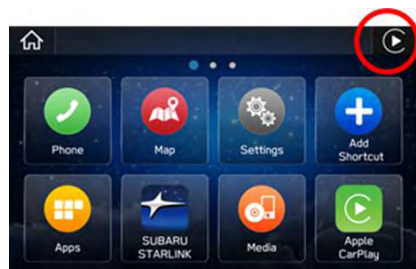
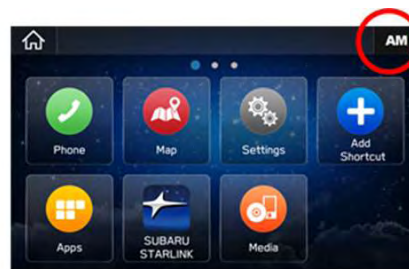
**On Ver. 6.0 and before:**

Music playing via iPhone in CarPlay.

After disconnecting, the music source changes to Radio automatically.

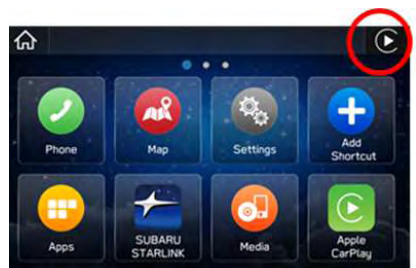
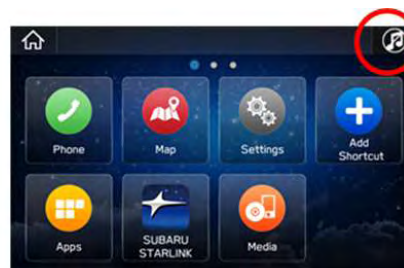
Music playing via iPhone in CarPlay.

After disconnecting, no music source is selected automatically.

If a source of music other than CarPlay has been playing when the iPhone is disconnected, the music source remains same (it is not turned off.)

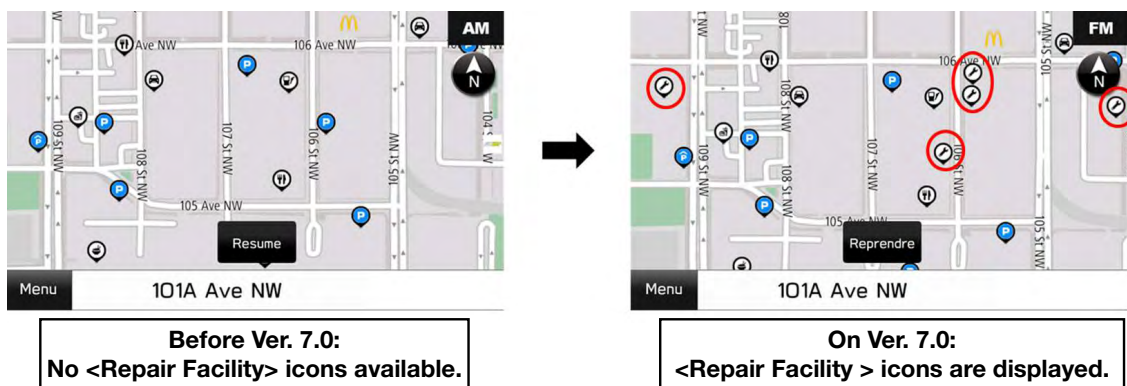
**NOTE 4:** Displaying Repair Facility POI icons:

<Repair Facility> Icons can be displayed in the NAVI Map.

<Repair Facility> Icons can be turned On or OFF by going to: Settings > Navigation > POI Icons.

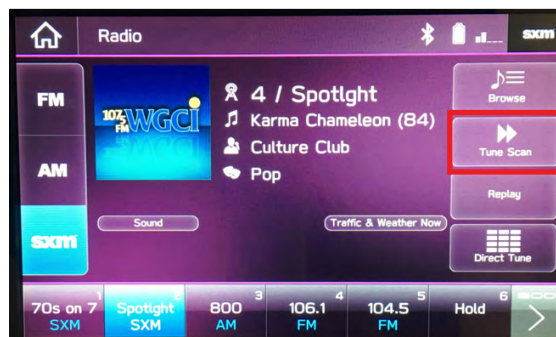
<Scan> previously displayed on SXM screen was changed to <Tune Scan> (a.k.a. SEEK).

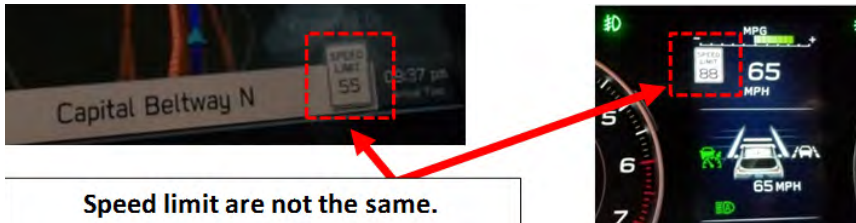
- 12) Mismatch of Speed Limit between Navigation display and the Speed Limit displayed in the Combination Meter Multi-Function Display (MFD).

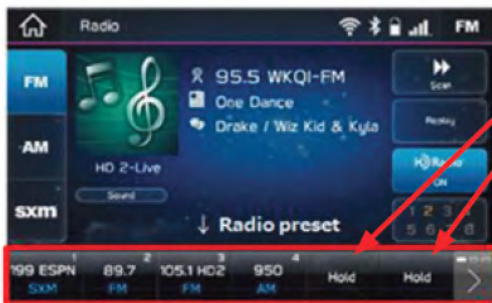
- 1) Station presets are lost. Touch buttons read “Hold”. (Applicable for software versions Rel\_4.18.25.50 (or before)). Included in software version Rel\_U1.18.38.50.
