**SERVICE BULLETIN**

**APPLICABILITY:** 2019-24MY Ascent

**NUMBER:** 06-92-24R

**SUBJECT:** Front Brake Pulsation/Squeal Diagnosis & Repair Front Brake Warranty Extension

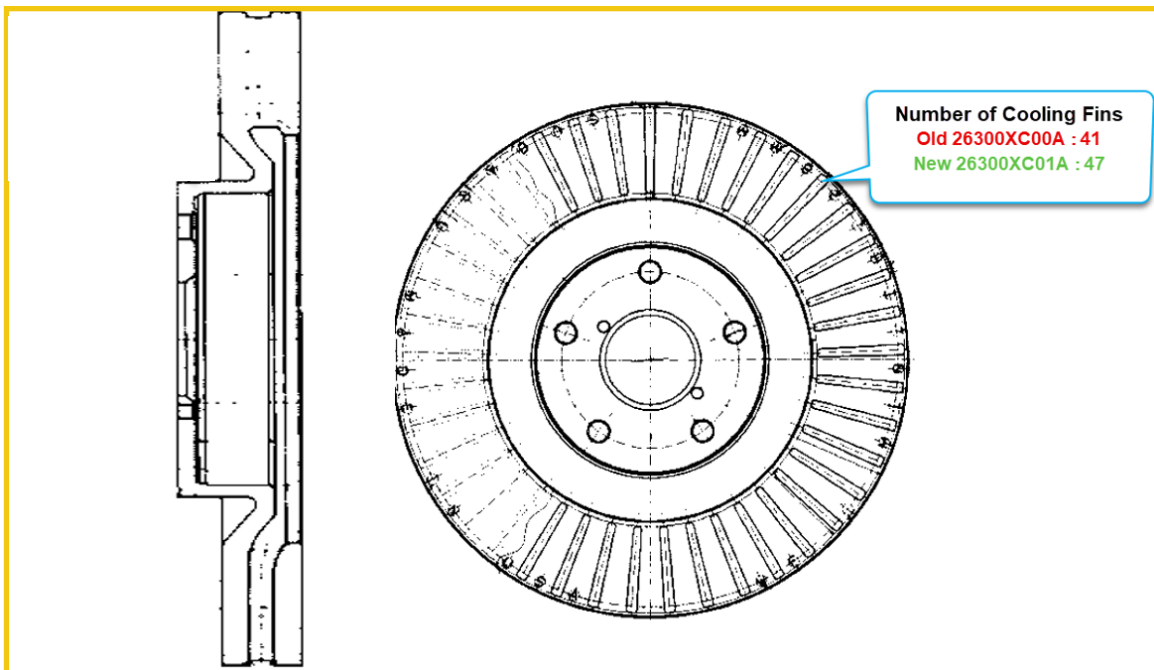
**STEP 2:** Raise the vehicle using the lift manufacturer's specified procedures. Remove both front wheels. Inspect the brake disc part numbers to confirm the brake disc version currently installed on the vehicle. See the images below for part number location.

**NOTE:** The new parts have 47 cooling fins, and the old parts have 41 cooling fins.

**YES:** Resurface the brake discs using a Subaru approved brake lathe. Perform a road test and confirm there is no front brake squeal/pulsation. Record and note the before and after brake thickness. **IMPORTANT: ALWAYS** use an approved brake lathe. A list of approved equipment can be found on the Subaru tools and equipment site: <https://subaruretailersolutions.com/equipment/category/601>

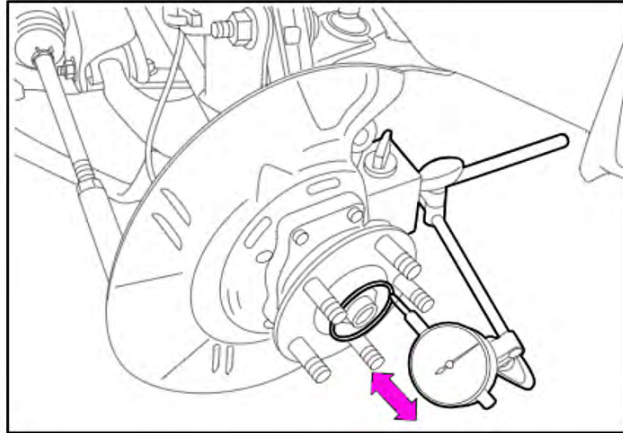
**STEP 7:** Using a dial gauge, inspect for any excessive play in the axial direction of the front hub bearing. Confirm the observed measurement is below the service limit of 0.05mm (0.002 in). If the measurement exceeds the specified value, the front hub bearing will require replacement. Record and note all measurements.

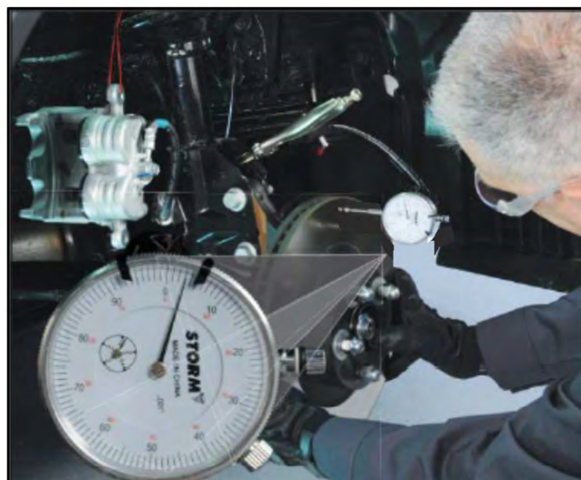
**IMPORTANT:** For best accuracy, the runout measurement should be taken 10mm from the outer circumference of the brake disc. See the example image below.

**STEP 8:** Install the new brake disc. Secure the disc to the hub using the five lug nuts in conjunction with matching suitable washers. Torque the lug nuts in a star pattern to **120 Nm (88.5ft-lb)**. Using a dial gauge, inspect the outer brake disc runout. Confirm the observed measurement does not exceed 0.05 mm (0.002 inch). If the measurement exceeds the specified value, remove the brake disc from the hub. Using the wheel studs as a guide, rotate the disc clockwise one wheel stud position and reinstall the brake disc. Inspect the runout using the procedures described above. The brake disc position can be rotated up to 4 more times to confirm the position with the least amount of runout. Install the brake disc at this position. In rare cases of the measurement not reading within specification after the five position inspection, exchange the brake disc with the other side of the vehicle and repeat the measurement. If the measurement continues to produce results out of specifications, replace the brake disc. Record and note all measurements.

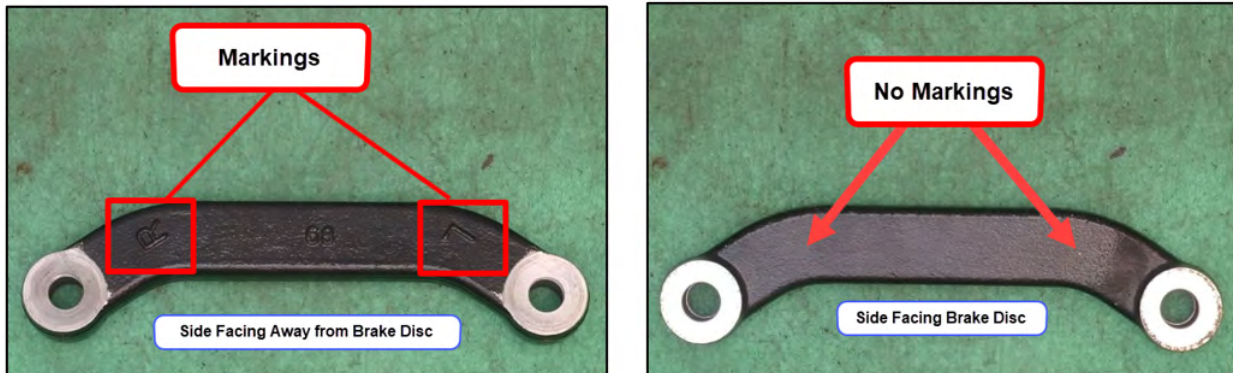
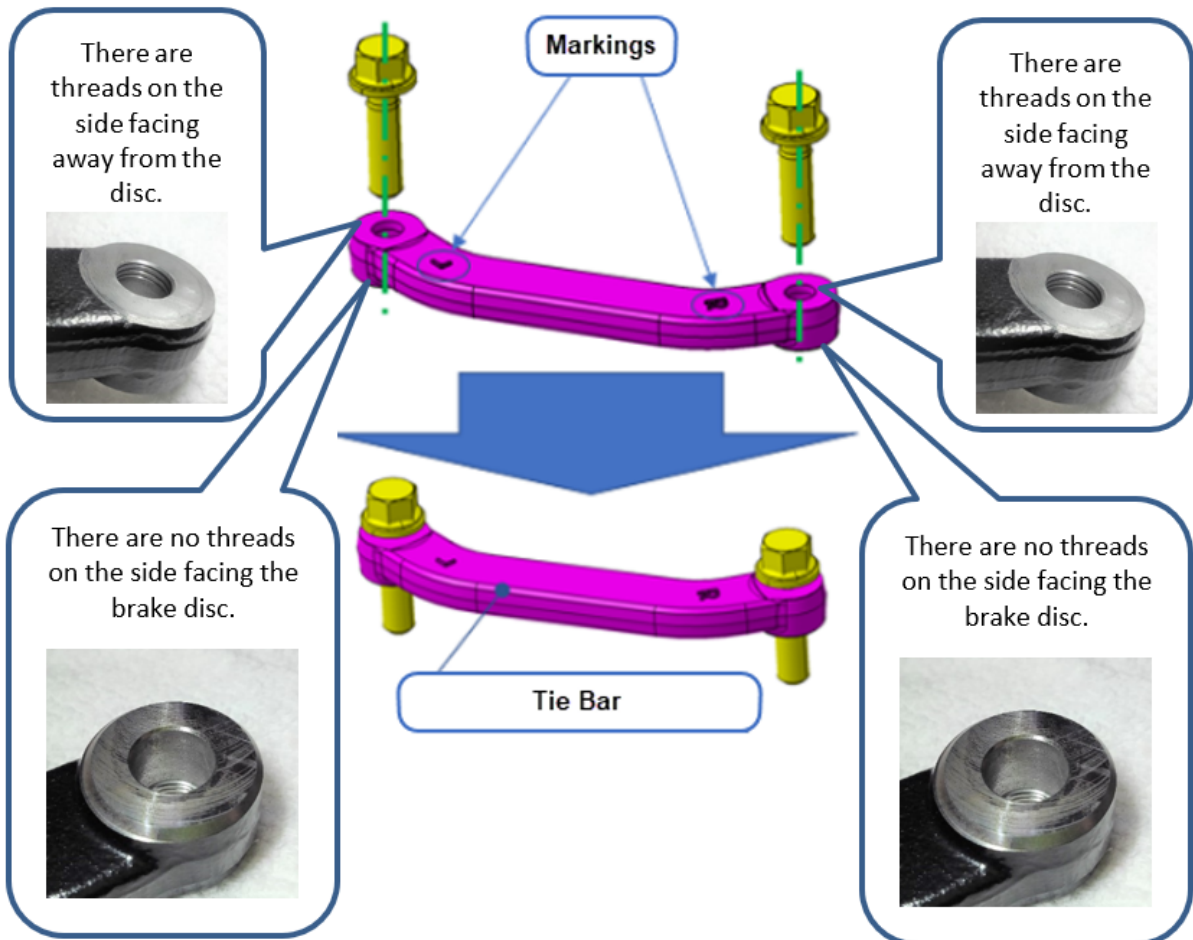
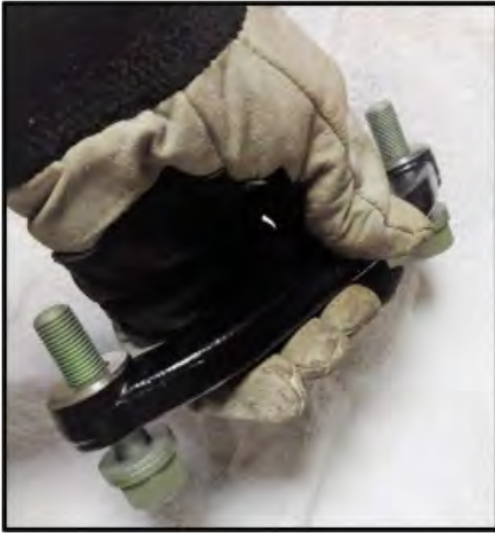
**IMPORTANT:** Orientation of the tie bar is designated by **R** (Right) and **L** (Left) markings located on the outside of the tie bar casting. The tie bar is to be installed with the markings facing away from the brake disc (toward the transmission) with the correlating side marking positioned on top.

The threaded ends of the tie bar help prevent the bolts from falling out during installation.

**STEP 11:** Pre-assemble the new mounting bolts and the new tie bar as shown below.
