SERVICE BULLETIN

NUMBER: 16-150-24R

SUBJECT: Transmission Control Module (TCM) / Software Enhancement

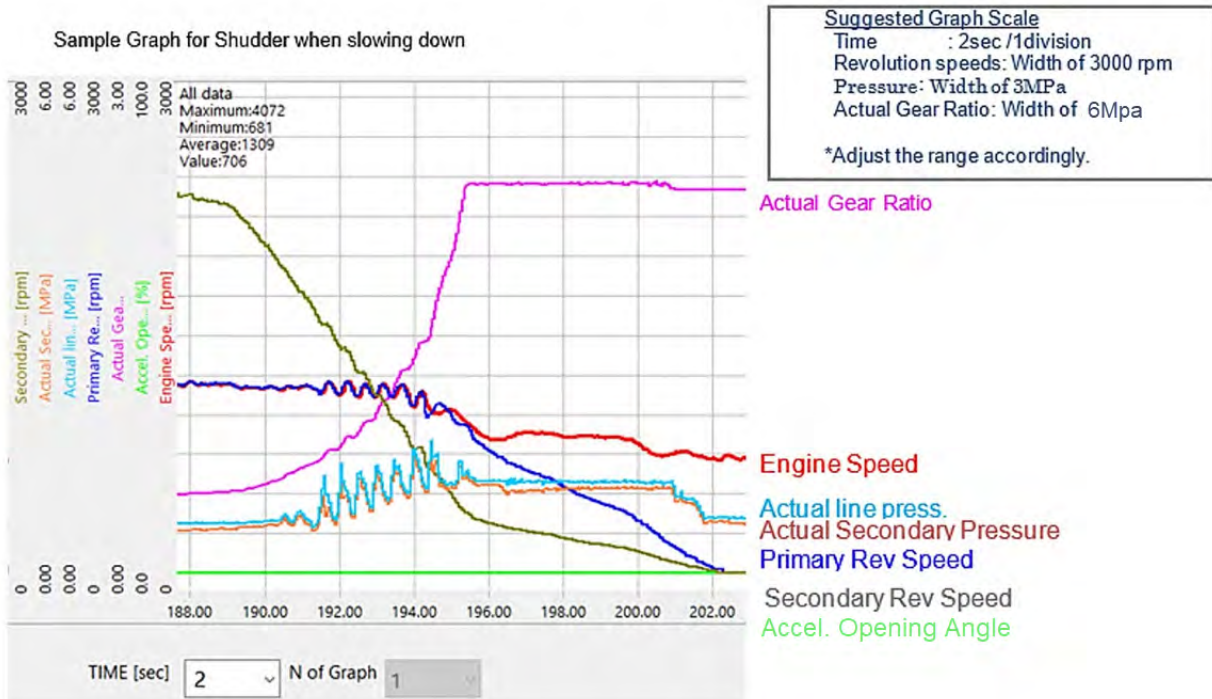
Reference: Judgement Criteria

Actual line press. and Actual Secondary Pressure are fluctuating while feeling shudder when slowing down

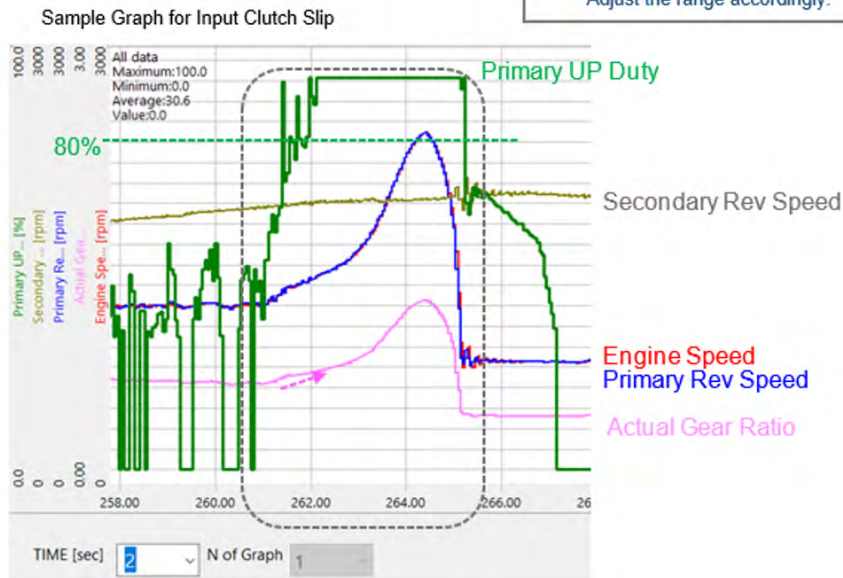
(*) **NOTE:** In case of chain slip caused by input clutch slip, customers may experience symptoms under the following driving conditions.

- (1) Constant speed driving between 25 and 62 mph.
- (2) Gentle acceleration between 25 and 62 mph.

Reference: Judgement Criteria

- All of the following are satisfied.
- Primary UP Duty > 80 %
 - Actual Pulley Ratio changes to Low
 - Above conditions last for 0.5sec or more
