SERVICE BULLETIN

APPLICABILITY: 22-23MY WRX Models **NUMBER:** 15-301-22R
SUBJECT: Reprogramming File Availability for Optimization of Gen 4 Denso CP1 Infotainment Systems **DATE:** 09/09/22
REVISED: 11/26/24

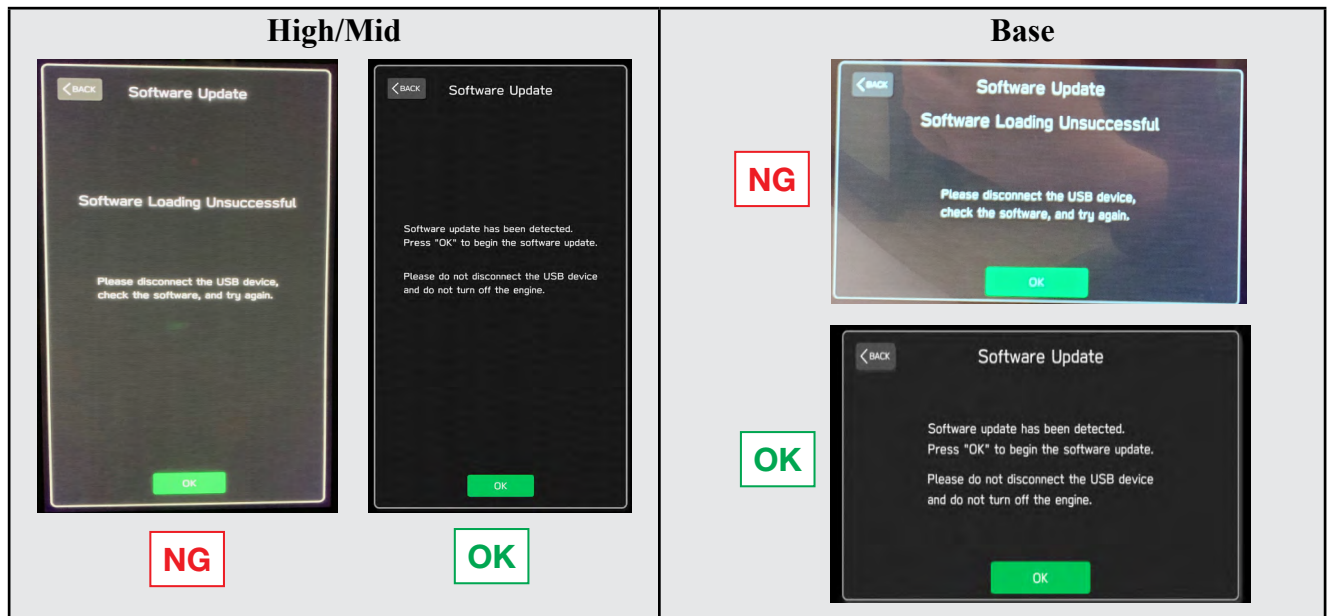
NOTE: If after plugging in the USB, the screen displays a **Software Loading Unsuccessful** message, confirm the USB device has been properly formatted and the the software on the device matches the system being reprogrammed (example: Base software is being used to update a Base system) and retry.

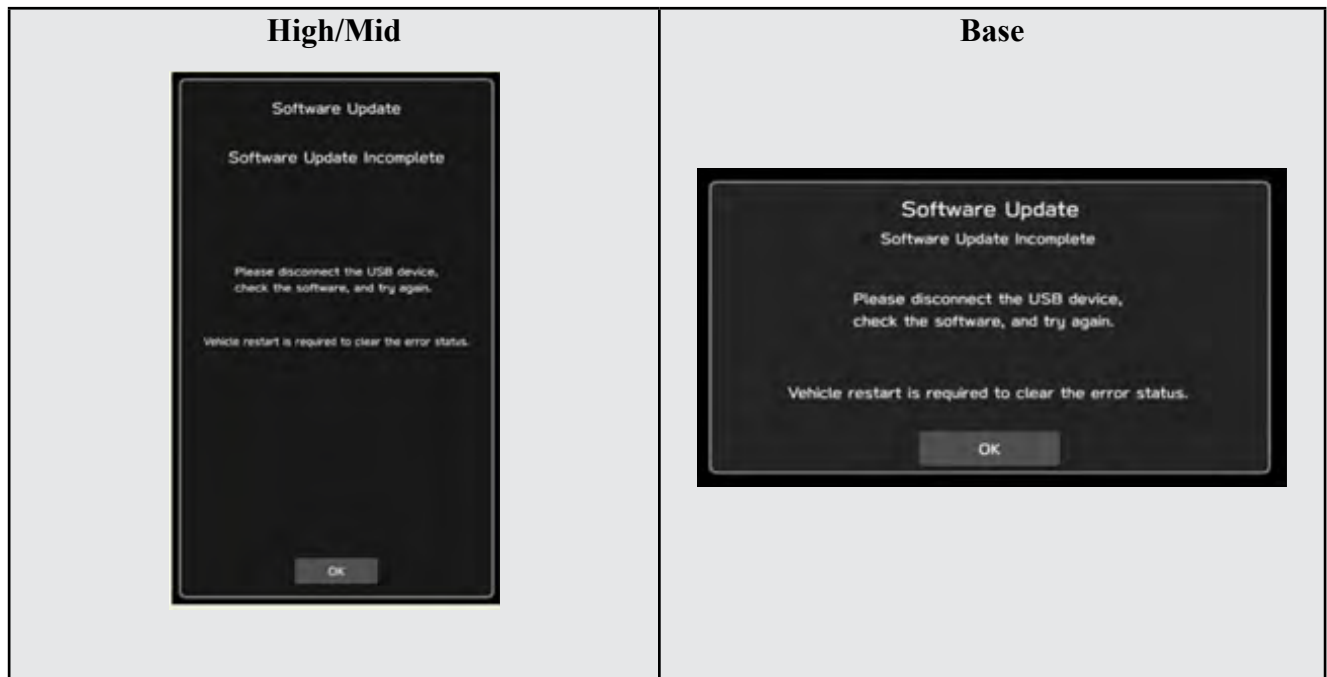
If you get the message **Software Update Incomplete** as shown below, please don't replace the hardware but retry updating the software according to the instructions in "**Appendix B**" on pg. 17.

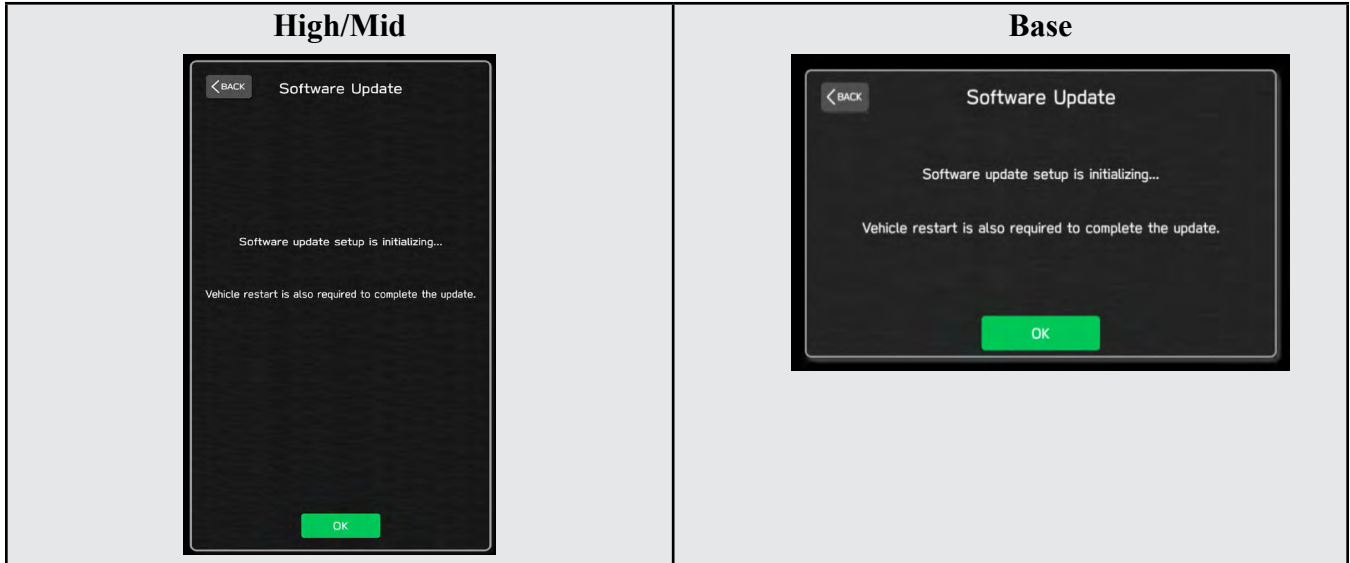
- If the screen shown below appears, **WAIT** for approximately 30 minutes or as long as necessary (waiting for longer than 60 minutes might indicate system malfunction). In that case please perform recovery according to the instructions in “Appendix B ” to allow the Software update setup initialization process to complete.

1. Turn the ignition OFF, open the driver’s door, close the driver’s door and **WAIT** for 3 or more minutes before proceeding further.
2. Open the driver’s door again and either turn the ignition ON (if a charger is connected) or start the engine.
3. Go to Dealership Mode menu again (PRESS and HOLD the RIGHT-side temperature control buttons (both up and down) and press the Tune / Scroll knob 6 times then release all to display the Dealership Mode) and select Software Update as in **STEP 4c** beginning on pg. 10.

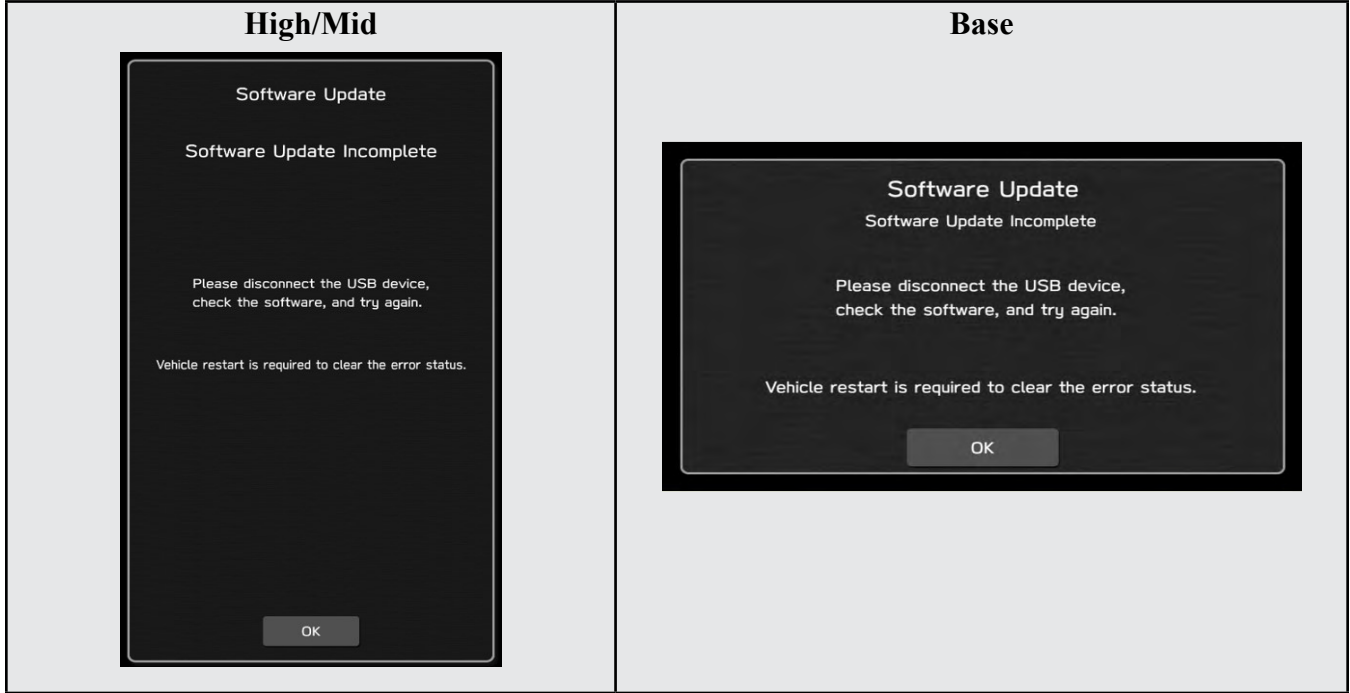
- If the first attempt of update fails with the message below, follow the steps described below 1-2 to 1-8 before retrying the software update.

1-1. Select OK in the screen below

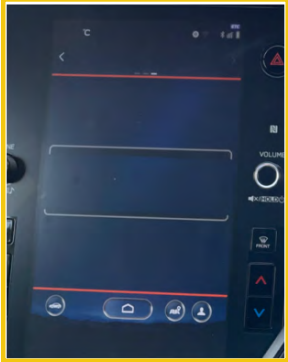
7	The CID screen display becomes distorted causing icons and text to be displayed incorrectly, when using USB audio in folder playback mode: the track list is scrolled at the moment when the playing folder switches

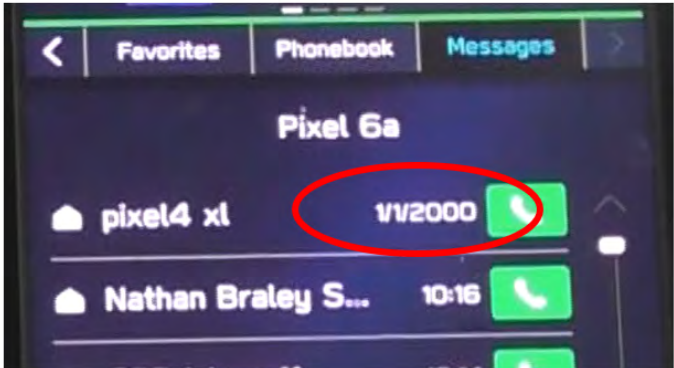
28	<p>The date of receipt of a received message is displayed as "2000/1/1." This occurs on some models of phones with Android OS 13 or later.</p>

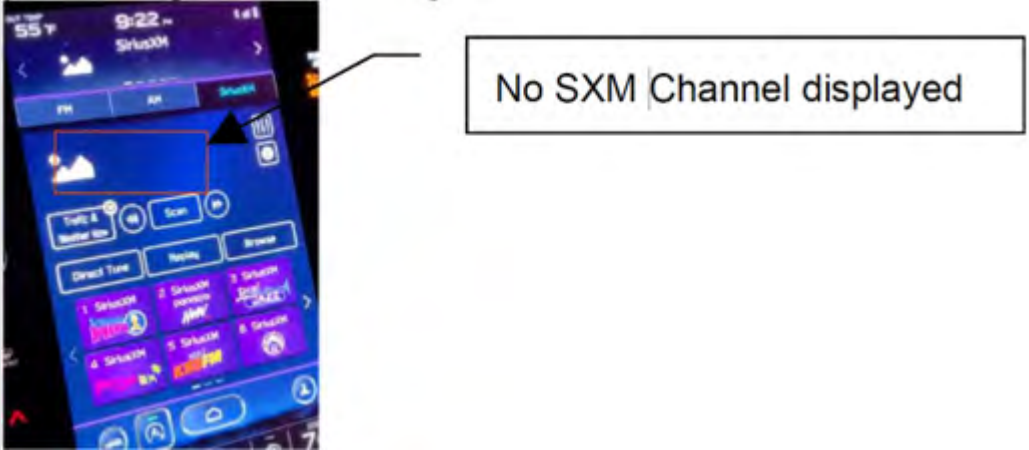
26	<p>SXM has blank screen and no sound when the SXM screen had been selected as audio source at the previous ignition off timing.</p>

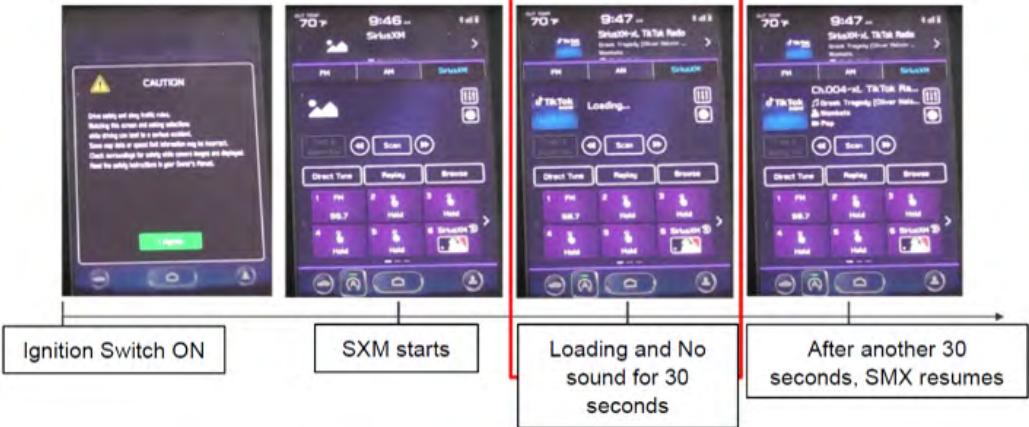
27	<p>About 30 seconds after starting the SXM the operation is paused with loading screen and resume after another 30 seconds. This symptom occurs when the SXM screen had been selected as audio source at the previous ignition off timing.</p>
