Service Bulletin

Bulletin No.: 20-NA-136

Subject: Diagnostic Tip for DTCs Set at a Low Mileage for 9T65 Transmissions

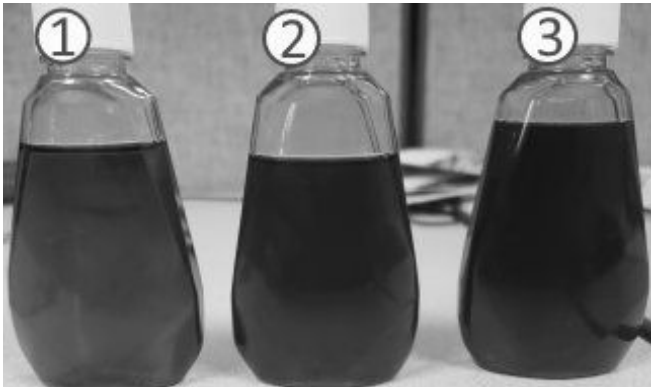
5840393

- 8.1. Inspect the fluid color.
 - The fluid should be red or dark brown.
 - It should be transparent so that objects or writing can be seen through it. Sample #1 is an example of acceptable fluid. Sample #2 is an example of very dark fluid. Sample #3 is an example of black fluid.
 - In addition to checking the fluid color and transparency, the fluid should be checked for an odor of burnt fluid. If the fluid is very dark, black, or has a burnt odor it would indicate clutch damage has occurred internally in the transmission and it would need to be removed from the vehicle and investigated.
