<b>HYUNDAI</b> <b>Technical Service Bulletin</b>	GROUP <b>BODY ELECTRICAL</b>	NUMBER <b>24-BE-007H-1</b>
	DATE <b>NOVEMBER 2024</b>	MODEL(S) <b>SEE BELOW</b>
<b>SUBJECT:</b> COAXIAL CABLE SHIELD ADJUSTMENT FOR DISPLAY SCREEN FLICKERING/BLANK

**This TSB supersedes 24-BE-007H to include Santa Cruz (NXT), Santa Fe Hybrid (MX5A HEV), and Tucson (NX4A) models, add additional Op Codes to the Warranty Information table on page 2, and include shop manual details for the added models on pages 3-4.**

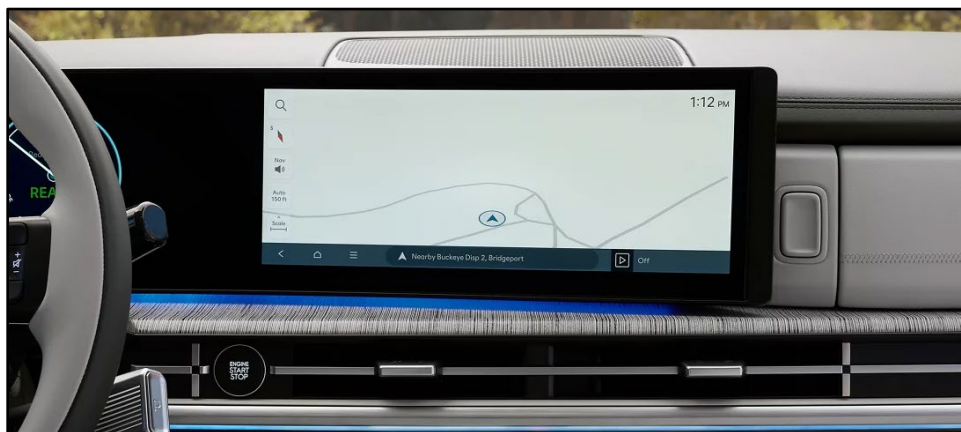
**Description:** Certain Santa Cruz (NXT), Santa Fe (MX5A), Santa Fe Hybrid (MX5A HEV), and Tucson (NX4A) vehicles may exhibit a display screen flickering or intermittently going blank. This may be due to the shield width of the coaxial cable being too wide, causing a loose connection. Follow the procedures in this bulletin to adjust the width of the shield using a supplied shield adjustment jig.

Example of Display Screen on Santa Fe (MX5A)

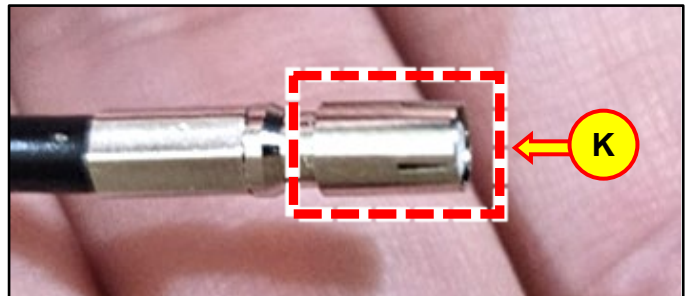
Shown at right is a coaxial cable shield (K) that is too wide and needs adjustment.

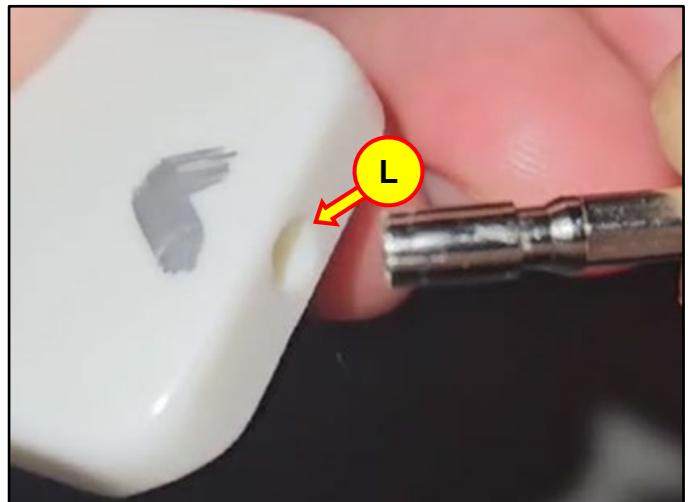
Notice that the coaxial cable shield is larger than the hole of the jig (L). Proceed to next step.

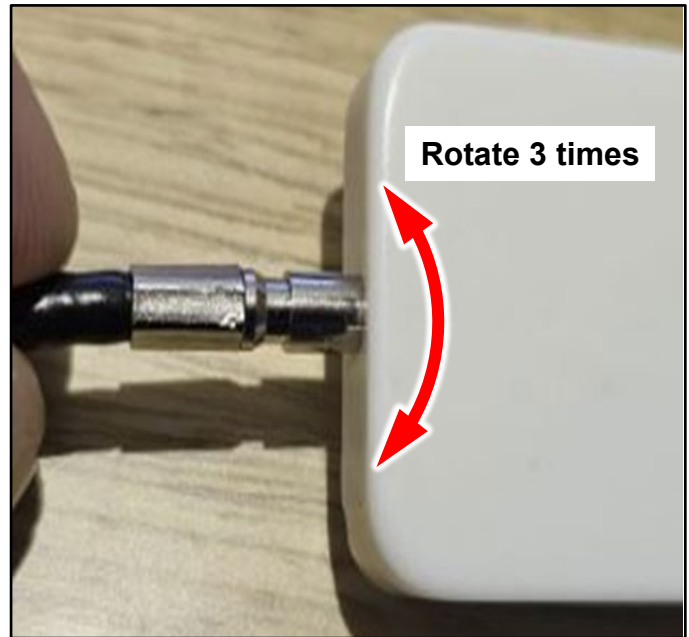
This will reduce the width of the shield to enable a better connection in the connector.

7. Once inserted, rotate the jig around the shield 3 times.

8. Remove jig for use in next affected vehicle.
