<b>Subject:</b>  CHATTERING NOISE FROM UNDERBODY WHEN DRIVING ON ROUGH ROADS	<b>Bulletin No.:</b> 01-011/24
	<b>Last Issued :</b> 11/27/2024

2024-2025 CX-90

2025 CX-70

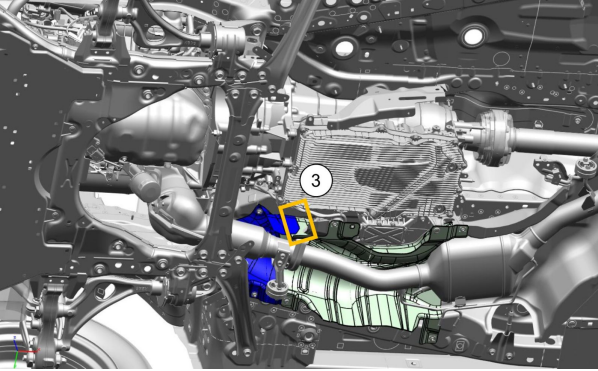
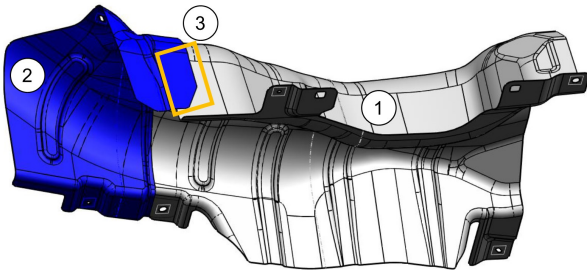
d. Check the gap in the overlapping area on the left side between the front No.1 and No.2 insulators.

- 1) Front No.1 insulator
- 2) Front No.2 insulator
- 3) Overlapping area

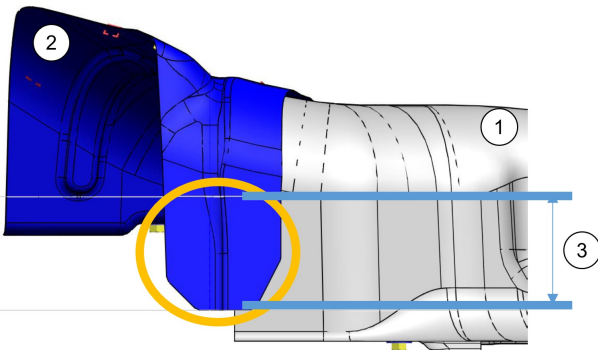
- 1) Front No.1 insulator
- 2) Front No.2 insulator
- 3) 80 mm

e. Manually adjust Insulator No.2 within the 80 mm range as shown below to create an approximate 3 mm gap with Insulator No.1.

**NOTE:** Repeated bending of the insulator may cause damage.
