Subject: MISALIGNMENT BETWEEN REAR END OF FRONT DOOR GLASS RUN-CHANNEL AND FRONT END OF REAR DOOR GLASS RUN-CHANNEL	Bulletin No.: 09-050/24
	Last Issued : 11/20/2024

2024 CX-90
2025 CX-70

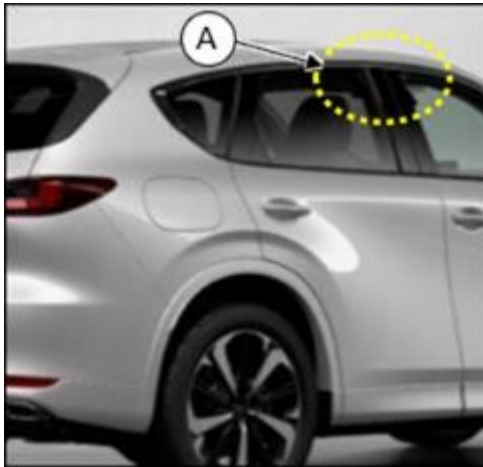
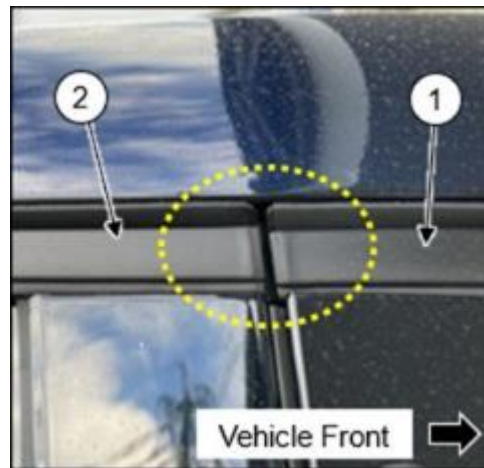
Detail of A

Some vehicles may exhibit misalignment (in any direction) between the rear end of the front door glass run-channel (1) and the front end of the rear door glass run-channel (2).

This may be caused by the rear end of the front door glass run-channel sagging downward due to repeated thermal expansion and external forces. To eliminate this concern, the shape of the clip at the rear end of the front door glass run-channel has been modified to reduce deformation.

1. Verify the customer concern.
2. Replace the front door glass run-channel(s) with a modified one(s) according to the instructions in MGSS.

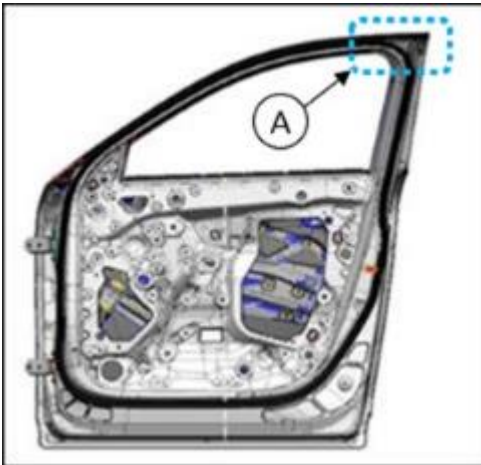
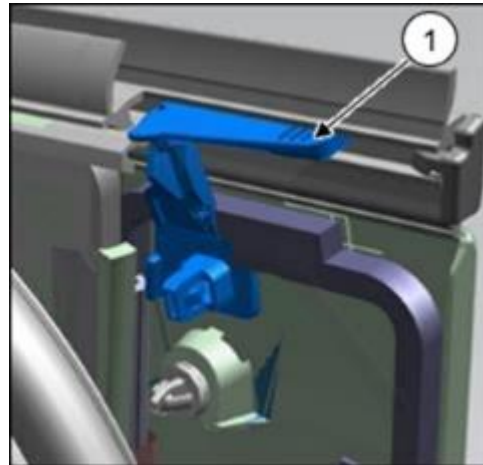
NOTE: The clip is located under a part of the glass run channel. The modified clip (1) installation has been completed in the image.

Install the clip correctly, as shown in the following images.

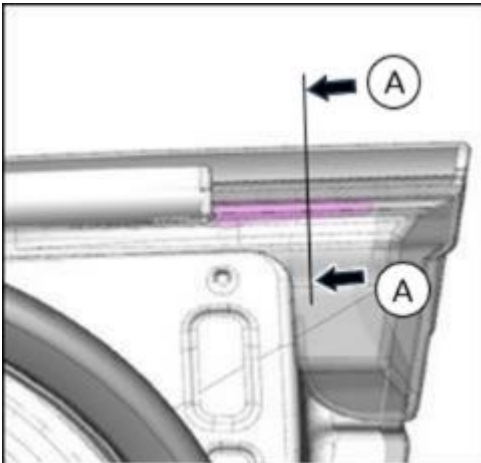
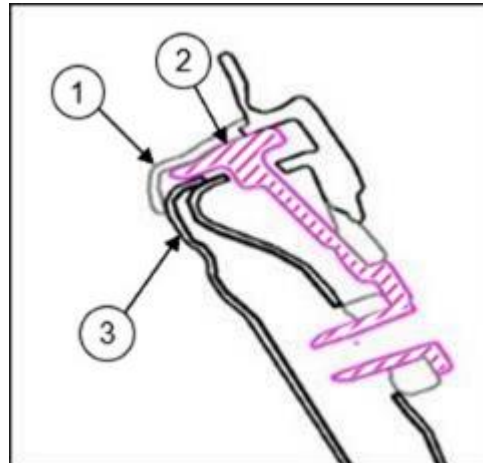
Section A-A

- **Good:** When partially removing the front glass run-channel (1), the clip (2) is visible and installed above the door panel (3).

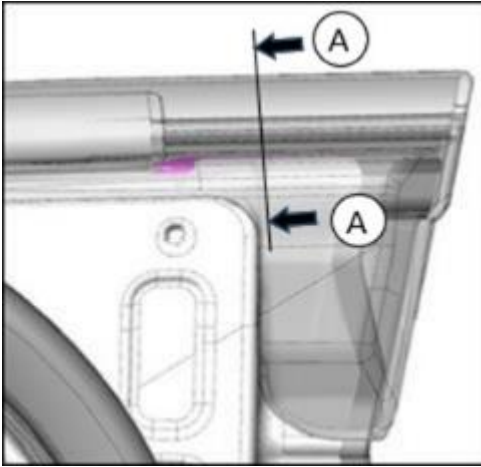
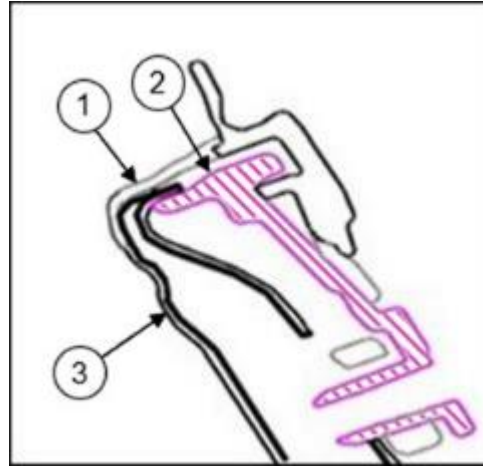
**Section A-A**

No Good

When partially removing the front glass run-channel (1), the clip (2) is NOT completely visible and installed under the door panel (3).
