**Re: Motiv Technical Bulletin for the following recall notices**

- 24V698 (Ring-terminal) non-school bus
- 24V699 (Ring-terminal SB)
- 2024-563 (Ring-terminal / TC)

**RECALL INFORMATION**

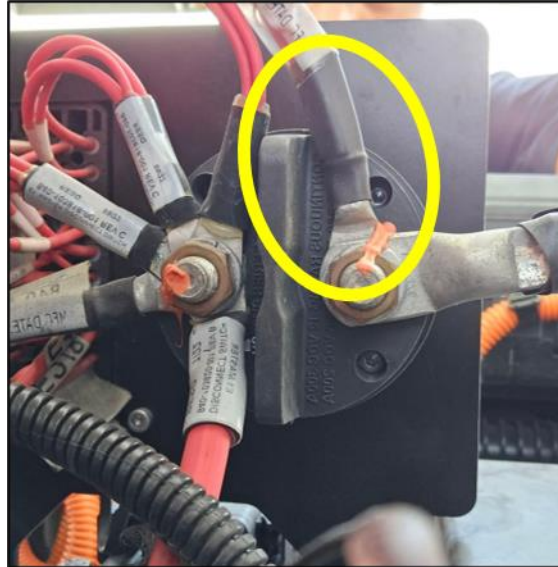
2. Locate wire harness P/N 840-106336-001 that runs from the post on the back - **DRIVER** - side of the master disconnect switch
3. Inspect the junction point of the six (6) wires and ring terminal for the presence of heat shrink.
4. If heat shrink is present and the harness has adequate strain relief, as circled yellow in the picture below, the harness is acceptable.

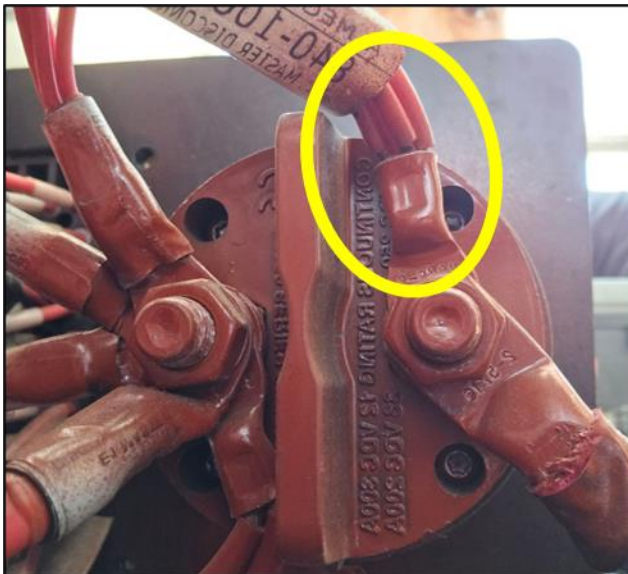
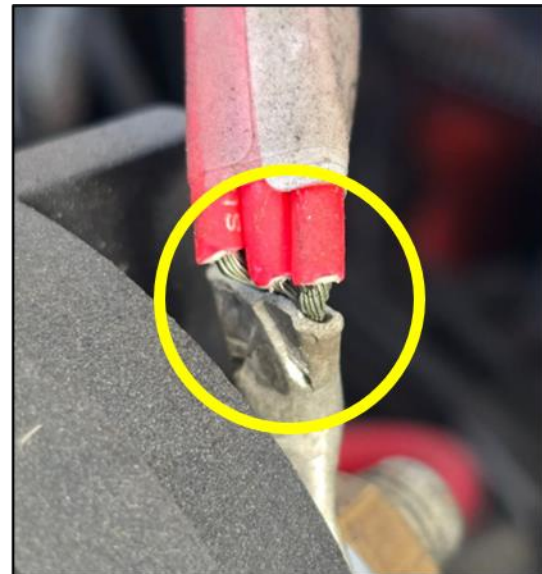
5. If there is no heat shrink, as circled in yellow in the picture below, the harness must be replaced.

6. To replace the harness

- a. Turn the mater disconnect switch to the OFF position and wait for five (5) minutes for the vehicle to completely de-energize.

- b. Disconnect the positive lead to the 12v battery
- c. Remove the 13mm nut that secures the ring terminal to the master disconnect switch.

- d. De-pin the six (6) wires that enter the back side of the adjacent fuse box - taking note of what positions the wires go into.

- e. Remove the harness
- f. Reverse steps “b” through “c” to reinstall the new harness
- g. Tighten the nut on the back of the master disconnect switch to 13 ft/lbs.
- h. Turn master disconnect switch on
- i. Test drive vehicle
