Service Bulletin

Bulletin No.: 21-NA-169

Subject: Diagnostic Tip for DTCs Set at a Low Mileage for 9T45/50/60 Automatic Transmissions

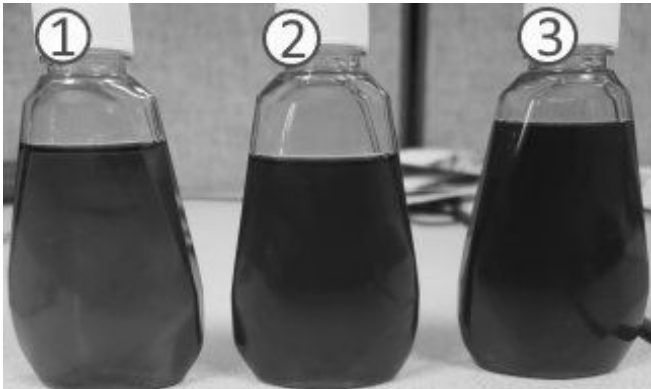
5840393

- The fluid should be red or brown.
- The fluid should be transparent so that objects or writing can be seen through it. Sample #1 is an example of acceptable fluid. Sample #2 is an example of very dark fluid. Sample #3 is an example of black fluid.

- In addition to checking the fluid color and transparency, the fluid should be checked for an odor of burnt fluid. If the fluid is very dark, black, or has a burnt odor it would indicate clutch damage has occurred internally in the transmission and it would need to be removed from the vehicle and investigated.
