## ROOF BLIND OPERATION

### Range Rover

- 22 - 25MY RR Sport (L461)

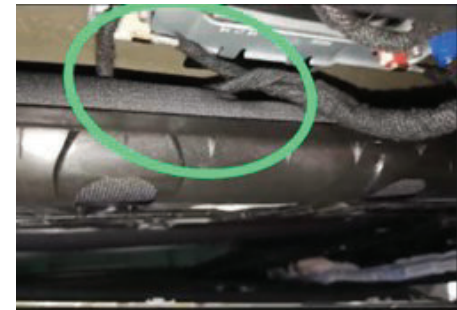
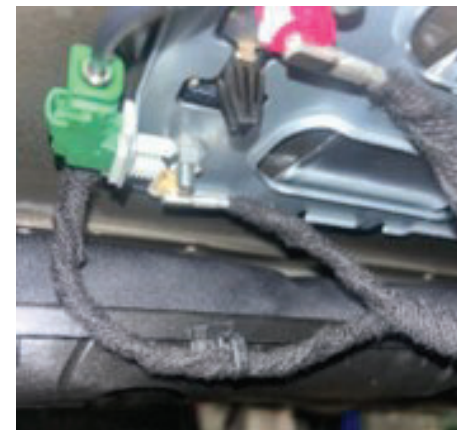
- The roof blind does not open or close properly.

- The roof wiring harness may be misrouted and interfere with the roof blind run channel.

- SSM76211 has been published to provide repair instructions to address this concern.
