Rear Differential Pump Motor Connector Corrosion Sets AWD DTCs

AFFECTED VEHICLES

Year	Model	Trim Level	VIN Range
2019-22	Passport with AWD	ALL	ALL
2016-22	Pilot with AWD	ALL	ALL
2017-22	Ridgeline with AWD	ALL	ALL

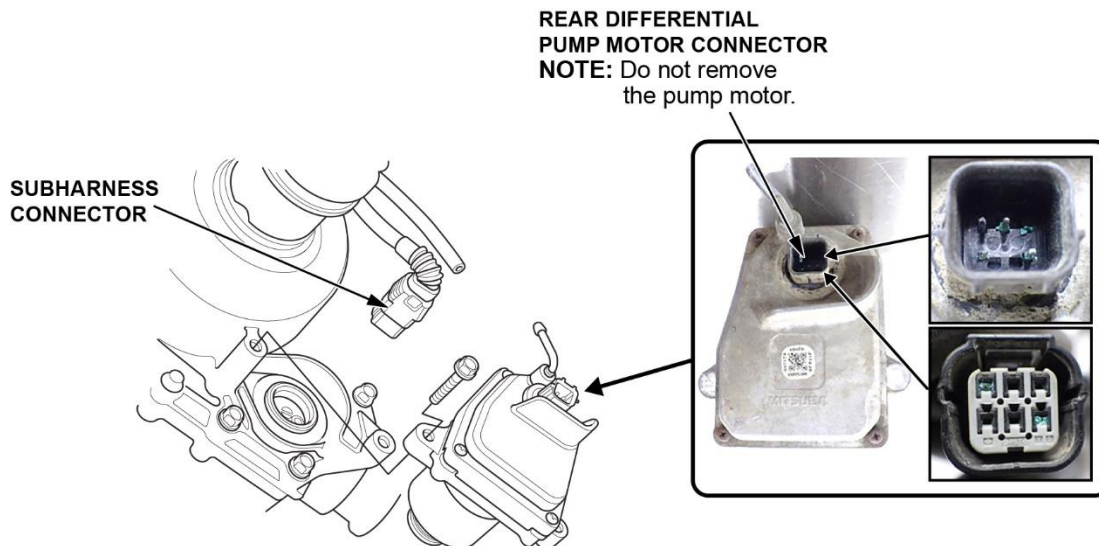
Water intrusion into the rear differential pump motor connector area corrodes the terminals.

- Put the vehicle on a lift and position the lift pads under the vehicle's front support points and rear support points.
 - 2019–22 Passport - [Lift and Support Points](#)
 - 2016–22 Pilot - [Lift and Support Points](#)
 - 2017–22 Ridgeline – [Lift and Support Points](#)
- Inspect the connectors at C125 (Rear Subframe Subharness to Rear Differential Pump Motor) for signs of water intrusion or corrosion.

Do either connectors have any signs of water intrusion or corrosion?

If the DTCs listed in SYMPTOM are present, replace the rear differential pump motor and rear subframe subharness.
