November 22, 2024

Version 1

## Rear Differential Pump Motor Connector Corrosion Sets AWD DTC's

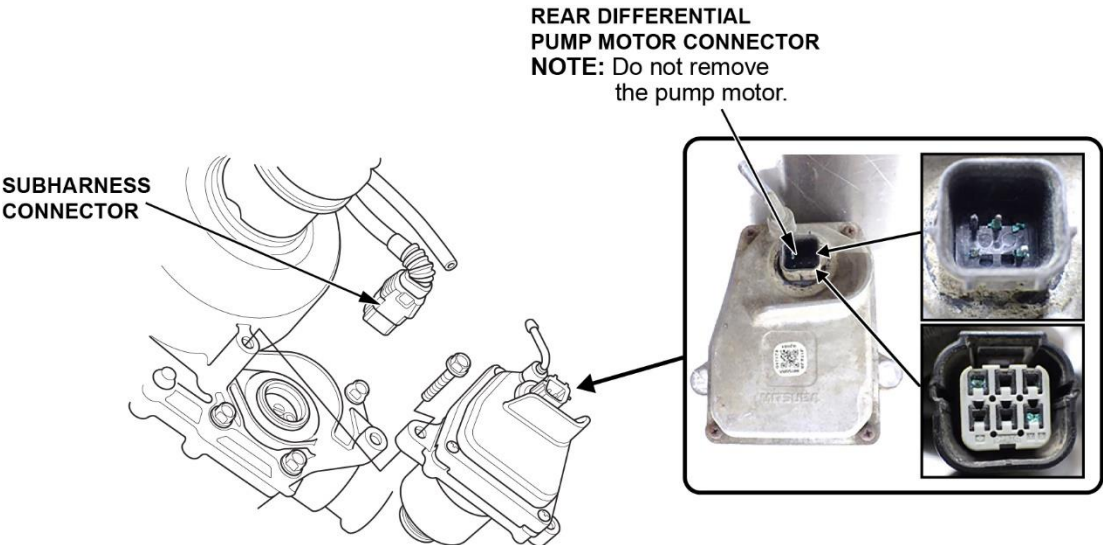
Water intrusion into the electric oil pump motor connector area corrodes the terminals.

- Put the vehicle on a lift and position the lift pads under the vehicle’s front support points and rear support points.
  - 2015–20 TLX - [Lift and Support Points](#)
  - 2016–20 MDX - [Lift and Support Points](#)
- Inspect the connectors at C125 (Rear Subframe Harness to Rear Differential Pump Motor) for signs of water intrusion or corrosion.

Do either of the connectors have any signs of water intrusion or corrosion?  
**YES** - Go to the REPAIR PROCEDURE.  
**NO** - This service bulletin does not apply. Continue with normal troubleshooting.

If the DTCs listed in SYMPTOM are present, replace the rear differential pump motor and rear subframe subharness.
