42-080 ABS Wheel Speed Fault Code Correction for MBSP Equipped Vehicles

TSB-42-080-FTL

Creation Date:2024-05-13
Last Revision Date:2024-11-21

► New Cascadia

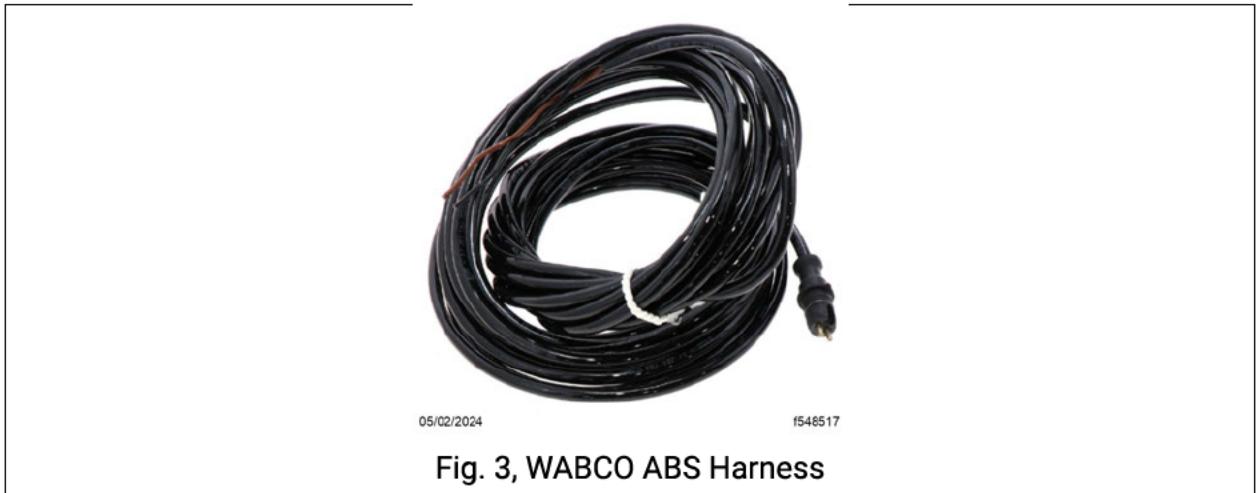
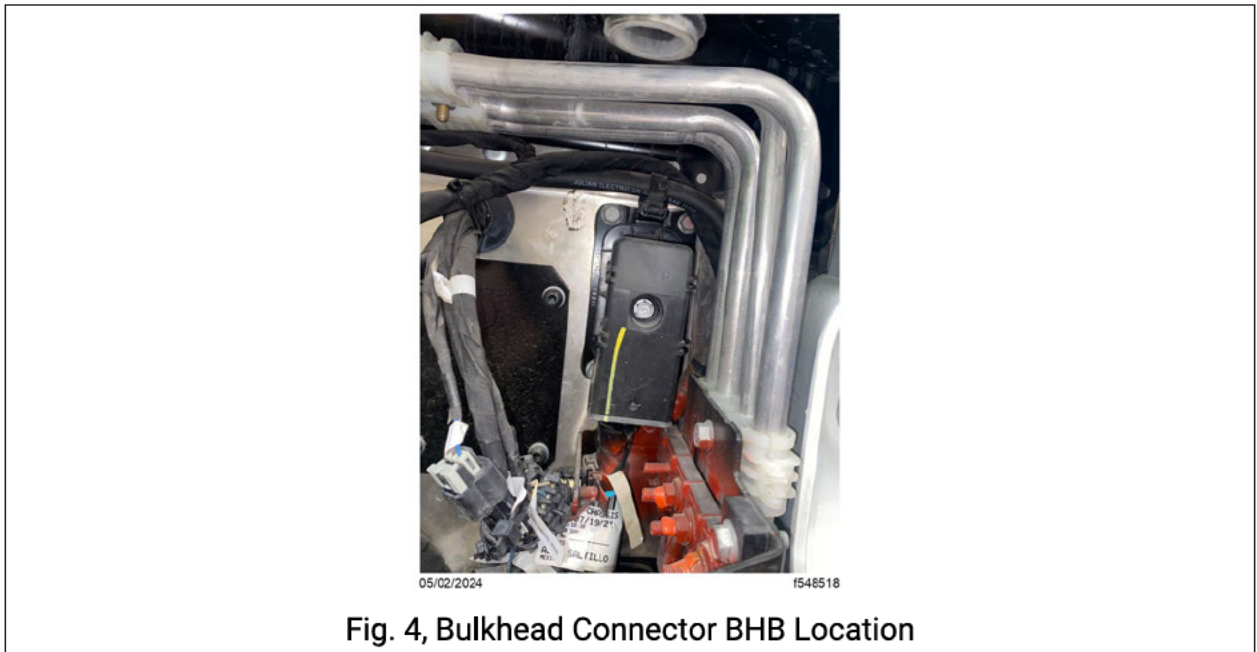
- b. All harnesses listed above in Table [WABCO Harness Part Numbers 5](#) will require termination at the bulkhead connector BHB. See Fig. [3](#) and Fig. [4](#) for bulkhead connector BHB location.

- c. The lengths of the WSS overlay harness required will vary based on the wheelbase of the vehicle. See 'Determine Vehicle Wheelbase' below.
- d. All the harnesses listed in Table [WABCO Harness Part Numbers 5](#) will require trimming to length and termination at the 76-pin bulkhead connector BHB. See Fig. [3](#) for image of a typical WABCO ABS Harness and Fig. [4](#) for bulkhead connector BHB location.
- e. Choose the closest available harness length in order to minimize harness waste when trimming to length.
- f. Installation of the terminal part number 23-13211-410 (Qty: 8 Nos.) requires crimping tool SPX J-38125-6 (non-ratcheting) or SPX J-38125-7 (ratcheting).
