# 54-098 Disabling the 'Park Brake Set / Door Open' Warning

## TSB-54-098-WST

Creation Date:2024-11-18

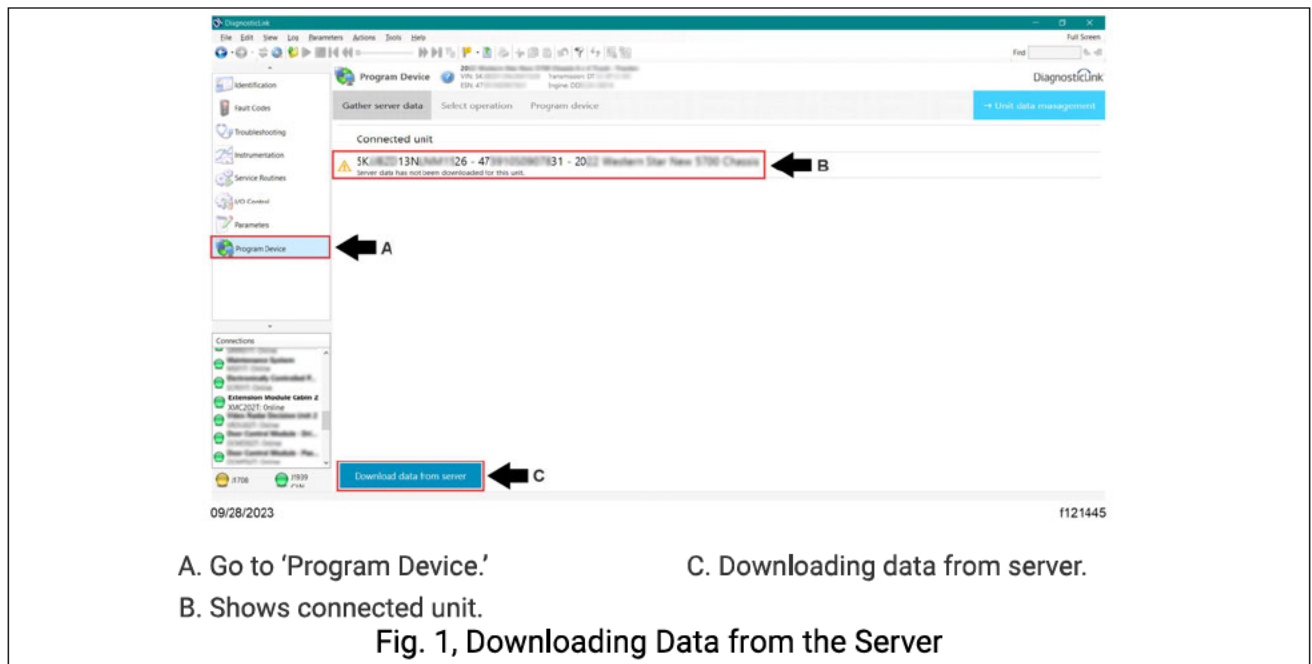
6. ☐ Select 'Gather server data' and select the Vehicle Identification Number (VIN). Then select 'Download data from server.' See Fig. 1.

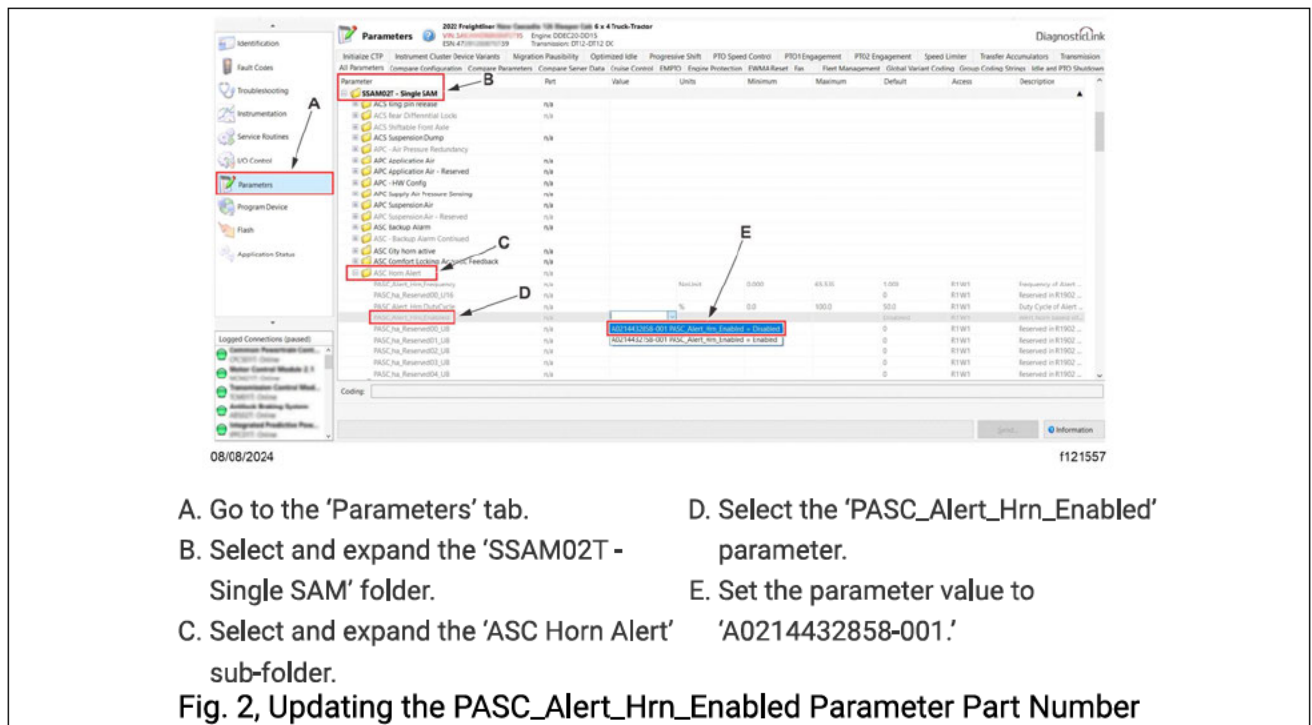
7. ☐ When the data download is complete, a green check mark will appear next to the VIN on the 'Gather server data' screen.
8. ☐ Go to the 'Parameters' tab, then select and expand the 'SSAM02T - Single SAM' folder.
9. ☐ Select and expand the 'ASC Horn Alert' sub-folder.
10. ☐ Select the 'PASC\_Alert\_Hrn\_Enabled' parameter, and set the parameter value to 'A0214432858-001.' See Fig. 2. This disables the horn alert when the door is opened.

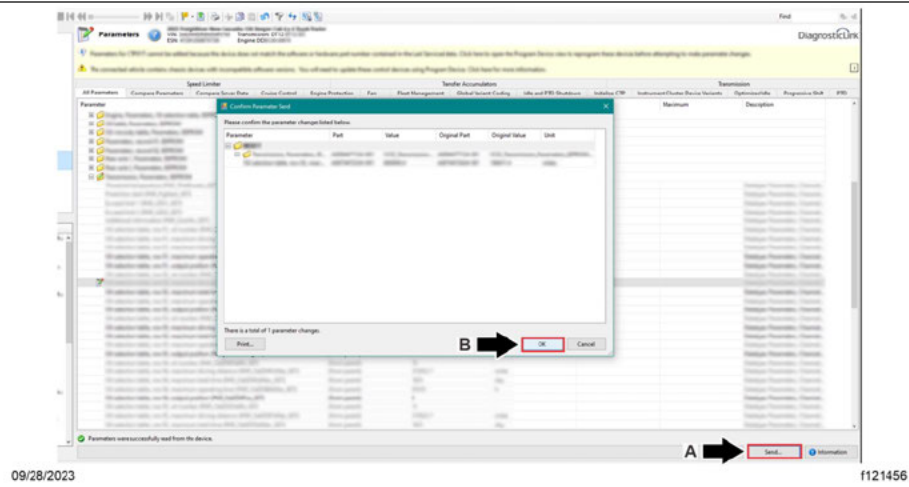
**Fig. 3, Writing the Parameter Changes to the Vehicle**

11. ☐ Select the 'Send' button to write the parameter changes to the SSAM02T ECU in the vehicle. A window opens asking to confirm the parameter change; select 'OK.' See 3.

A. Select the 'Send' button.

B. Select 'OK' to confirm the parameter changes.

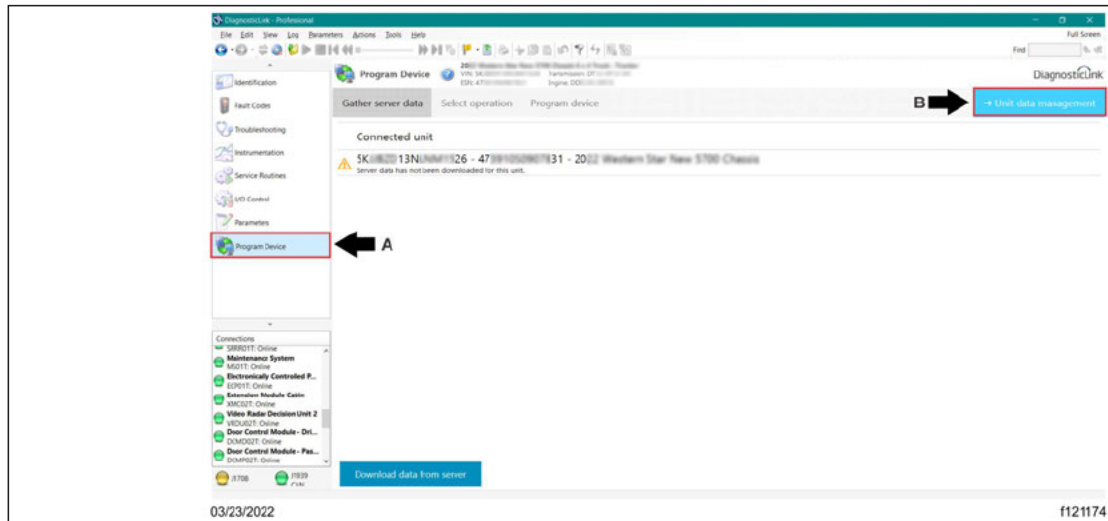
**Fig. 4, Selecting Unit Data Management**

12. Once the parameter change is complete, go to the 'Program Device' tab. Select 'Unit data management' in the upper-right corner. See Fig. 4.

A. Go to the Program Device tab.

B. Select 'Unit data management.'

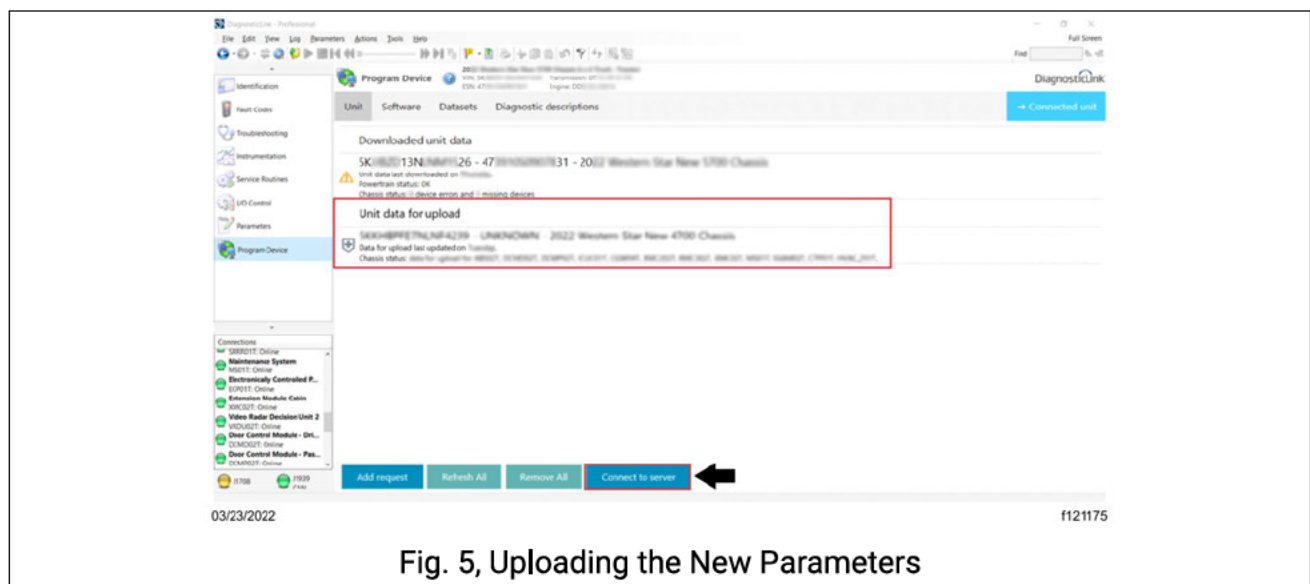
Fig. 5, Uploading the New Parameters

13. The information corresponding to the VIN should appear under the 'Unit data for upload.' Select 'Connect to server' to upload the new parameters. See Fig. .
