# 91–016 Repairing Seat Occupancy Sensor for ISRI, SEARS and National Truck Seats

## TSB-91-016-FTL

### Engine or Vehicle Affected:

- ▶ Business Class M2-Plus
  - ▶ Business Class M2
  - ▶ 108SD Plus/114SD Plus
  - ▶ New Cascadia
  - ▶ eM2
  - ▶ eCascadia
-

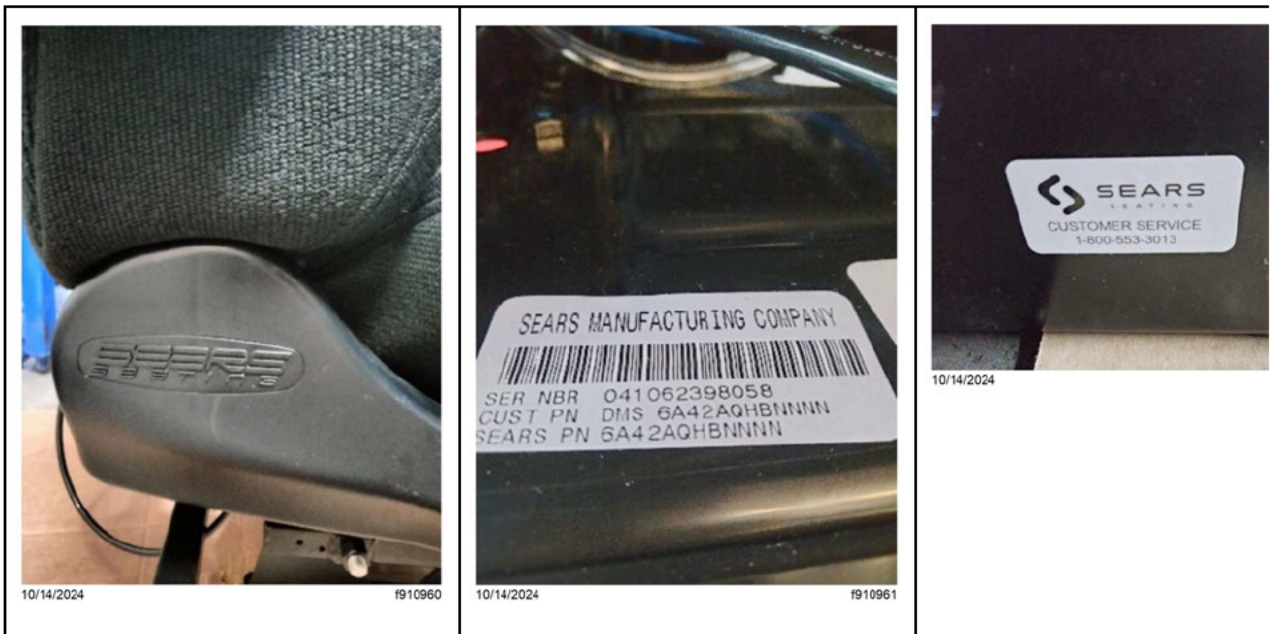
Table 1, SEARS Seat Information

2.  Use the BOM to identify what seat is installed;
  - For visual ID of a SEARS seat, see figures in [Table 1](#).

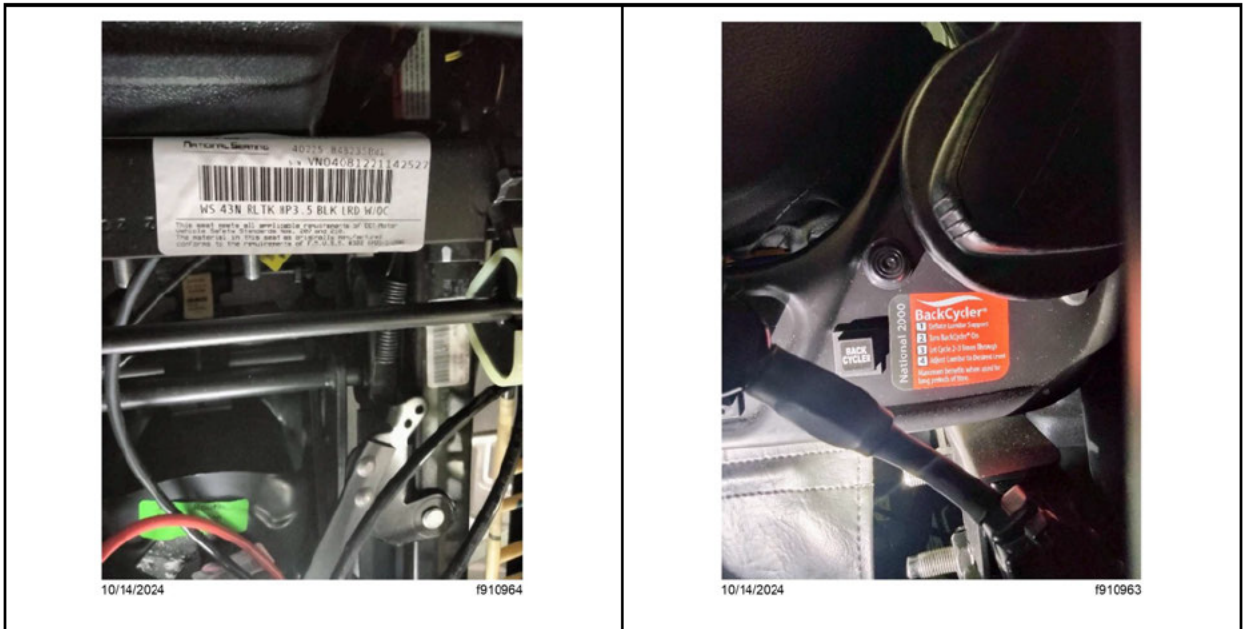
Table 2, National Truck Seat Information

- o For visual ID of National Truck Seat, see figures in Table 2.
