SF709 A

**Subject: FCCC EconicSD ICUC**

On behalf of the entity listed below, Daimler Truck North America LLC (DTNA), is initiating Field Service Campaign SF709 to modify the affected vehicles.

Replacement of the Instrumentation Control Unit (ICUC)

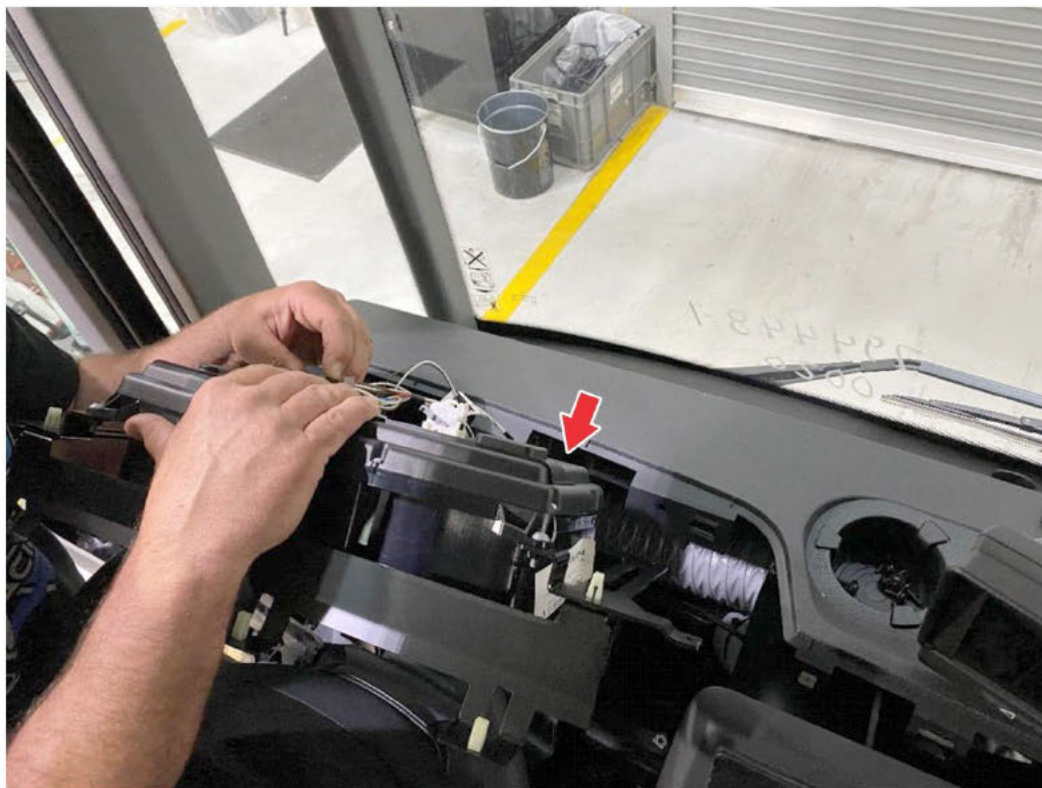
**Fig. 16, Removing the ICUC from the Vehicle**

The supplier of the ICUC installed a spare part (RTC) that increases the load on the battery, causing voltage to drop at low, undefined cold temperatures. This voltage collapse resets the system date to 2007, leading to incorrect data display in the maintenance system.

21. Remove the old ICUC and disconnect the harness. See [Fig. 16](#).
