Stained Coolant Surge Tanks

No.: 24CSA.20
October 2024

TO: Service Locations
FROM: Powertrain Service Engineering
SUBJECT: Discolored Coolant Surge Tank on Heavy Duty Engine Product (HDEP)

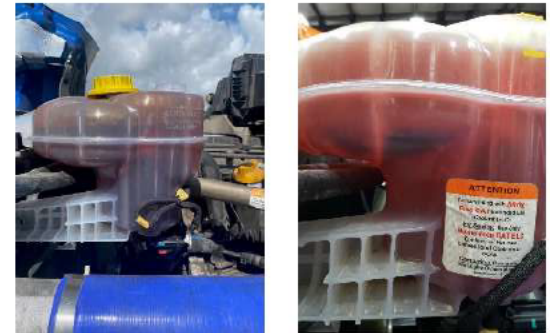
Some units may experience an issue with a complaint of a discolored coolant surge tank. Units may also come in with a complaint of oil or combustion gas in the coolant, based on the visible condition of the surge tank.

Examples of discolored surge tanks
