M2 and SD Vehicles Transfer Case Failures Due to Excessive Vehicle Speed

Field Service Solution SS 3155-FTL

Published Date: 10/1/24

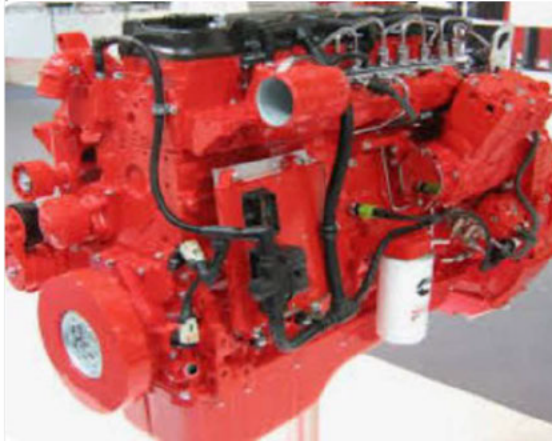
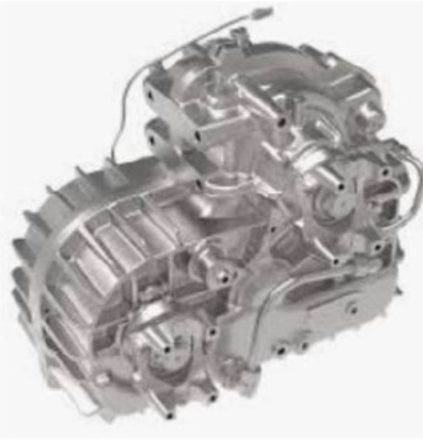
- There is a procedure that some customers have discovered where **multiple unintended inputs** are applied to the Cummins ECM, that allows for the programmed maximum vehicle speed to be defeated. When the programmed maximum vehicle speed is exceeded, damaged to the transfer case can occur.

- **Unintended inputs** especially multiple inputs intended on defeating a system are hard to detect. Now knowing of the issue, engineering has more robust interlocks that prevent this from happening in the future.

- Published Service Solution **SS 3155-FTL** on **10/1/24** that provides technician information on how to update the 2-speed wiring which eliminates the vehicle speed from being exceeded when multiple unintended inputs are applied to the Cummins ECM.
