Problem Details:

- Shop call 510847 brought awareness to J1939 communications issues for vehicles built with Cummins engines, automated transmissions and Bendix side radar. The CAC is also receiving many complaints of new vehicles, arriving with the side radar being unplugged and/or fault codes generating when customers add components to our RP1226 customer connections.
- **Symptoms reported** when the issue is present, include **transmission shifting issues, no crank** and a common **fault code** seen includes **37/523615/31-Received Network Data In Error -XBR**

- FSPR **38389**, Shop Call **510847**, FRACAS **13879**

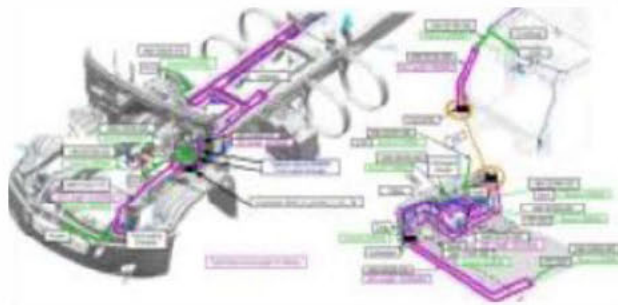
- Investigation has confirmed that the harness physical layer is causing reflections/Error Frame in J1939 CAN network. Reflections are normally caused by harnesses with too many unnecessary stubs, stub length too long (>1.6M) and too many individual stub lengths that are the same length.
- **Direct Cause:** CAN bus signal integrity is insufficient.

Creating **new harnesses** in parallel to field containment to optimize/reduce backbone length and breakout length.

- Freightliner Service Bulletin **54-366** Published on **10/29/24** for P4 vehicles that identifies problem vehicles, while providing corrective actions. The corrective action includes providing a dash, engine and chassis J1939 overlay harness.
