SF710 A-D

Subject: Freightliner High-Voltage Cable

PROBLEM: E-vehicles with inverters having improperly torqued high-voltage (HV) cable connections may encounter issues including intermittent propulsion power or complete loss of power from one inverter.

SOLUTION: A Daimler Truck North America authorized service facility will conduct a thorough inspection and check the torque levels of all HV cable connections on the inverter as well as the HV battery connections.

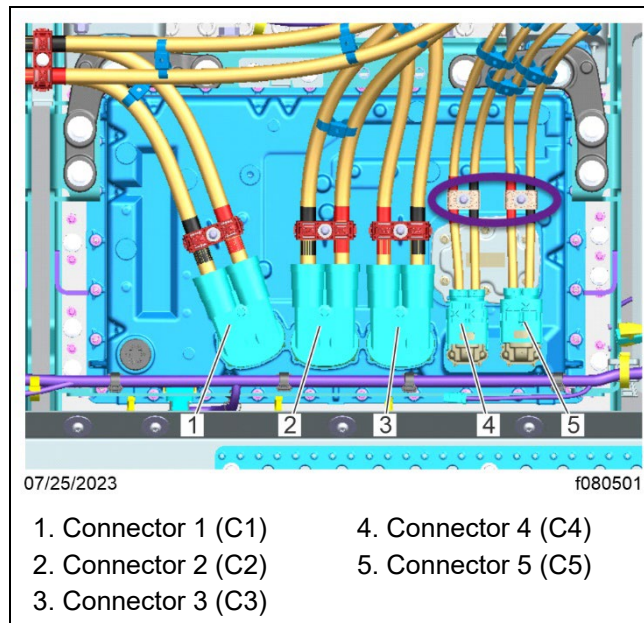
Fig. 4, HV Battery Connectors

5. Inspect all the HVS420 connector fasteners, located on the HV battery EE boxes and DC boxes, for the correct torque of 17 lbf·ft (23 N·m) by tightening the fasteners. Fill out the torque values in [Table 3](#) and [Table 4](#). See [Fig. 4](#), [Fig. 5](#), and [Fig. 6](#).

IMPORTANT: If any HV connections are found to be visibly backed-out, loose, or hand-tight, remove the connection and inspect the electrical contact surfaces for damage. If any signs of damage are found, replace the cable assembly and the mating component (inverter or HV battery).

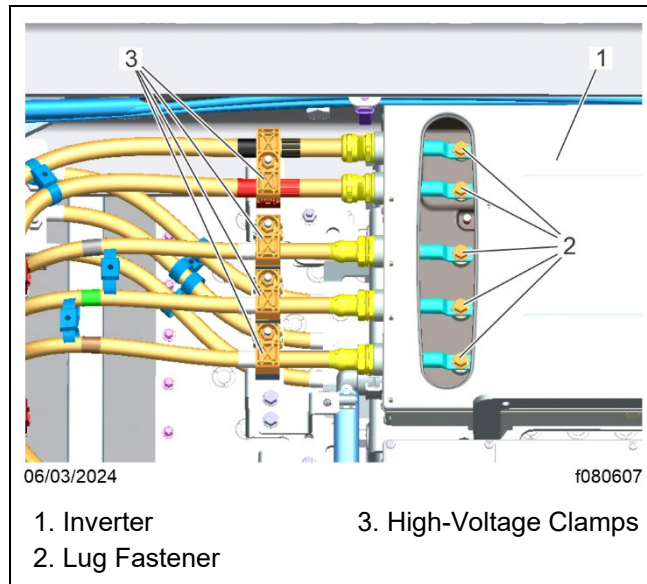
Fig. 9, High-Voltage Cable Clamps

8. Inspect all the inverter lug fasteners for the correct torque of 17 lbf·ft (23 N·m) by tightening the fasteners. Fill out the torque values in [Table 5](#). See [Fig. 9](#).

IMPORTANT: If any HV connections are found to be visibly backed-out, loose, or hand-tight, remove the connection and inspect the electrical contact surfaces for damage. If any signs of damage are found, replace the cable assembly and the mating component (inverter or HV battery).

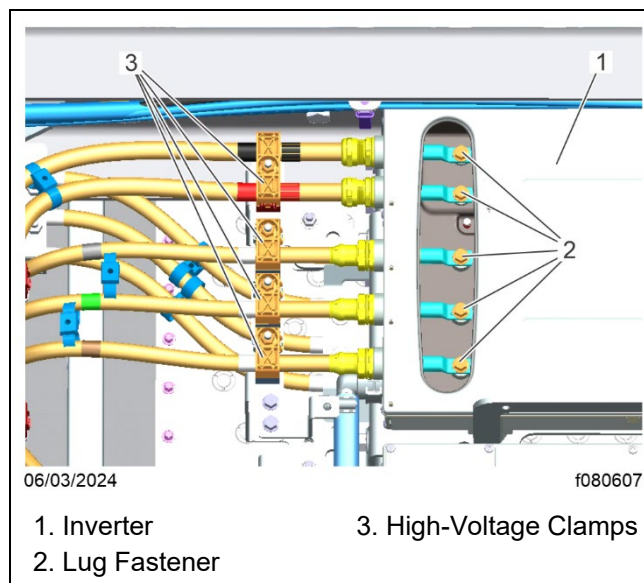
Fig. 14, High-Voltage Cable Clamps

8. Inspect all the inverter lug fasteners for the correct torque of 17 lbf·ft (23 N·m) by tightening the fasteners. Fill out the torque values in [Table 6](#). See [Fig. 14](#).

IMPORTANT: If any HV connections are found to be visibly backed-out, loose, or hand-tight, remove the connection and inspect the electrical contact surfaces for damage. If any signs of damage are found, replace the cable assembly and the mating component (inverter or HV battery).

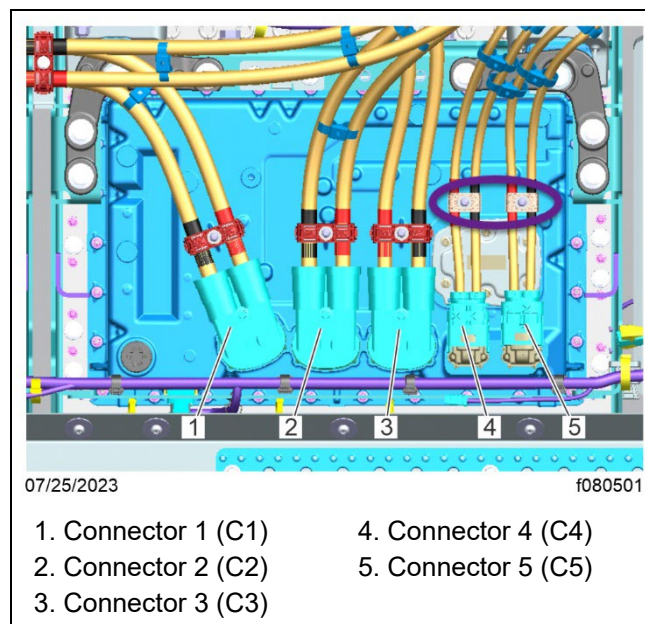
Fig. 15, HV Battery Connectors

- Inspect all the HVS420 connector fasteners, located on the HV battery EE boxes and DC boxes, for the correct torque of 17 lbf·ft (23 N·m) by tightening the fasteners. Fill out the torque values in [Table 7](#) and [Table 8](#). See [Fig. 15](#) and [Fig. 16](#).

IMPORTANT: If any HV connections are found to be visibly backed-out, loose, or hand-tight, remove the connection and inspect the electrical contact surfaces for damage. If any signs of damage are found, replace the cable assembly and the mating component (inverter or HV battery).

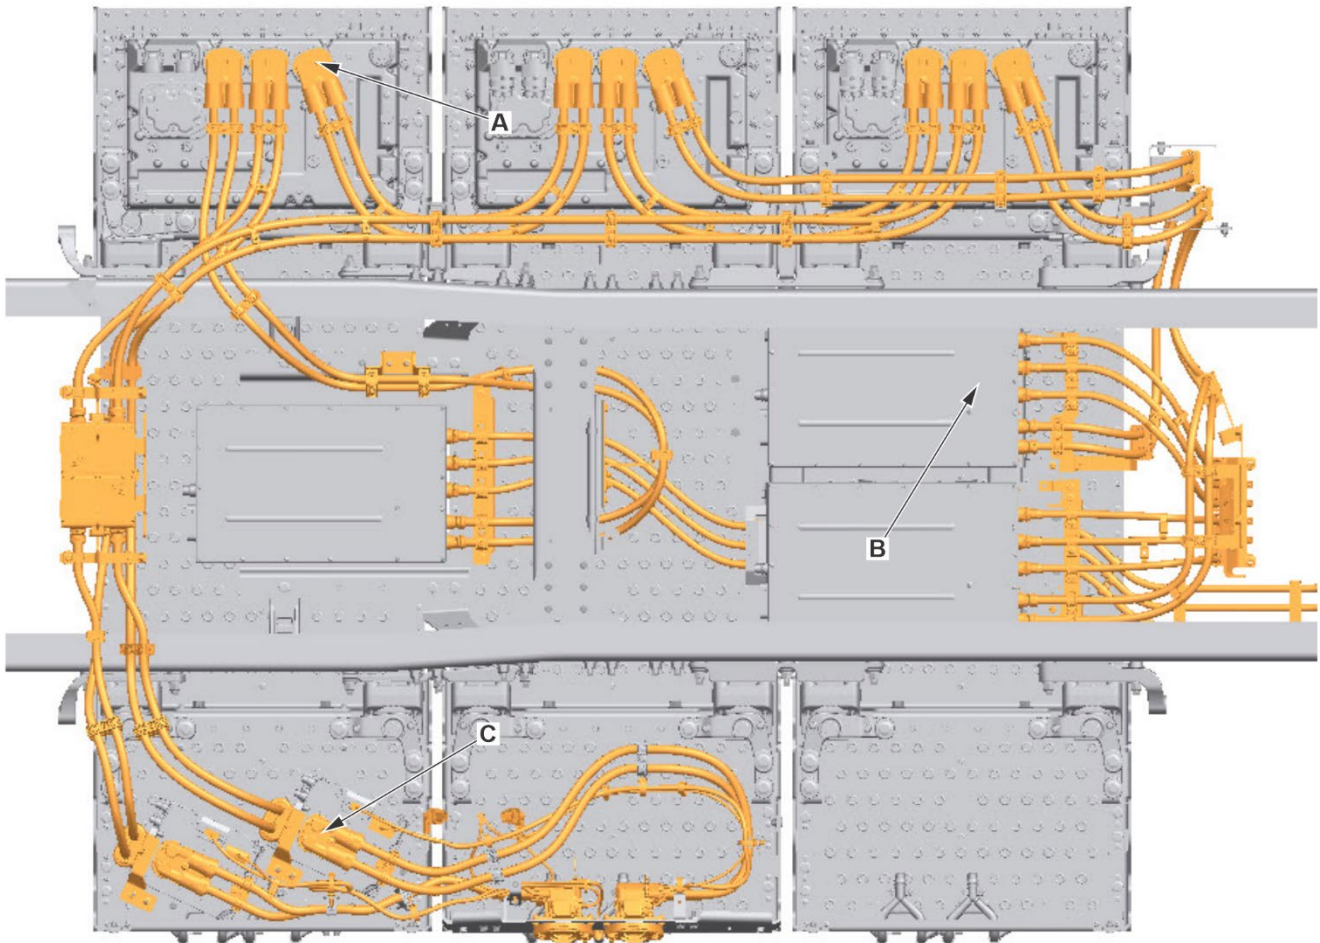
Fig. 16, 6x4 Cable Layout

A. Check the large HV connectors on the HV batteries.

C. Check the HV connections on the DC boxes.

B. Check the cable lug fasteners inside the inverter.
