SS 3142-FTL J1939 CAN issues for vehicles equipped w/ Bendix Side Radar w/ expanded field of view

NOTE: Freightliner Service Bulletin 54-366 published on 10/29/2024. Please refer to the Service Bulletin for instructions on addressing the containment provided in this Service Solution. Also refer to the Service Bulletin for any future concerns associated with the information provided in this Service Solution.

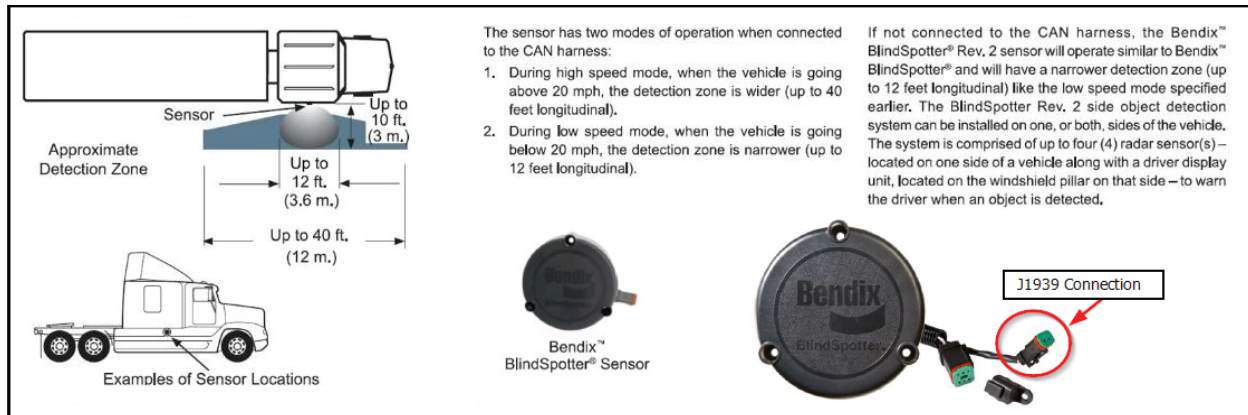
The Bendix Side radar revision 2 uses J1939 to monitor vehicle speed. The containment would include unplugging only the 2-pin J1939 connection to the side radar. Unplugging of the J1939 allows the Bendix side radar to function like the earlier version. The only function difference with the J1939 unplugged relates to vehicle speed. With the J1939 unplugged, vehicle speed above 20 MPH, will not expand the detection zone to up to 40 feet, but rather maintain the roughly 12-foot detection zone as pictured in the Figure 1 below.
