# SS 773-WST Optimized Idle icon missing on instrument cluster

Model Year 2024 Western Star vehicles equipped with Optimized Idle.

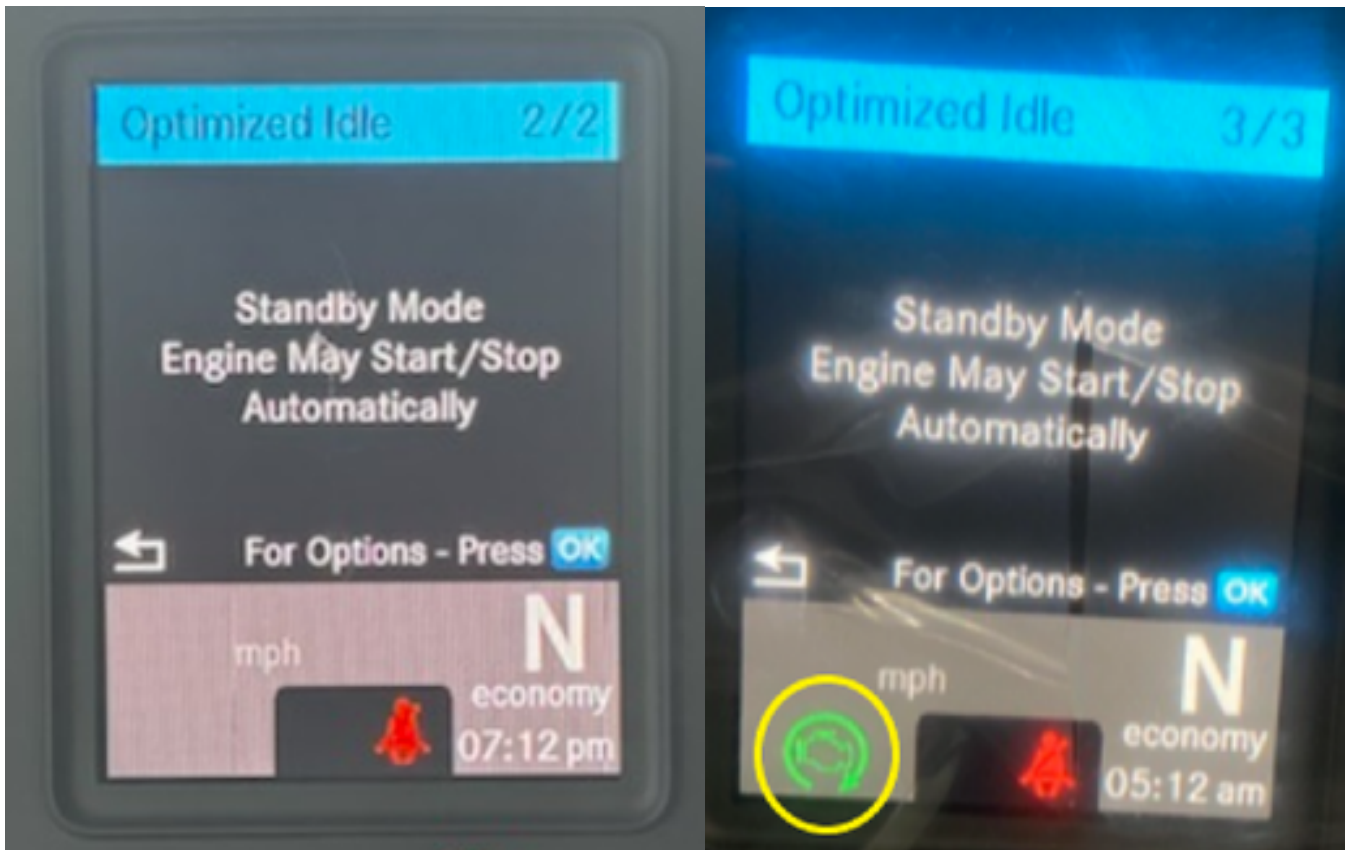
Figure 1

While Optimized Idle is running the icon or telltale does not illuminate. See figure 1. This icon does not prevent the Optimized Idle feature from functioning.

A bug with model year 2024 software in the instrument cluster can cause the Optimized Idle icon to not illuminate.

This will be fixed in the model year 2025 software package. Model year 2024 vehicles will **not** be compatible with model year 2025 software.
