# Service Bulletin

Bulletin No.: 23-NA-086

**Subject:** Information on Dark Spots Noticed in Headlamp Pattern When Vehicle is Pulled Up to a Wall or Garage

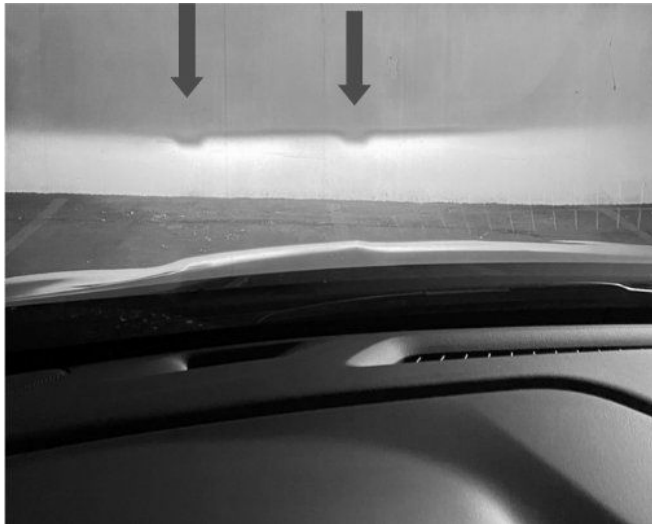
<p style="text-align: right;">6340797</p> <p>Shown in the picture above is an example for Enclave, Blazer, Traverse, and Acadia headlamp.</p>

<b>Cause</b>	This dark spot in the lighting pattern is <b>NORMAL</b> and part of compliance with the IIHS safety standards to minimize glare to oncoming traffic.
<b>Correction</b>	<b>DO NOT</b> replace the headlamps for this condition. This is a normal function of the lamps.

Please communicate to the customer that the headlamp system is functioning as designed and this is a normal condition of their vehicle. Please share this information with the customer, including a copy of this bulletin.

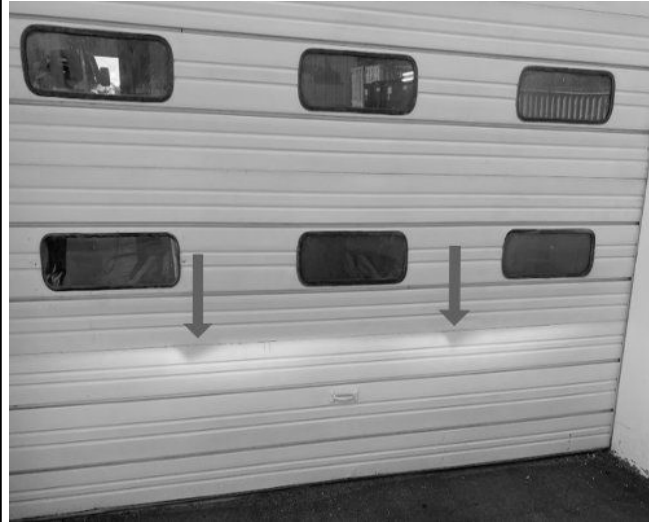
Shown in the picture above is an example for Encore, Encore GX, Envista, Trailblazer, and Trax headlamp. 6472911
