Service Bulletin

Bulletin No.: 24-NA-166

Subject: DTC C1171 C1172 C1173 C1174 Tire Pressure Monitor Sensor Unable to Relearn Ethernet Cable Overlay for TCP OnStar Module

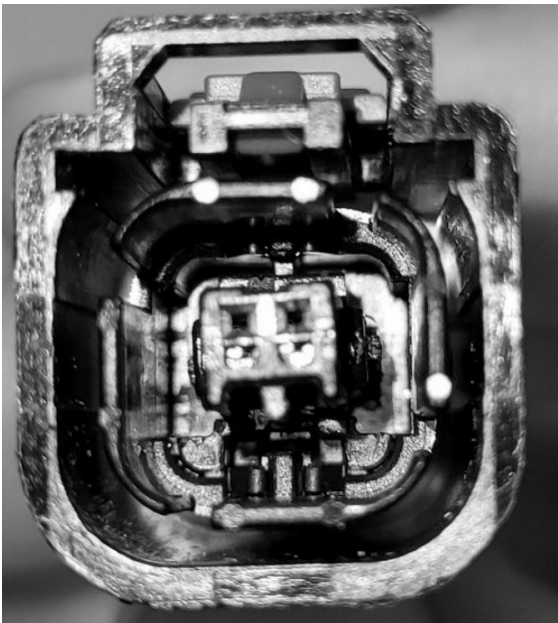
6720432

Following the middle ridge to the back, this is where the housing locks onto the cable.

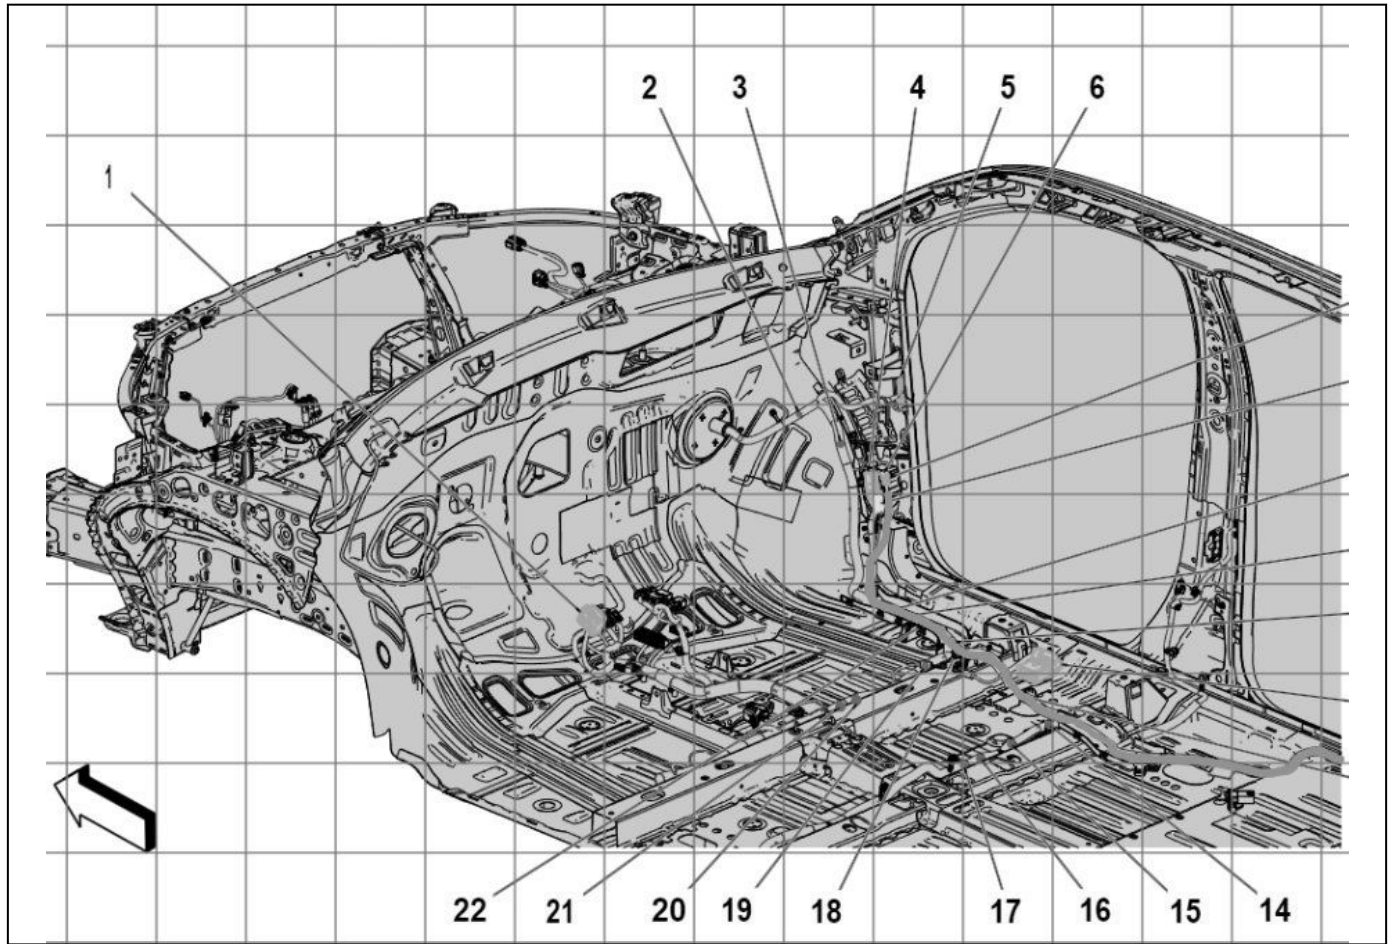
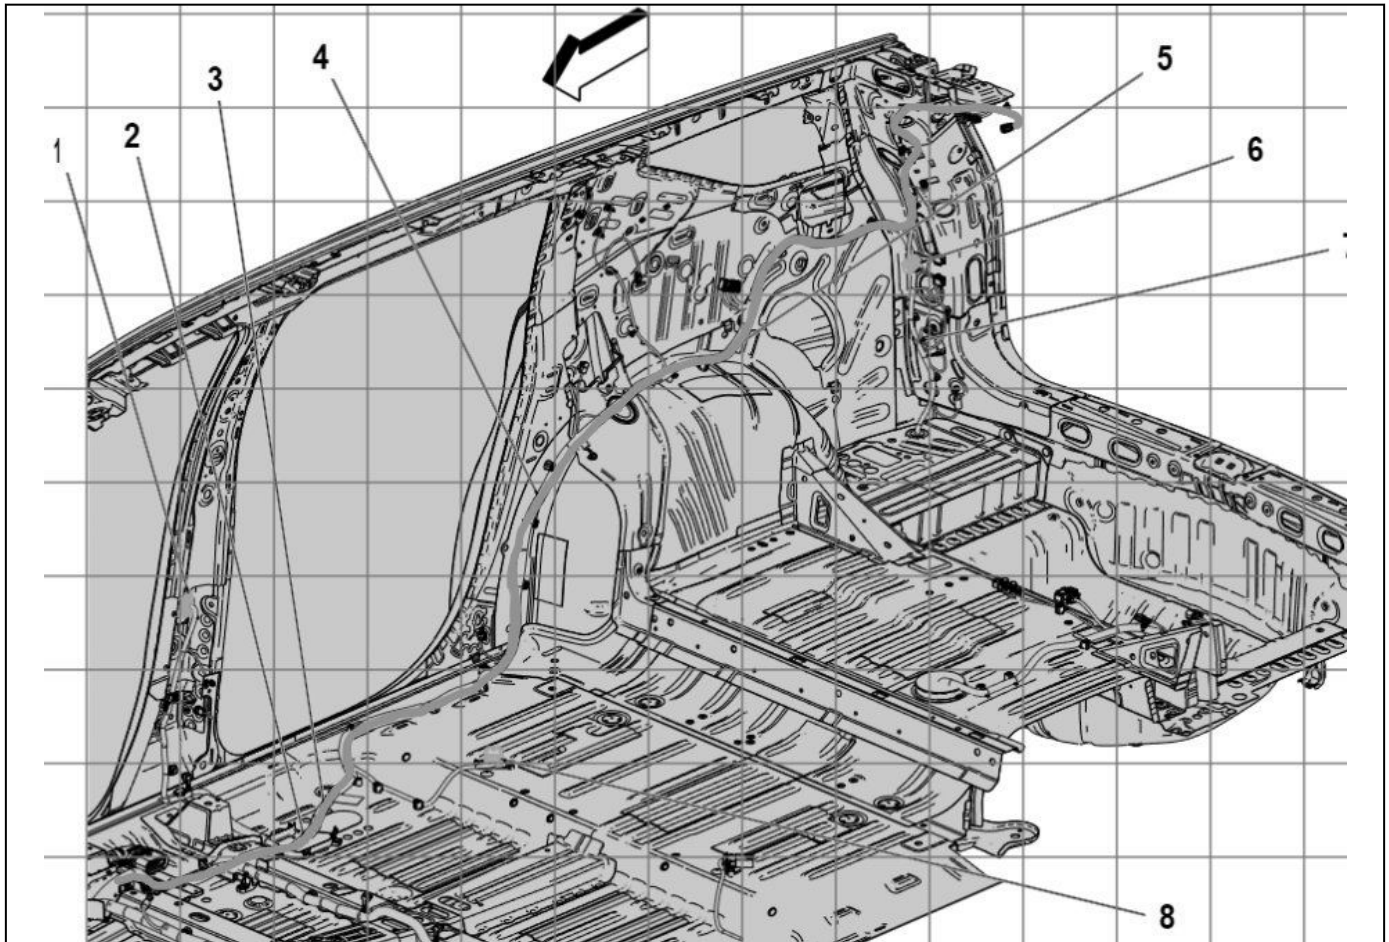
6706066

Note: Replacement Ethernet Cable routing shown in Green.

18. Begin to route the new Service cable starting at X205 and following the Body Wiring Harness running back towards the Telematic Control Module. Use the diagrams above to reference cable routing.
