Service Bulletin

Bulletin No.: 24-NA-234

Subject: Front Hood Misadjusted (Re-align), Front Hood Dented When Latched (Lower Front Hood Bumpers and/or Slightly Raise Latch to Remove Appearance of Dents)

Brand:	Model:	Model Year:		Date Breakpoint:		Engine:	Transmission:
		from	to	from	to		
Chevrolet	Malibu	2024	2025	SOP	Built Prior to October 8, 2024	All	All

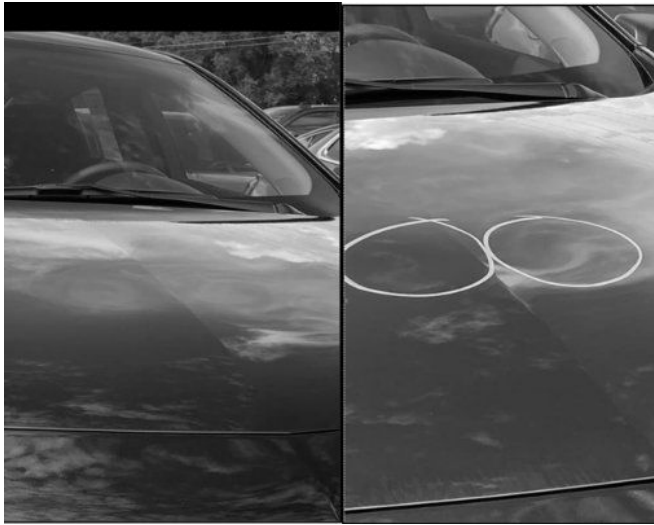
<p style="text-align: right;">6751912</p> <p>Some customers or Dealer technicians may comment on the appearance of low spots or dents in the hood when it is completely latched. The concern may be more noticeable on darker exterior colors.</p>
Cause	The condition may have been caused by an improper adjustment of the primary and secondary latch assembly, causing the hood to be in tension when latched.
Correction	Refer to the procedures outlined below.

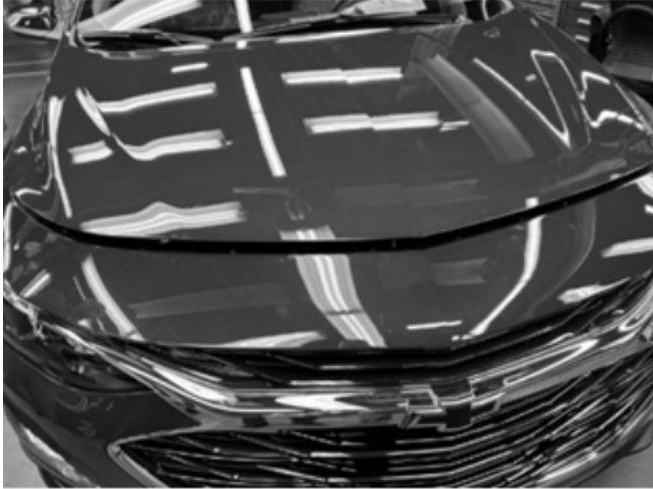
6751914

1. Identify the specific area of the dent(s) on the hood.
2. Open the hood to the secondary latch position by pulling and releasing the hood primary latch release cable handle.

3. Observe the specification location identified in step 1 with the hood at the secondary latch position.
4. If the dents are no longer visible, then the hood needs to be adjusted based on the Service Procedure below.
